**FINAL REPORT**  
**A - 020/CENIPA/2018**

| <b>AIRCRAFT:</b> | <b>PT-AVO</b> |
| <b>MODEL:</b> | <b>F35</b> |
| <b>DATE:</b> | <b>07FEB2018</b> |

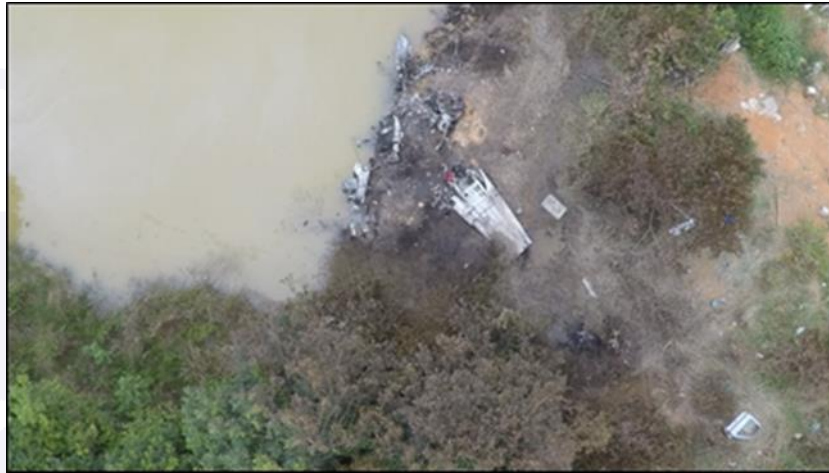
The aircraft crashed into the ground, 280 meters away from threshold 09 of the Crepurizão community runway. No evidence of previous impact was identified. The wreckage was concentrated.

The plane hit the ground in a pitch down attitude (approximately 10°) and banked left. There was fire after the impact.

Figure 1 - Location of the accident at the margins of a water reservoir with concentrated wreckage.

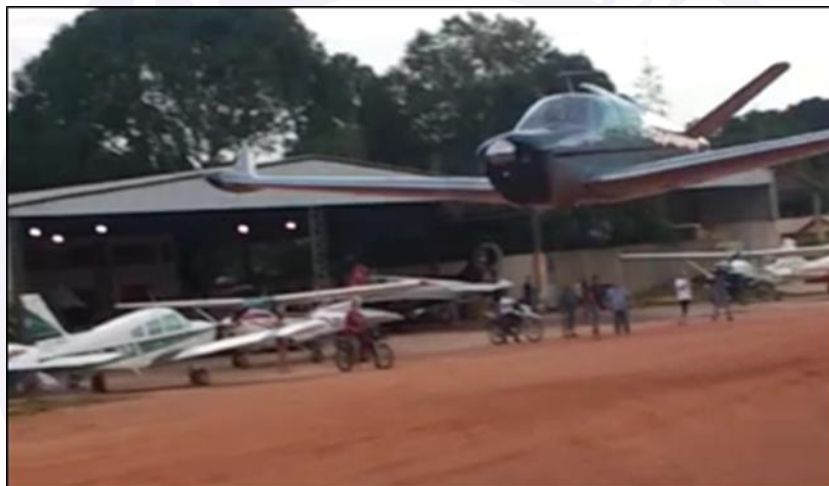
Videos presented to investigators during the field investigation showed the aircraft performing low-level passes and performing acrobatic maneuvers at the location (Figures 2 and 3).

Figure 2 - PT-AVO low pass in Crepurizão. In the background, there was the hangar in which the radio station was located.

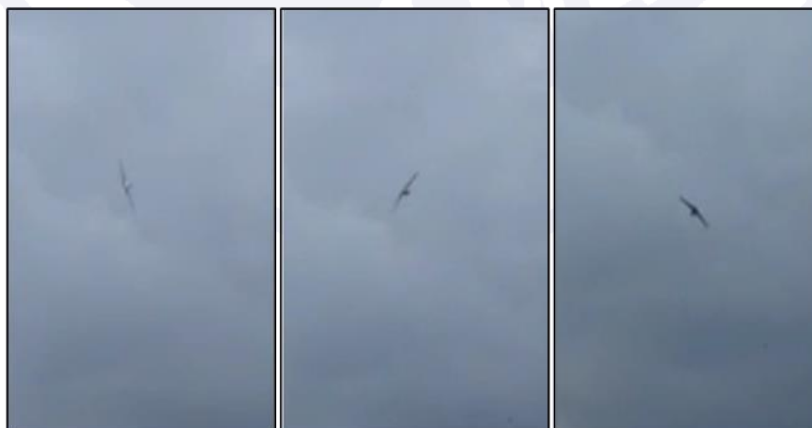
Figure 3 - Acrobatic maneuvers after low pass in Crepurizão.

According to statements collected, the pilot had the habit of performing these types of maneuvers in the locality.

In addition to the reports received, this fact could be evidenced in the video in which the crewmember performed a low pass and then performed acrobatic maneuvers, demonstrating an attitude marked by overconfidence and exhibitionism.

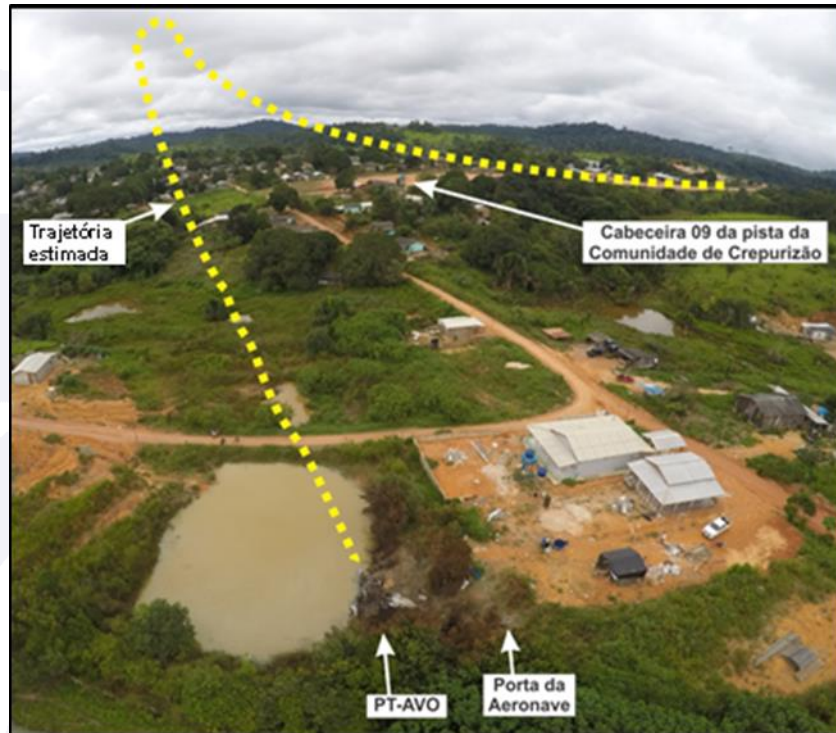
According to observers, the flight on which the accident occurred started with an aggressive takeoff, with rapid climb and subsequent left turn. After that, the plane lost altitude, with its left wing down, and crashed into the margins of a water reservoir.

Figure 4 - Estimated trajectory of the aircraft until the crash site on the margins of a water reservoir.

The course taken by the plane after the left turn was very close to the one that would take it to its destination, the SWSI Aerodrome.

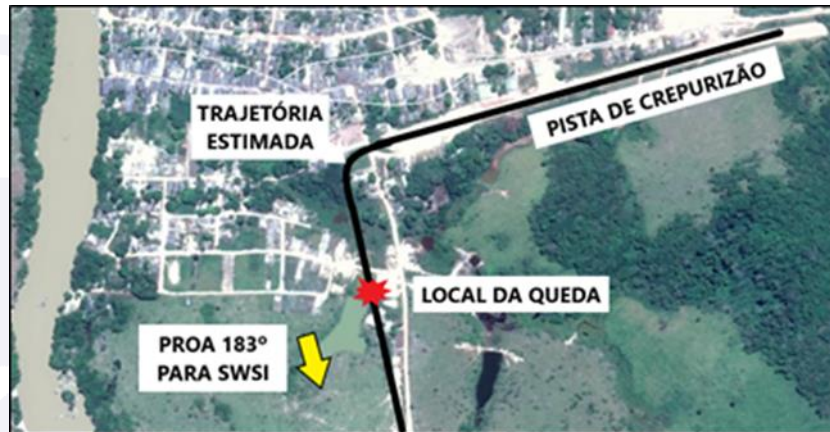
This hypothesis was also supported by the fact that the direction taken by the plane after the left turn was very close to the one that would take it to its destination, the SWSI Aerodrome. (Figure 5).

Figure 5 - Estimated trajectory, heading to SWSI and place of fall.
