FINAL REPORT
A - 548/CENIPA/2017

OCCURRENCE:	ACCIDENT
AIRCRAFT:	PT-IFS
MODEL:	PA-34-200
DATE:	17MAY2011

This is the Final Report of the 17MAY2011 accident with the PA-34-200 aircraft, registration PT-IFS. The accident was classified as “[LOC-I] Loss of Control in Flight”.

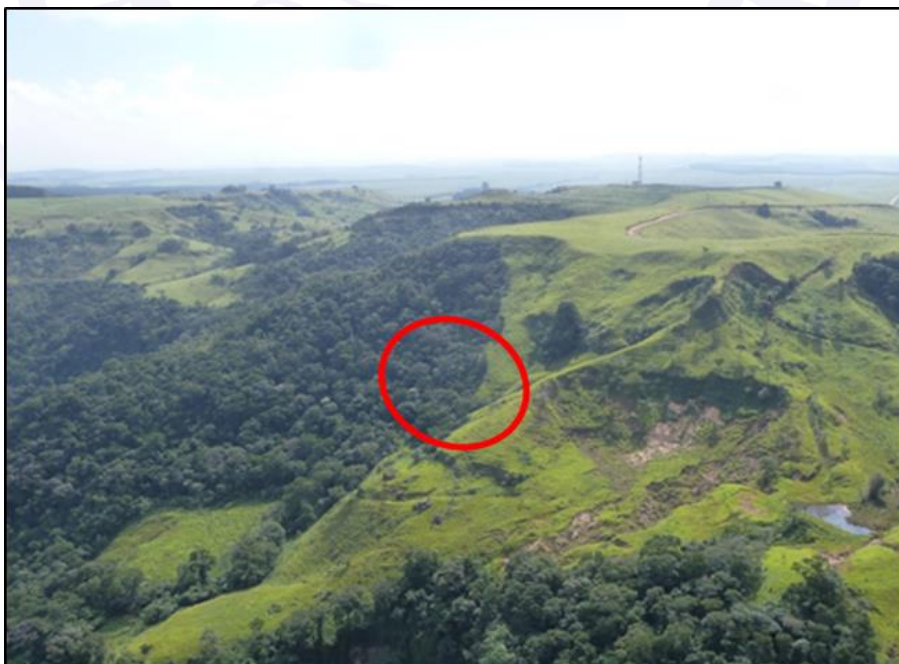
Figure 1 - Place where the aircraft fell down.

The aircraft collided with *Serra do Facão*, which had a steep profile and hillsides of rocky terrain, covered by trees. The top of the elevation was 1,000 meters high. The impact occurred on the southern hillside, at 930 meters high.

The damage verified in the local vegetation allowed to estimate that the angle of the collision trajectory was of approximately 70° pitched down and that the inclination of the wings was of approximately 30°, curving to the right.

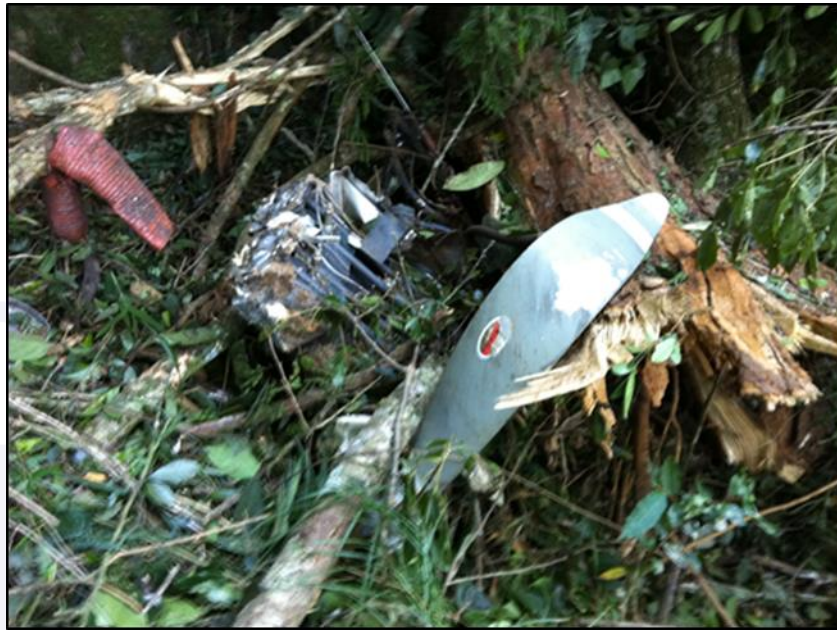
Figure 2 - Condition in which the right engine and propeller were found.

Both propellers presented deformation characteristics, compatible with a collision in soft terrain, in which the engines developed power. There were indications that the right engine propeller cut some tree trunks in the trajectory to the point of the last impact.

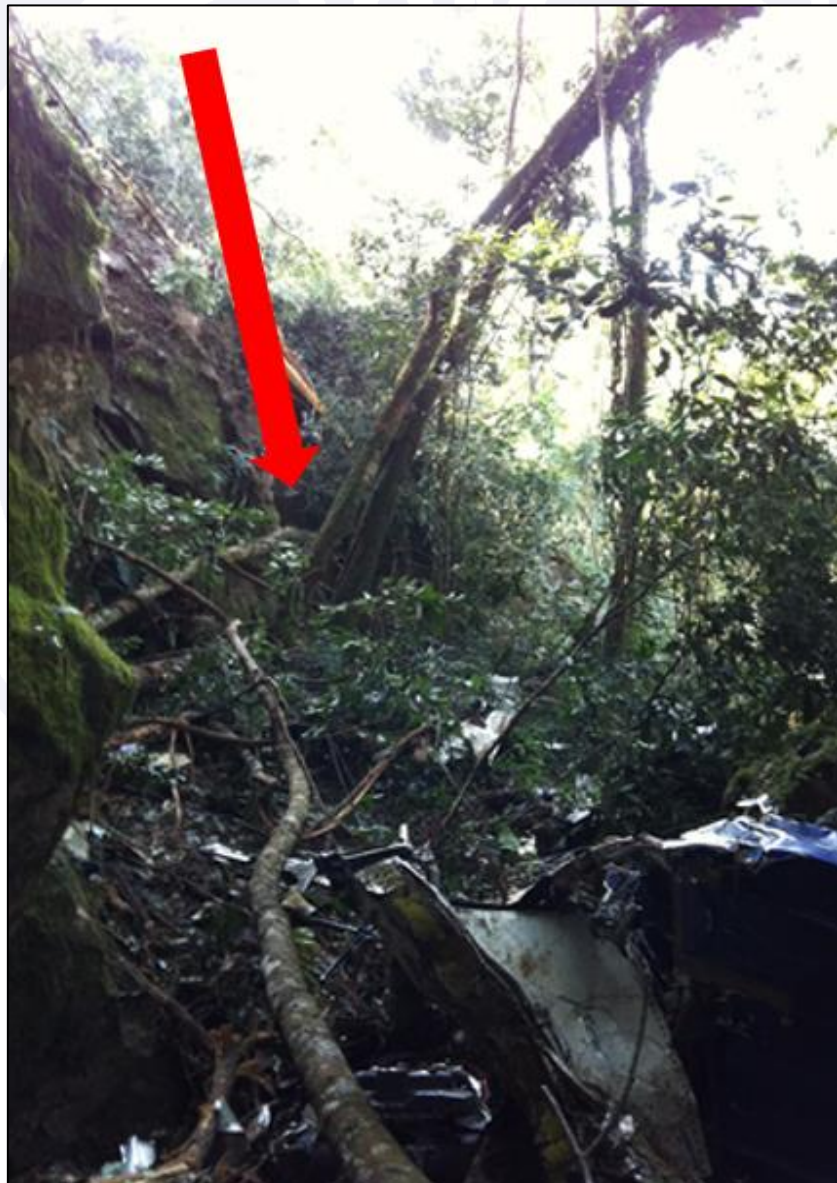
Figure 3 - Aircraft trajectory.

The wings were ripped off by the vegetation before the final collision against the ground.

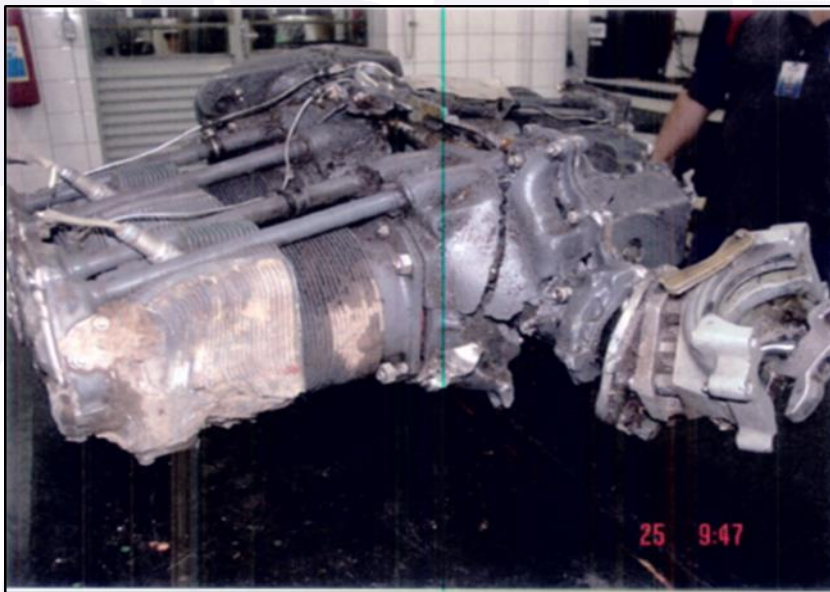
Figure 6 - Front view of left engine.

The tests performed on the engines by the IAE, in São José dos Campos - SP, showed that they presented similar damages. It was found that both were almost completely destroyed, evidencing that the collision occurred with high speed.

Due to the deformation that the fuel injector presented, it was not possible to assemble them in a test bench to verify performance. However, its partial disassembly revealed that the diaphragms were in good condition, and no evidence of fuel or air leakage was found.

During the analysis of the internal components of the two engines, no abnormalities were identified that could compromise their operation.

It was not possible to point out evidence of deficiency in lubrication, risks in the bearings, risks in the cylinders, detonation, pre-ignition or malfunction of the spark plugs.

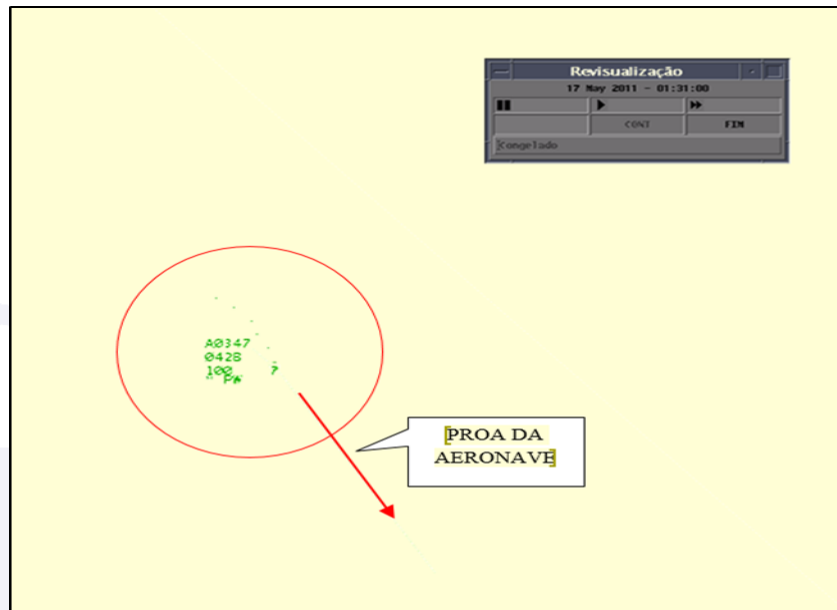
Figure 9 - Radar view 17MAY2011, 01:31:00 (UTC).

After being cleared by APP-YS, during the descent from the altitude of 5,500 FT to 4,200 FT it initially kept the heading of Piracicaba and reduced the speed from 140 to 100 KT.

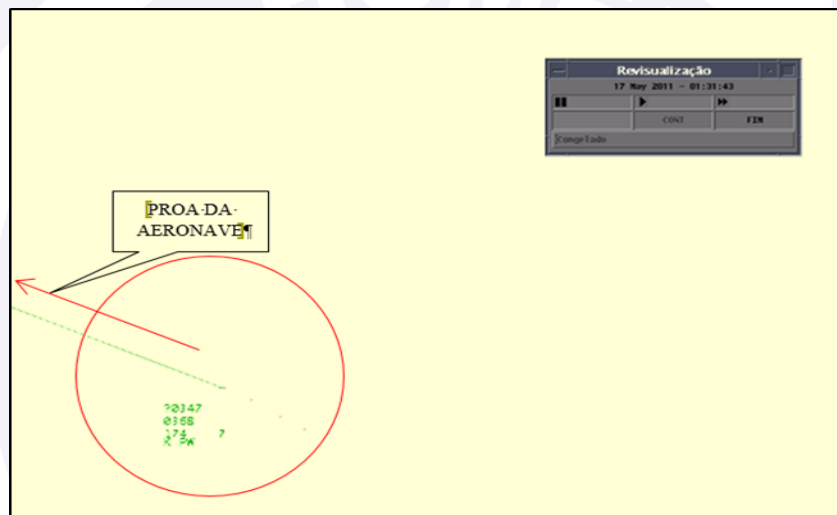
Figure 10 - Radar view 17MAY2011, 01:31:43 (UTC).

At 01h:31min:43sec (UTC), the aircraft started a right turn, accelerating to 174 KT.

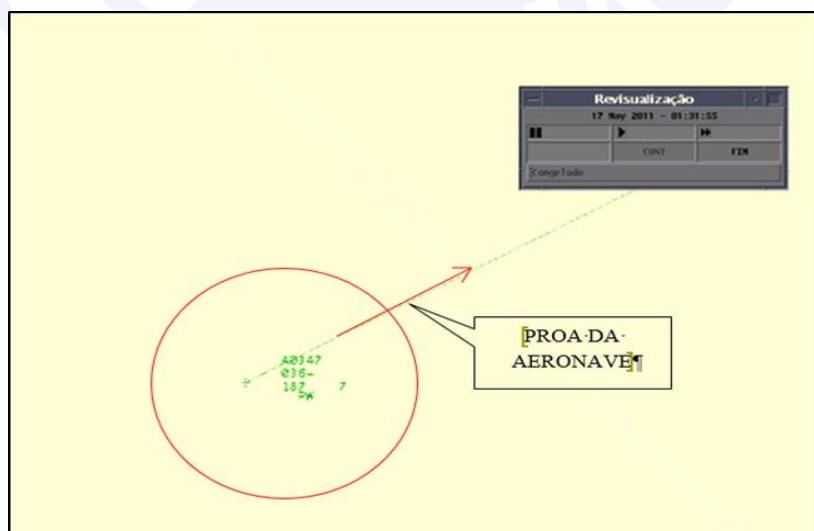
Figure 11 - Radar view 17MAY2011, 01:31:55 (UTC).

At 01h31min55sec, it continued the right turn, but had accelerated to 187 KT.

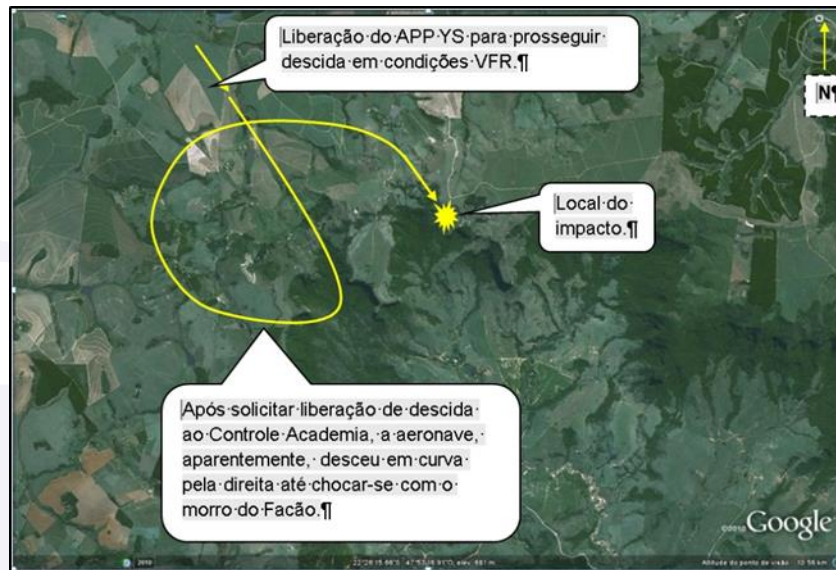
Figure 12 - Sketch of the occurrence.

It was not possible to determine the reason for the performance of this curve on the right, however, by the visualization presented by the radars, it was verified that it started with horizontal and vertical speeds compatible with a controlled curve.

After the first 90 degrees of curve, the gradual increase of the horizontal speed of the aircraft was verified, which accelerated until near the maximum structural speed in cruise prevised in flight manual.

The trajectory of the airplane from the moment it began the descent, performing a continuous curve, accelerating to a speed close to the structural maximum and colliding against the ground with high angle of impact, presented characteristics compatible with those of a Graveyard Spiral.
