**FINAL REPORT**  
**A - 101/CENIPA/2020**

<b>OCCURRENCE:</b>	<b>ACCIDENT</b>
<b>AIRCRAFT:</b>	<b>PP-GMC</b>
<b>MODEL:</b>	<b>AB-115</b>
<b>DATE:</b>	<b>26AUG2020</b>

This is the Final Report of the 26AUG2020 accident with the AB115 aircraft model, registration PP-GMC. The accident was classified as “[ARC] Abnormal Runway Contact and [RE] Runway Excursion”.

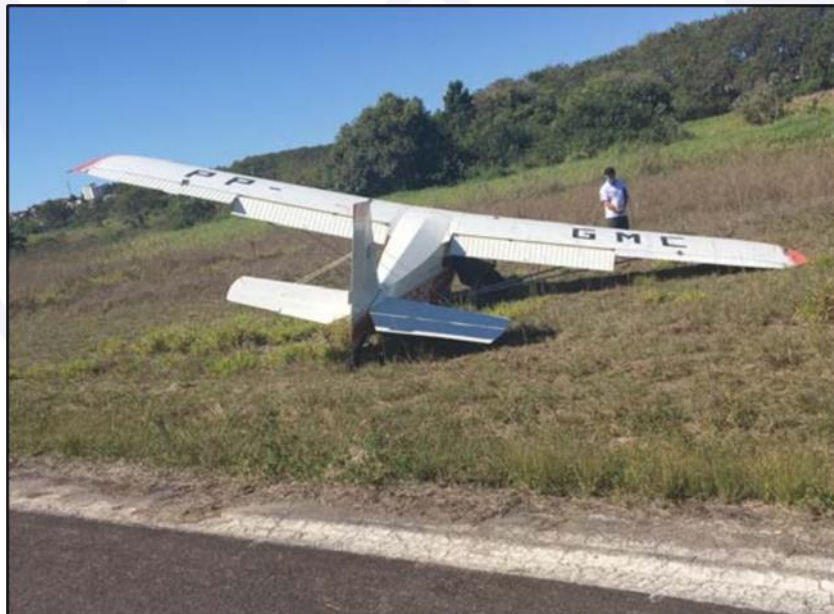
After the rupture of the right landing gear towbar, the aircraft leaned on the wingtip and the lower edge of the right side of the fuselage and swerved to the right, according to the marks left on the runway (Figures 1 and 2).

Figure 1 - Aircraft stopping position to the right of the runway 02 axis of SBGW.

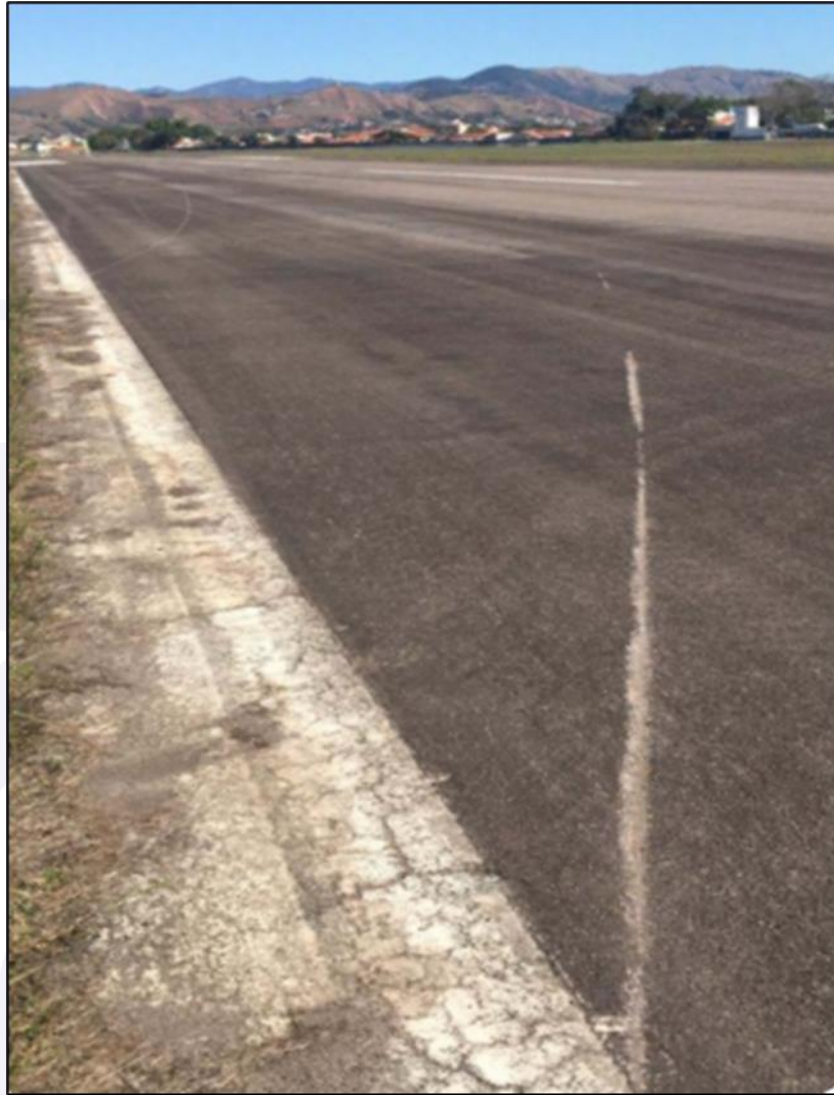
Figure 2 - Marks left on the runway by the right side of the aircraft structure in contact with the ground.
