FINAL REPORT
A - 133/CENIPA/2018

OCCURRENCE:	ACCIDENT
AIRCRAFT:	PP-MES
MODEL:	AS 350 B2
DATE:	10AUG2018

This is the Final Report of the 10AUG2018 accident with the AS 350 B2 aircraft model, registration PP-MES. The accident was classified as “[CTOL] Collision With Obstacle(s) During Take-off and Landing”.

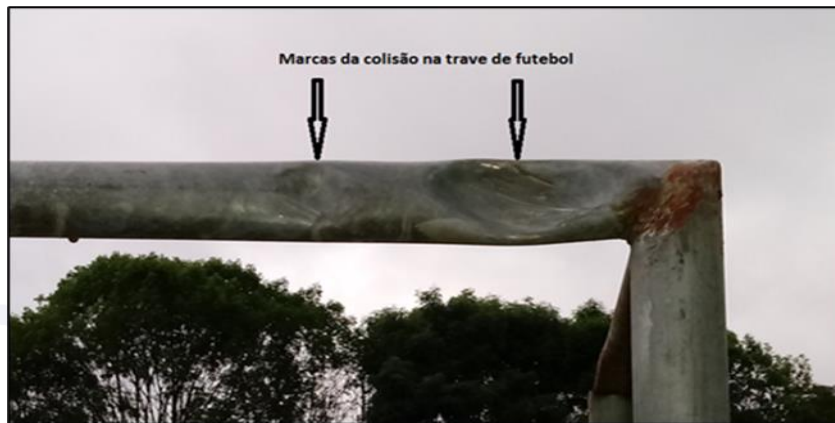
Figure 1 - Marks from the collision of the tail rotor blades against the soccer goalpost.

The goalpost's paintwork was gray, it was very worn and showed rust in several spots, offering little contrast to the local lawn.

On the other hand, the marks identified on the soccer goalpost, associated with other indications, such as the estimated height of the hovering flight, the position in which the goal was located, as well as its height, made it evident that the tail rotor collision had occurred against that obstacle.

The goalpost against which the collision took place was painted in gray and the paintwork was worn, offering little contrast with the local lawn, a factor that made it difficult to see.

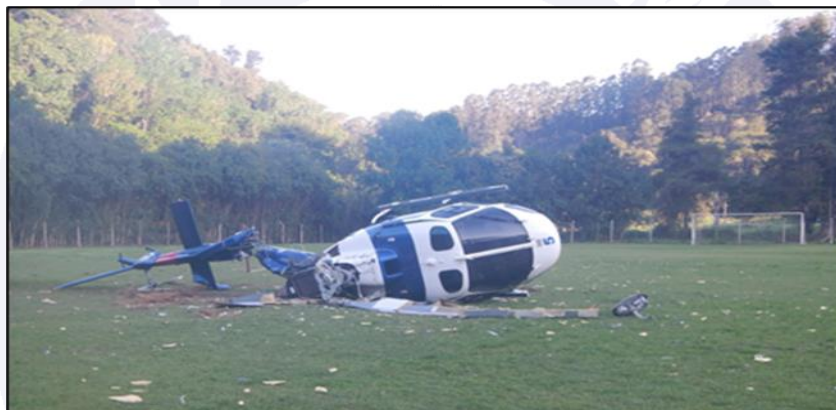
The investigators observed that, in the afternoon, the natural lighting at the accident site was reduced due to the shadow produced by the topography of the place (Figure 2).

Figure 2 - Image taken at the accident site in the afternoon showing the shadows produced by the topography.

These conditions, associated with the reduced natural lighting at the time of landing 1940 (UTC), impaired the pilot's ability to identify the existing obstacle near the point which he was approaching and led to a reduction in his level of situational awareness, which resulted in the tail rotor touching the soccer goalpost.

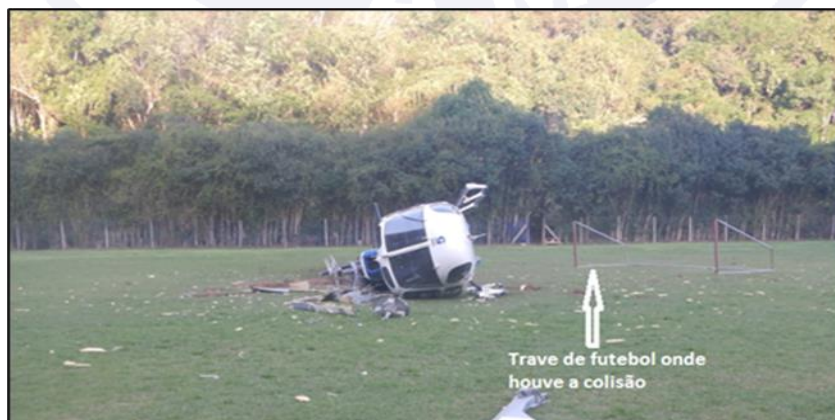
After the first impact, the helicopter destabilized and began an uncontrolled spin to the left, which resulted in the main rotor colliding with the ground and tipping the aircraft to the right. The wreckage was grouped in the center of the soccer field.

Figure 3 - View of the aircraft after coming to a complete stop and of the obstacle it collided with.

With this impact, the tail rotor had serious damage and lost its ability of acting to counteract the torque produced by the main rotor, which destabilized the flight, causing the aircraft to spin without control to the left, a few meters from the ground.

During this uncontrolled spin, the main rotor touched the ground, which triggered the sequence of impacts that followed until the helicopter tipped over and came to a complete stop.

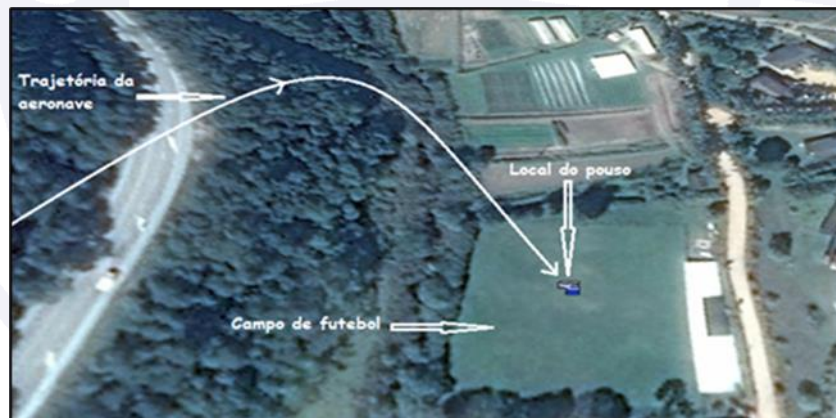
Figure 4 - Aircraft trajectory during approach for landing on the soccer field.

After positioning the aircraft in hover, in the center of the field, the PIC commanded a left turn to complete the landing procedure and, at that moment, the helicopter's tail rotor collided with the soccer goalpost.

After this first collision, the helicopter initiated an uncontrolled left turn, during which the main rotor collided with the terrain, and the aircraft tipped to the right after several other impacts occurred.
