**FINAL REPORT**  
**IG - 048/CENIPA/2017**

**SERIOUS INCIDENT**

**PP-PTQ**

**ATR-72-212A**

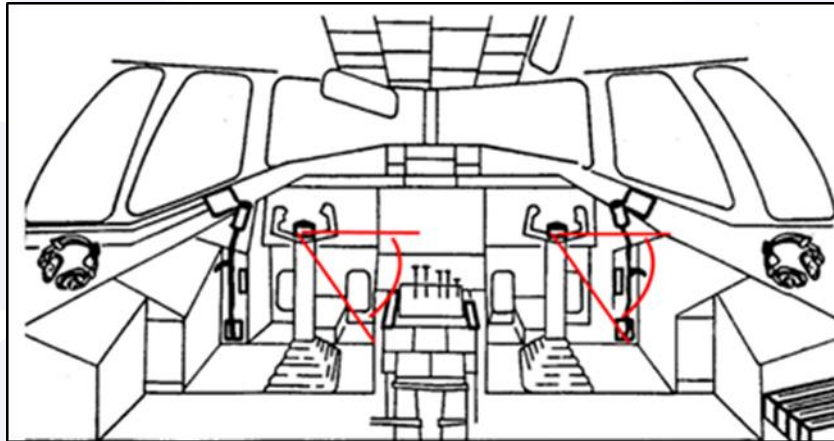
Starting from the neutral position, turning the steering wheel clockwise allowed the ailerons to be controlled throughout their course, up to their stop, and resulted in the expected movement of these surfaces, upwards on the right wing and downwards on the left wing (Figure 1).

Figure 1 – The approximate amplitude of command clockwise.  
Source: ATR.

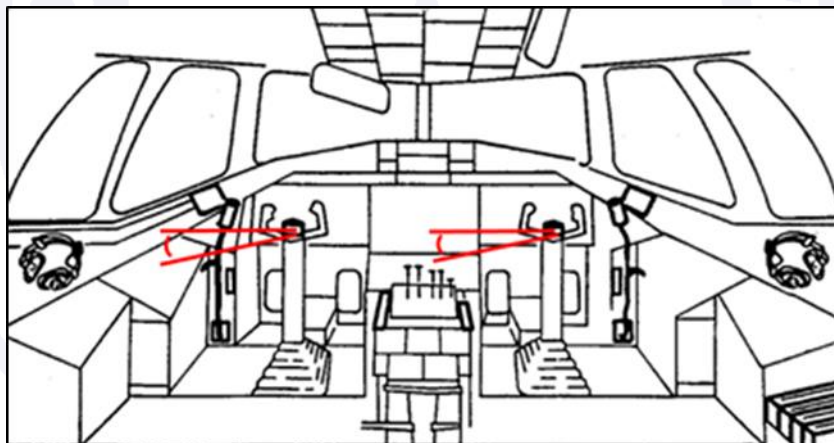
However, starting from the same position, turning the steering wheel counterclockwise did not allow the ailerons to be controlled throughout their course, since the rotation movement of the control wheel was blocked when the control reached approximately 15° of rotation.

Figure 2 - The approximate amplitude of command counterclockwise.  
Source: ATR.

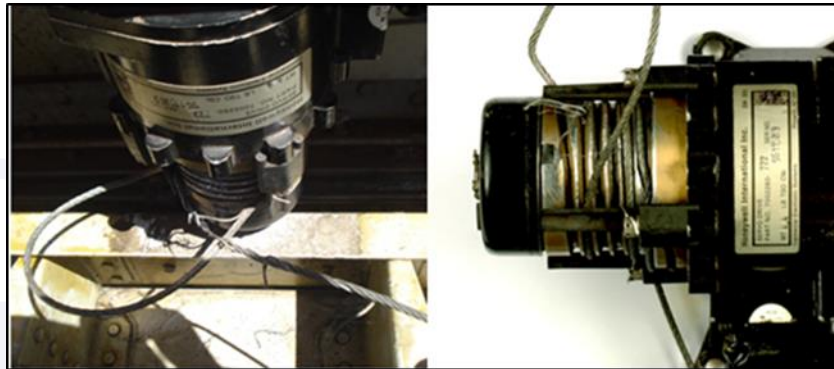
After removing the Servo Drive from the plane, together with the broken control cable, it was found that the rotating mechanism where the cables were rolled up, called capstan, was blocked and prevented from turning (Figure 6).

Figure 6 - Servo Drive removed from the aircraft with its cable broken.

Thus, it was concluded that the capstan was locked due to the control cable becoming entangled in the drum after breaking. In turn, the restrictions on the aileron command were due to the capstan being blocked by the broken cable.

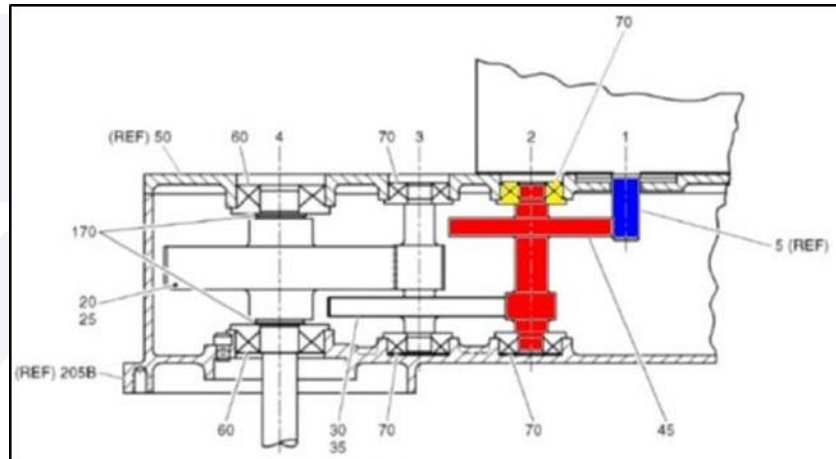
After separating the section of the electric engine / gearbox, with the disconnection of its gear set (n° 45, in red in the diagram below), the front block could be rotated without any resistance. However, the electric engine shaft (part n° 5, in blue) showed some resistance to manual rotation. The bearing (n° 70, in yellow) appeared to be in good condition (Figure 8).

Figure 8 - Identification of the electric engine / gearbox coupling components to the central body of the Servo Drive.

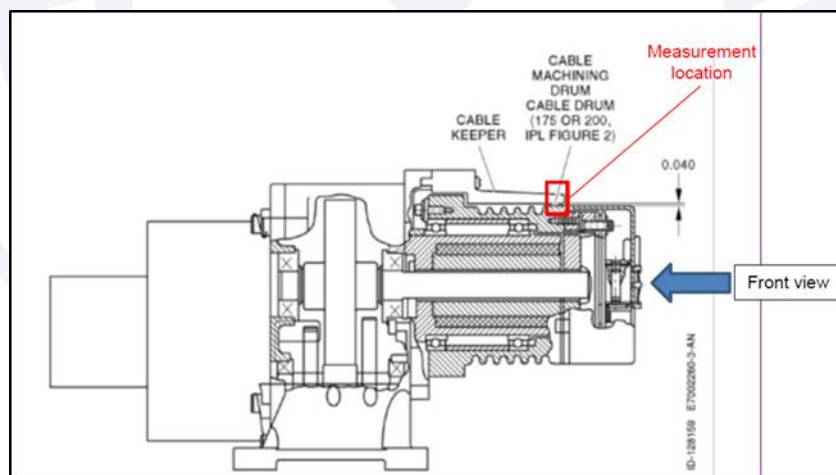
Figure 9 - Cable keepers distance measurement position.

They ranged from 0.95 to 3.10mm (+/- 0.10mm). The CMM required a maximum of 0.040 inches (1.016mm). No wear on the cable keepers was observed with the naked eye at the measurement positions. Wear areas have been identified in other regions, probably due to the friction between the cable keepers and the cables (Figure 10).

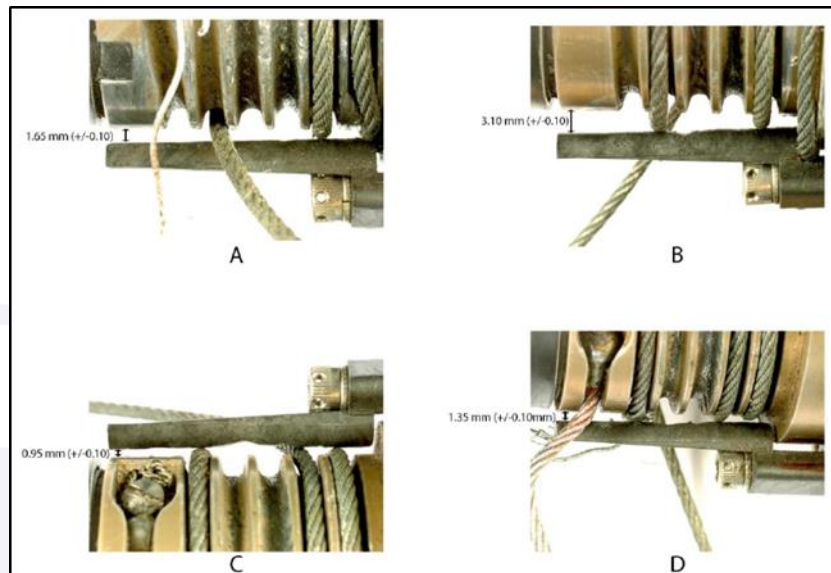
Figure 10 - Details of measurements and wear observed on cable keepers.  
Source: BEA.

In addition, measurements of the distances between the four cable keepers and the drum showed that three of them were further away from the capstan than recommended in the CMM and that they had regions of wear, probably due to the friction between them and the control cables.

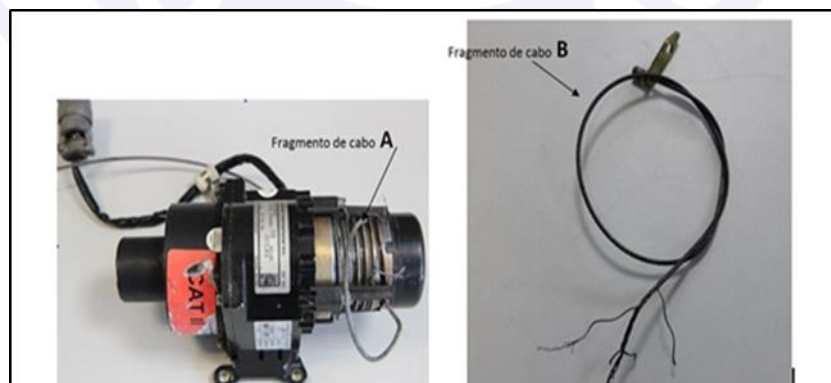
Figure 12 - Cable fragment connected to the Servo Drive (A) and cable fragment that was connected to the bellcrank (B).

The tests carried out showed that there were signs of wear, plastic deformation and ductile fractures, as well as the presence of corrosion on the surface of the cable.

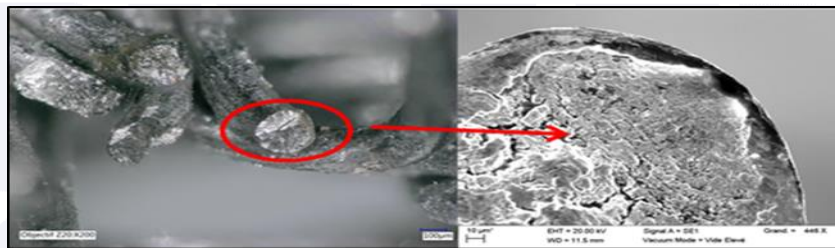
It was also found that a fatigue mechanism had occurred in several fracture regions.

Figure 14 - Fragment of cable A (connected to the Servo Drive). Fractured surface of one of the wires with beach marks, fatigue characteristics of the material.

Finally, the report issued by the AMR concluded that the cable failure was due to a fatigue process and that plastic deformations and oxidation probably occurred after the rupture.

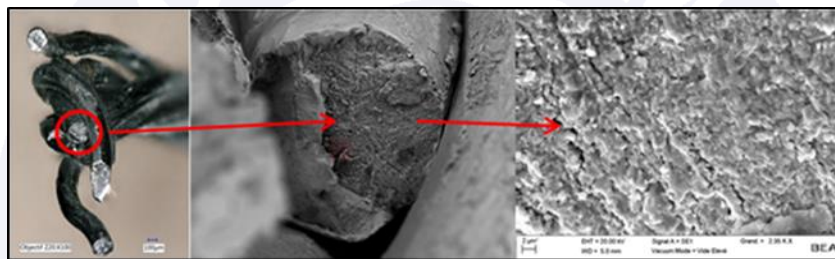
Figure 15 - Fragment of cable A. Fractured surface of another wire, also showing beach marks, characteristics of material fatigue.

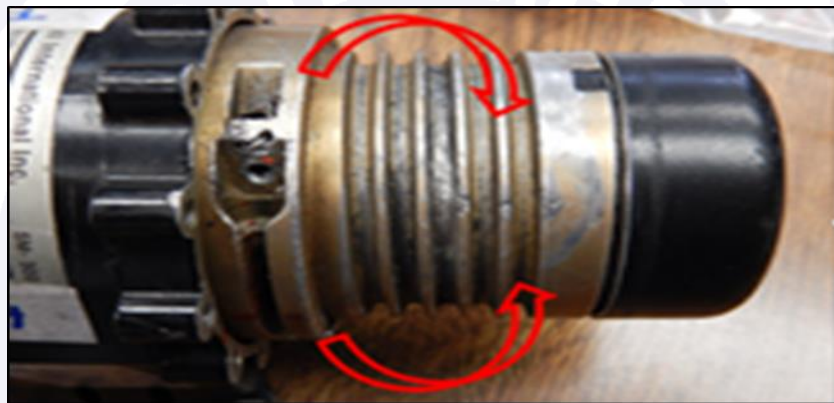
- the cable drum, or capstan, was free to rotate.

Figure 18 - Capstan free to rotate in both directions, clockwise and counterclockwise.

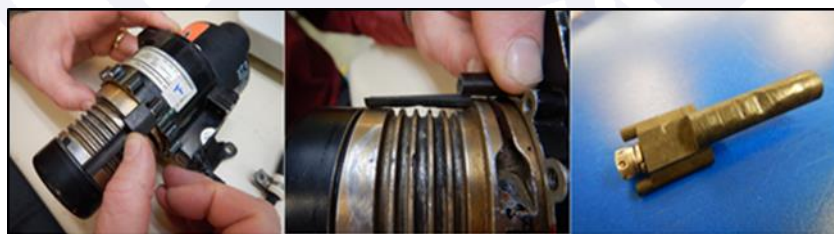
- the cable keepers were worn on the part facing the cable drum (capstan).
- most of the wear on the cable keepers was on the inner face associated with the three internal notches (closest to the clutch) of the cable drum (Figure 19).

Figure 19 - Cable keeper positioned and a wear detail.

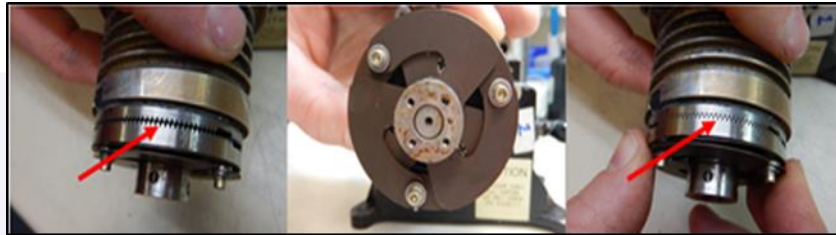
- the clutch was disengaged (Figure 21).

Figure 21 - Clutch disengaged, front view and manually engaged.

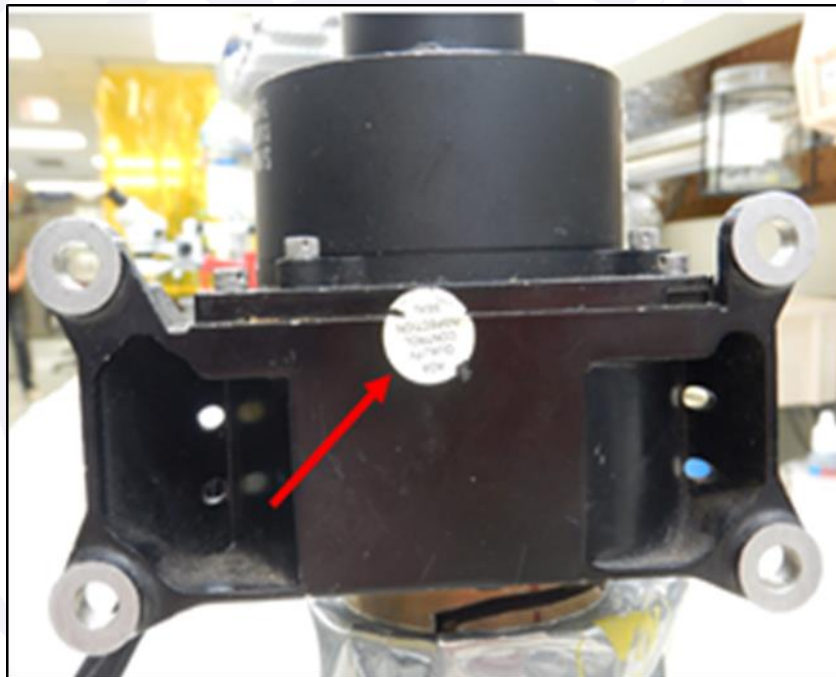
- the quality control seal on the underside, located between the engine cover and the gears train, was broken (Figure 22).

Figure 22 - Quality control seal broken.

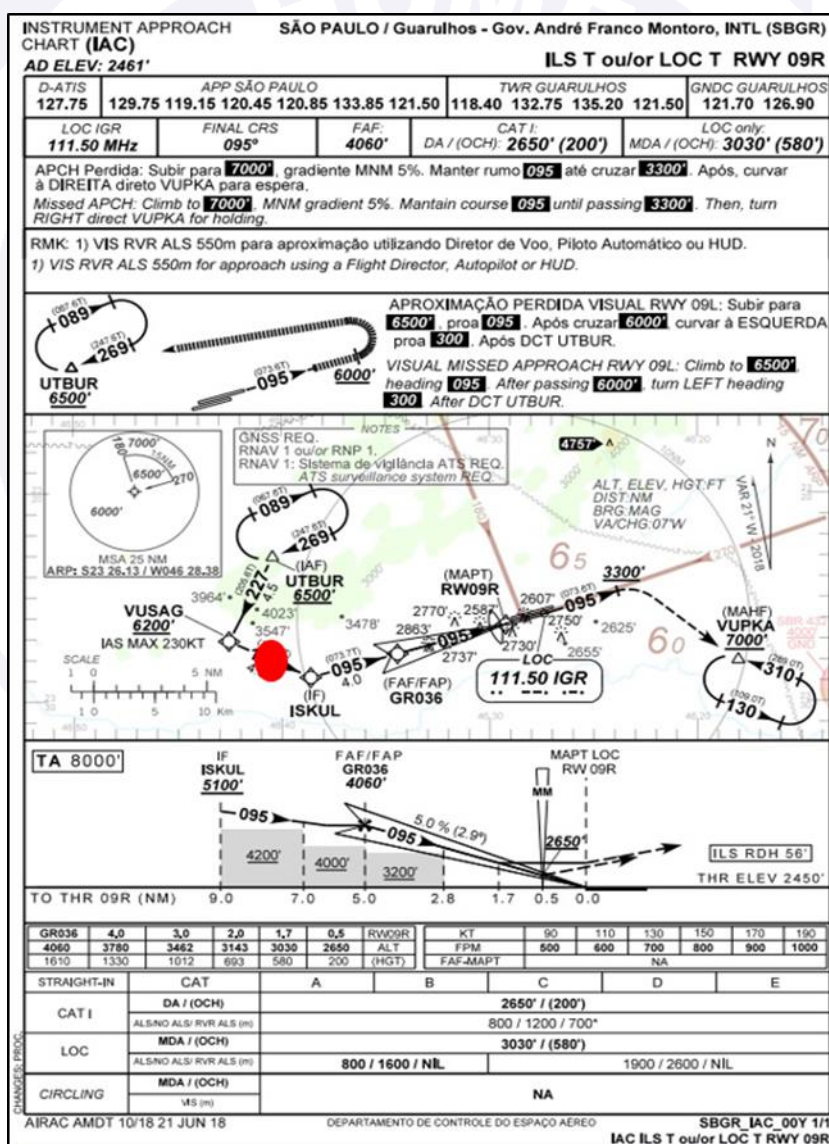
During the descent, crossing 5.500ft to intercept the locator of the ILS T procedure for runway 09R (Figure 23), in approach to the ISKUL point (Intermediate Fix), the AILERON MISTRIM message was lit.

Figure 23 - Approximate point of the AILERON MISTRIM alarm (in red), during the execution of the ILS T RWY 09R procedure.
