FINAL REPORT
A - 515/CENIPA/2021

OCCURRENCE:	ACCIDENT
AIRCRAFT:	PP-SAM
MODEL:	PC-12/47
DATE:	02MAR2012

This is the Final Report of the 02MAR2012 accident with the PC 12/47 aircraft model, registration PP-SAM. The accident was classified as “[WSTRW] Windshear/Thunderstorm”.

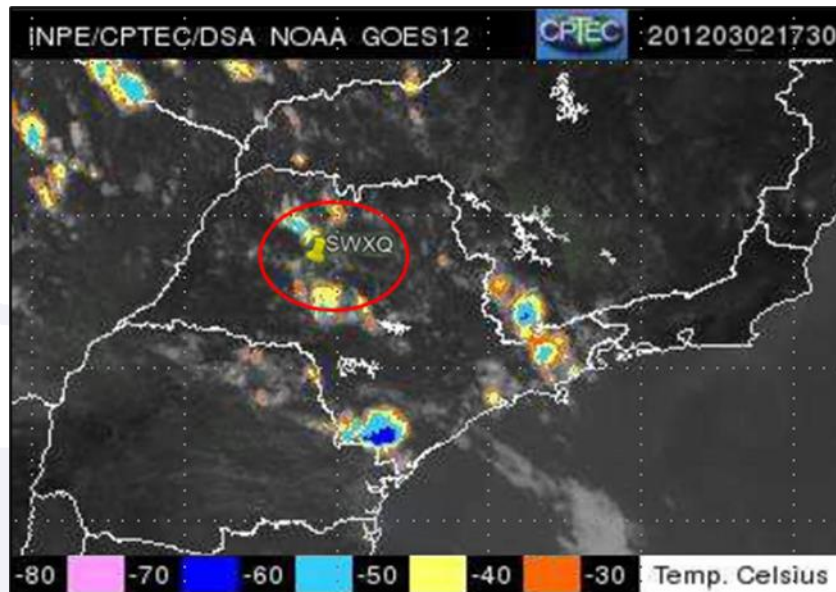
Additionally, the enhanced satellite image generated by the CPTEC at 1730 (UTC), showed the existence of significant meteorological formations in the surroundings of the Aerodrome (Figure 1).

Figure 1 - Satellite image highlighted with the weather condition at a time close to the occurrence. Source: CPTEC.

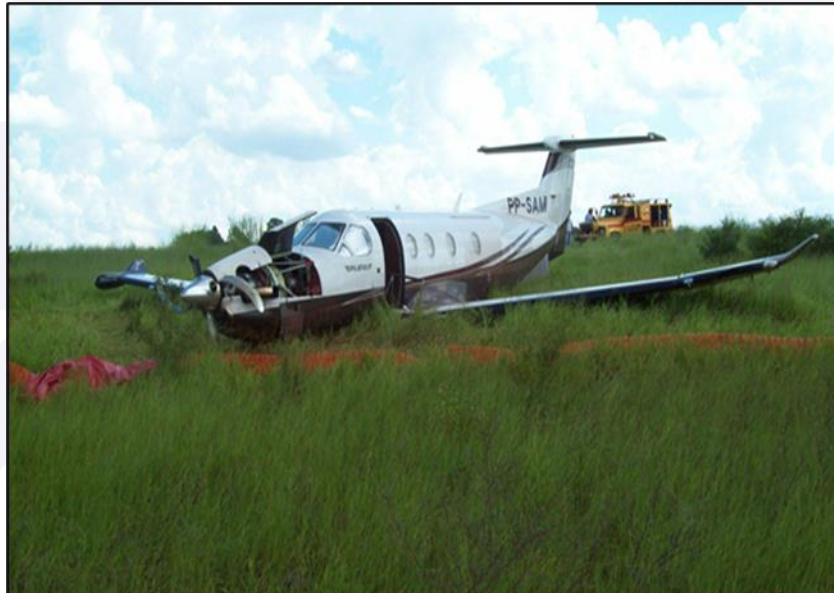
After the impact, the aircraft moved about 300 meters, with a yaw to the right, going down a small depression until it came to a complete stop at approximately 90° in relation to the axis of the runway, close to the threshold 14, as shown in Figure 2.

Figure 2 - Final position of the aircraft after the occurrence.

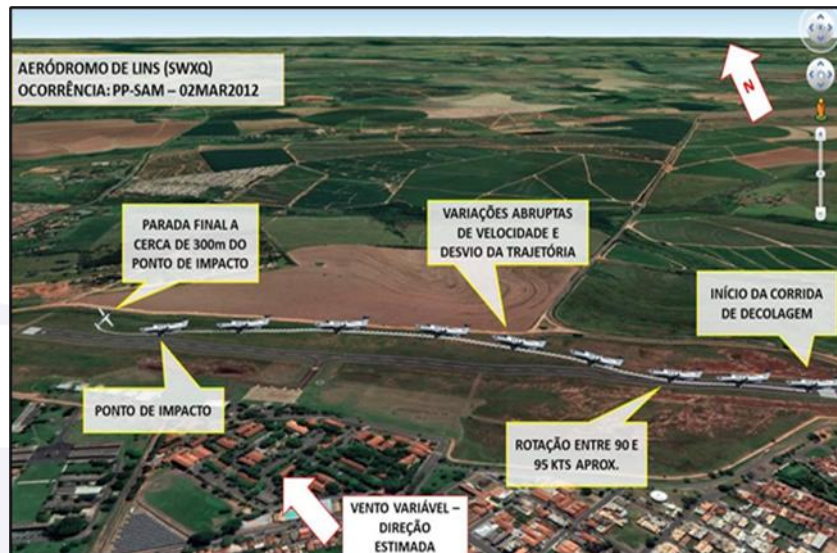
After touching the ground, the aircraft veered sharply to the right, having its stop position at approximately 90° in relation to the runway, near threshold 14 (Figure 3).

Figure 3 - Sketch of the occurrence, from the take-off to the final stop (out of scale).

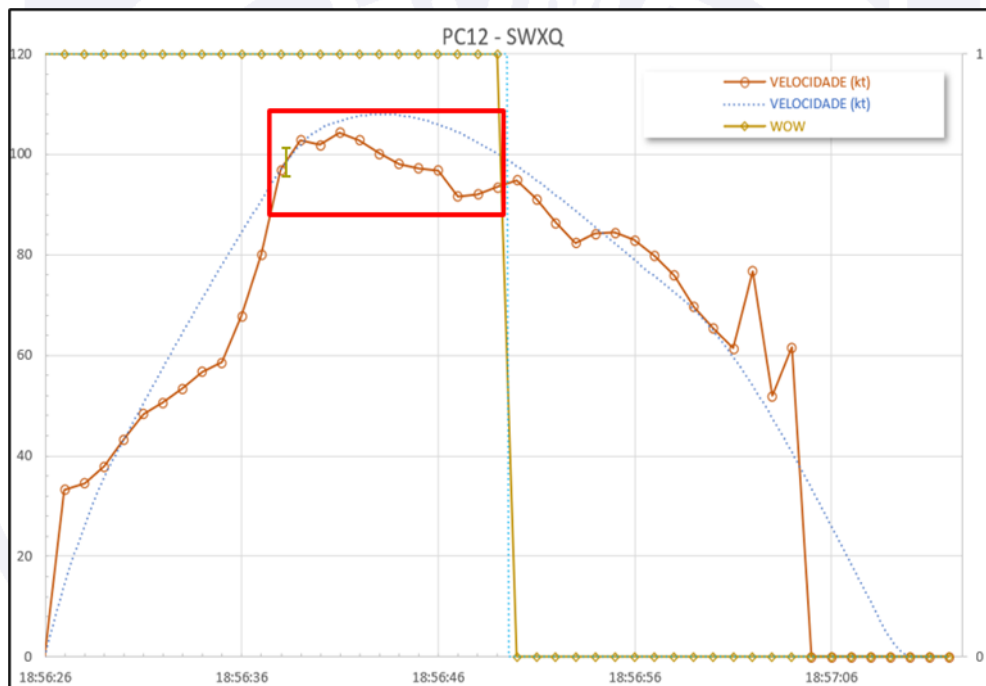
Figure 4 - Speeds recorded by the MAU from the take-off (WOW = 0) to the aircraft impact.

Considering the characteristics of the speed variation observed in the graph of Figure 4 and the wind parameters elucidated in Table 1, as well as the accident dynamics, it is inferred that the aircraft was subjected to a strong influence of wind currents variables and of great intensity that affected its performance during the take-off.

These conditions were consistent with an event typically related to what has been described as a windshear.
