FINAL REPORT
A - 140/CENIPA/2017

OCCURRENCE:	ACCIDENT
AIRCRAFT:	PP-ENM
MODEL:	AS-350 B2
DATE:	10NOV2017

This is the Final Report of the 10NOV2017 accident with the AS 350 B2 aircraft model, registration PP-ENM. The accident was classified as “[LALT] Low Altitude Operations”.

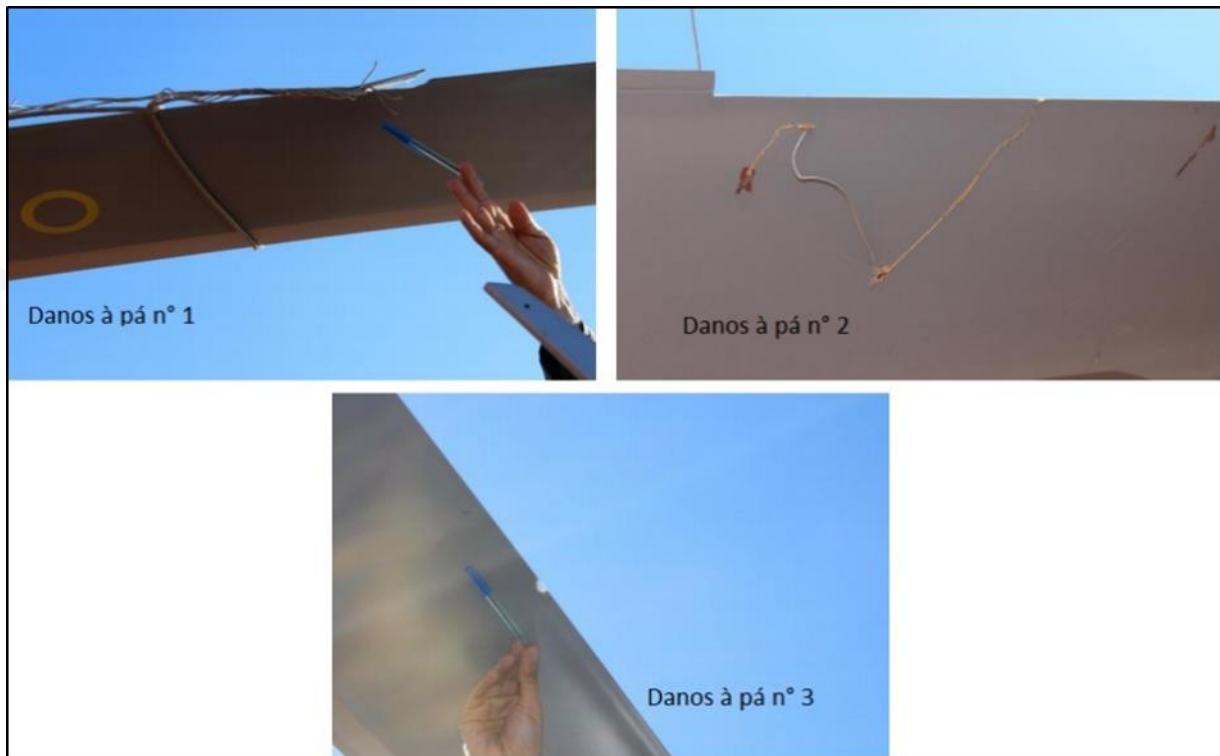
The aircraft had substantial damage to the main rotor blades.

After the precautionary landing, substantial damage was observed to the main rotor blades (Figure 1).

Figure 1 - Damage to the main rotor blades.

The risks arising from a low altitude operation were not adequately evaluated by the crew, which provided conditions for the collision of the main rotor blades against the low voltage power grid.
