**FINAL REPORT**  
**A - 029/CENIPA/2018**

**ACCIDENT**

**PP-GBP**

**AB-115**

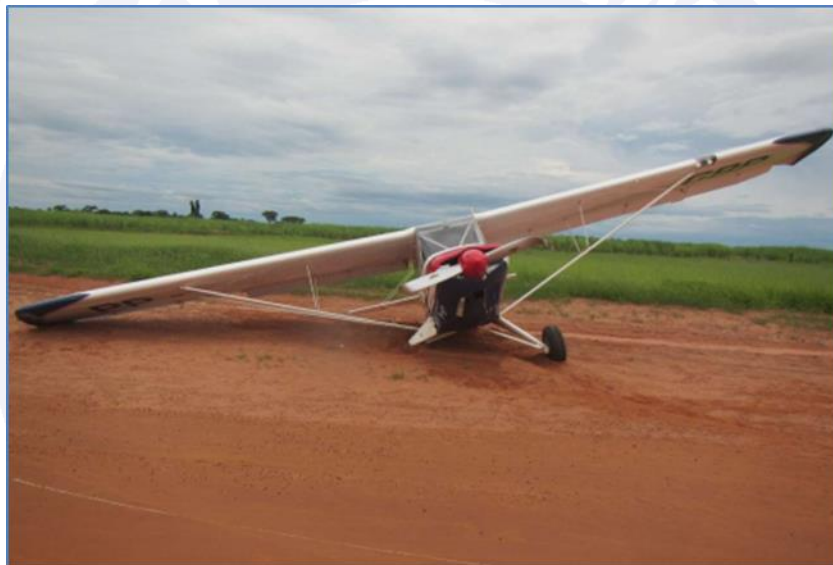
During the TGL training, there was loss of directional control, with the aircraft overpassing the lateral limit of the runway (veer off). In the return attempt, the right wing touched the ground, the landing gear broke and the propeller collided against the ground.

Figure 1 - Overview of the aircraft after the accident.

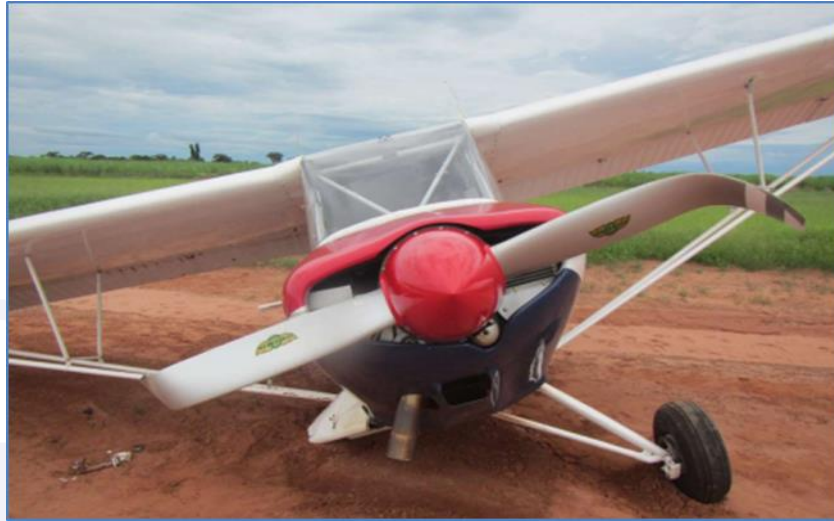
The aircraft had substantial damage to the engine, propeller, landing gear and right wing (Figures 2 and 3).

Figure 2 - View of the damage to the propeller blades and landing gear.

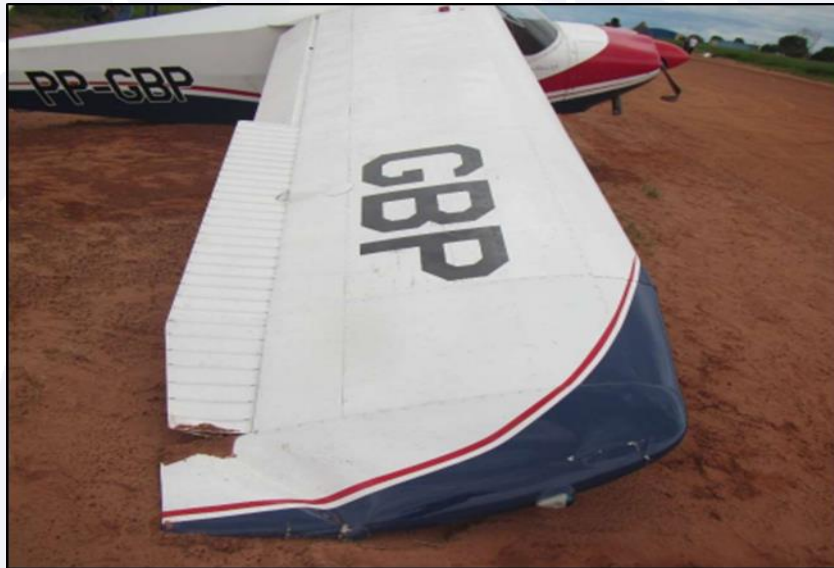
Figure 3 - View of the right wing damage.

The first impact was by touching the tip of the aircraft right wing against the ground. This event caused a change in its trajectory. Then, the landing gear of the aircraft, in contact

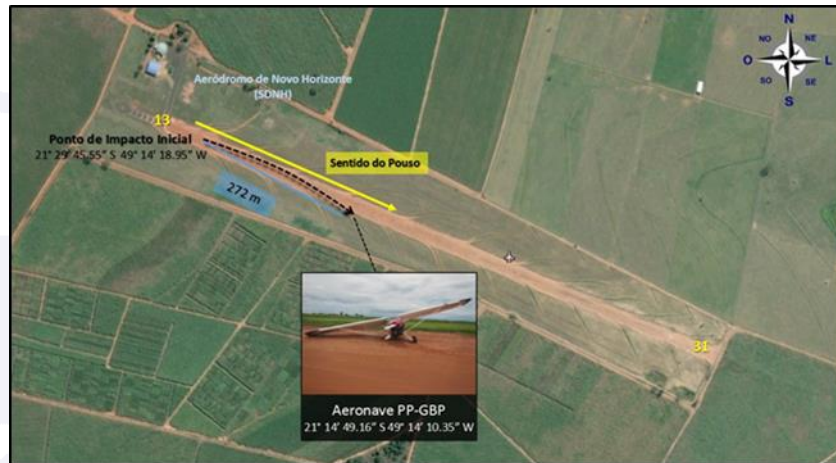
The aircraft traveled 272m from the first impact until the total stop (Figure 4).

Figure 4 - Diagram of the accident.
