**COMANDO DA AERONÁUTICA**  
**CENTRO DE INVESTIGAÇÃO E PREVENÇÃO DE**  
**ACIDENTES AERONÁUTICOS**

**FINAL REPORT**  
**A - 015/CENIPA/2018**

| <b>AIRCRAFT:</b> | <b>PP-HLI</b> |
| <b>MODEL:</b> | <b>R44 II</b> |

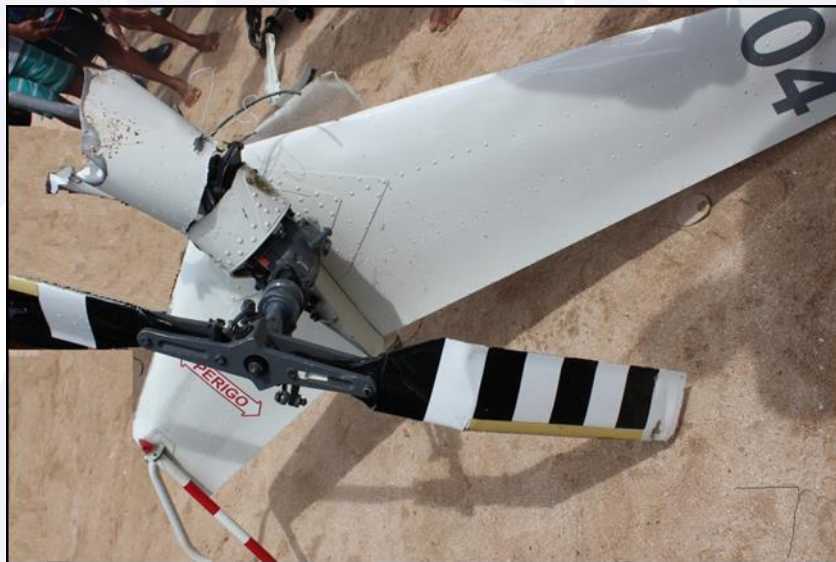
Most of the wreckage remained concentrated in the region of Pina Beach, where the main cabin was found. The tailcone was fractured and the tail rotor assembly was found separated from the rest of the aircraft structure.

Figure 15 - Aircraft tail rotor assembly.

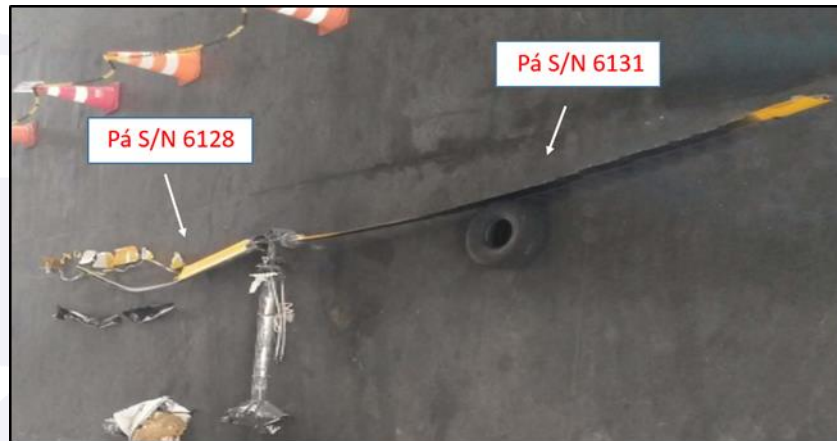
The S/N 6128 blade was found with its root still attached to the main rotor mast. This blade showed substantial damage to its structure, especially in the region farthest from the mast (Figure 17).

The S/N 6131 blade was found whole, relatively well maintained and still connected to the main rotor mast. This blade had slight upward curvature (warping) in its structure (Figure 17).

Figure 17 - Aircraft main rotor blades.

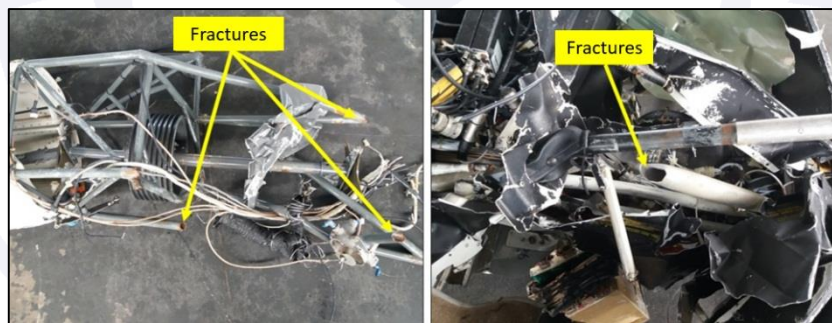
Examinations performed on the fuselage structure showed that all fractures found had an angle of approximately  $45^\circ$ , as well as bends and dents in the steel tubes covered by riveted aluminum sheets. These characteristics were consistent with overload fractures as a result of the impact of the aircraft into the sea (Figure 19).

Figure 19 - Bended and fractured steel tubes.

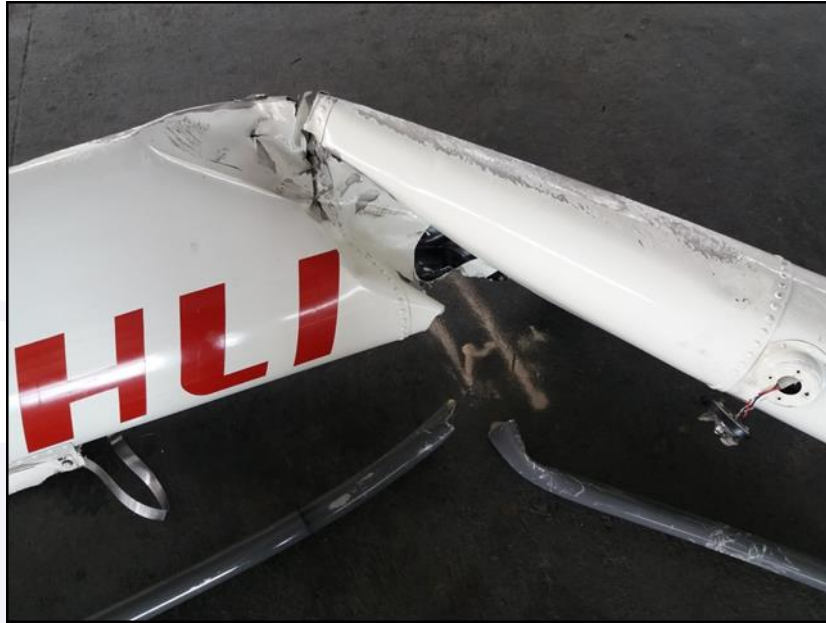
The tailcone of the helicopter had some bents, evidencing impacts of the main rotor blades against its structure. The appearance of the component as well as the characteristics of the damage found was consistent with the impact of the main rotor blades against the tail cone (Figure 20).

Figure 20 - Tailcone bents, due to impact of the main rotor blade.

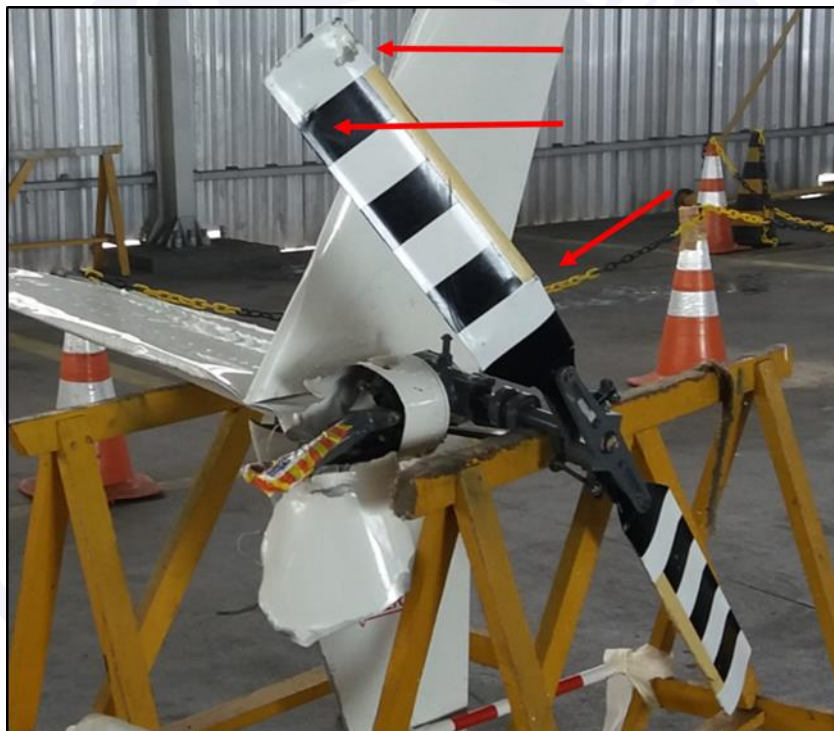
The damage found in the two tail rotor blades had characteristics consistent with overload, due to the impact of the aircraft into the sea (Figure 21).

Figure 21 - Damage to the tail rotor blades highlighted by red arrows.

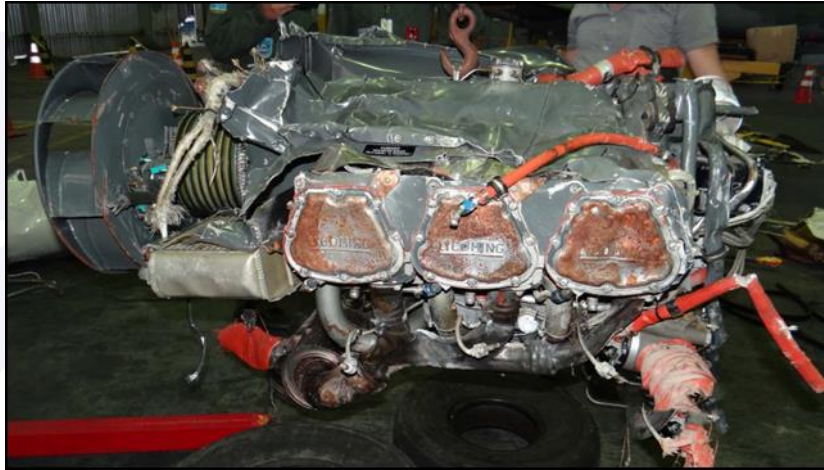
The engine had no severe damage or malfunctions resulting from the collision of the aircraft into the sea. However, there was a significant amount of sand and seawater inside the engine and its accessories, as well as severe oxidation and corrosion due to the period the component was submerged in saline water (Figure 22).

Figure 22 - Aircraft engine overview.

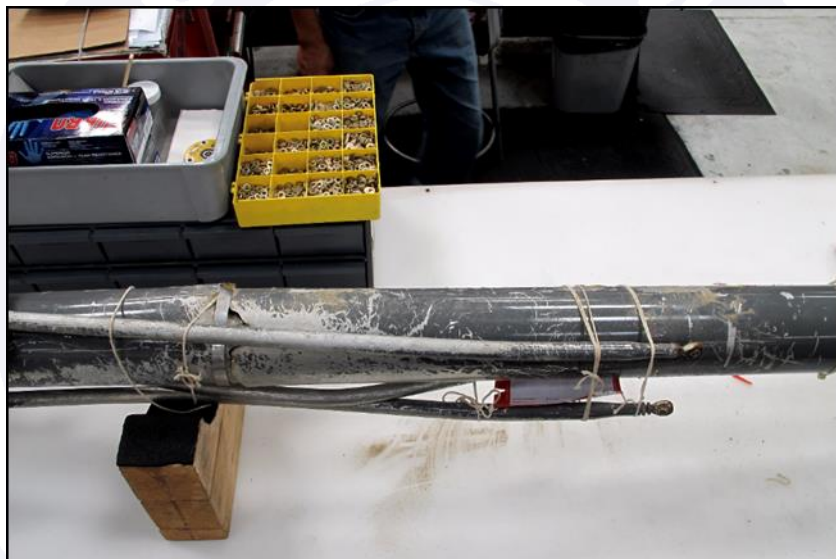
The mast tube had damage to the outer structure (Figure 24).

Figure 24 - Damage to external mast fairing.

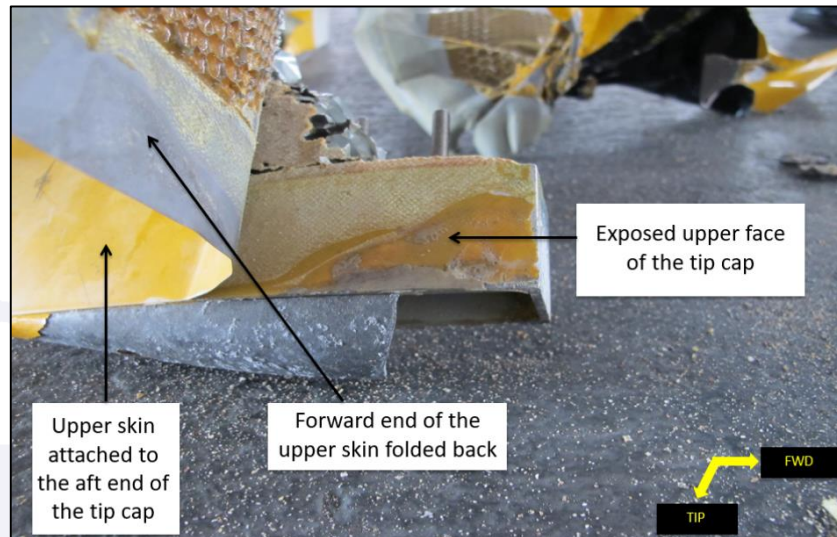
Visual examinations found that the upper skin was separated from the blade core at its forward portion, including the skin-to-spar bond line area. The forward end of the upper skin was found folded back and approximately 50% of the upper face of the tip cap was exposed. The upper skin remained attached to the aft end of the tip cap (Figure 28).

Figure 28 - Upper surface of the red blade (S/N 6128). Highlight the detachment of the front portion of the upper skin and the exposed part of the tip cap.  
(Source: Adapted from NTSB).

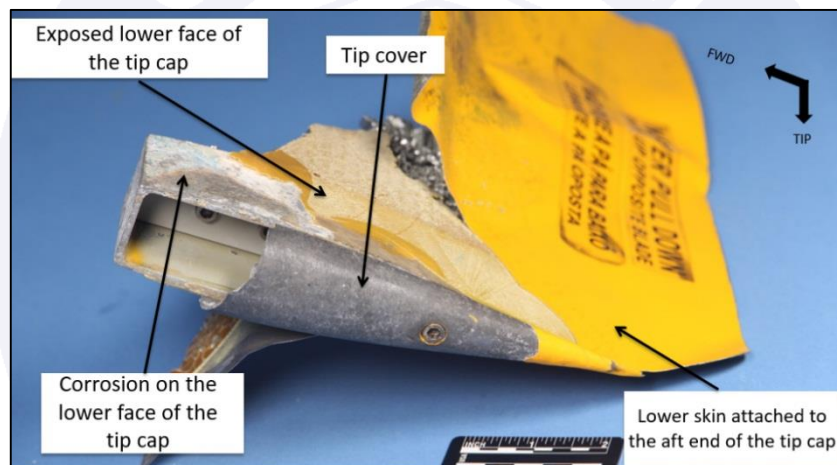
The forward end of the lower skin was fractured and missing, exposing approximately 90% of the lower face of the tip cap. The remaining rear end portion of the lower skin was attached to the tip cap (Figure 29).

Figure 29 - Red blade lower surface (S/N 6128). Highlight for the absence of the front portion of the lower skin and the exposed portion of the tip cap.  
(Source: Adapted from NTSB).

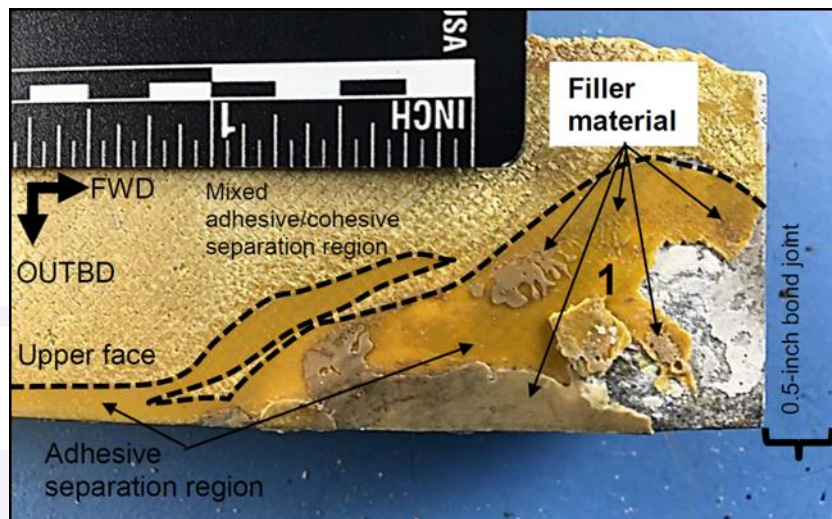
Figure 30 - Upper surface of the red blade tip cap (S / N 6128). Highlight for the presence of filler material in area "1".  
(Source: Adapted from NTSB).

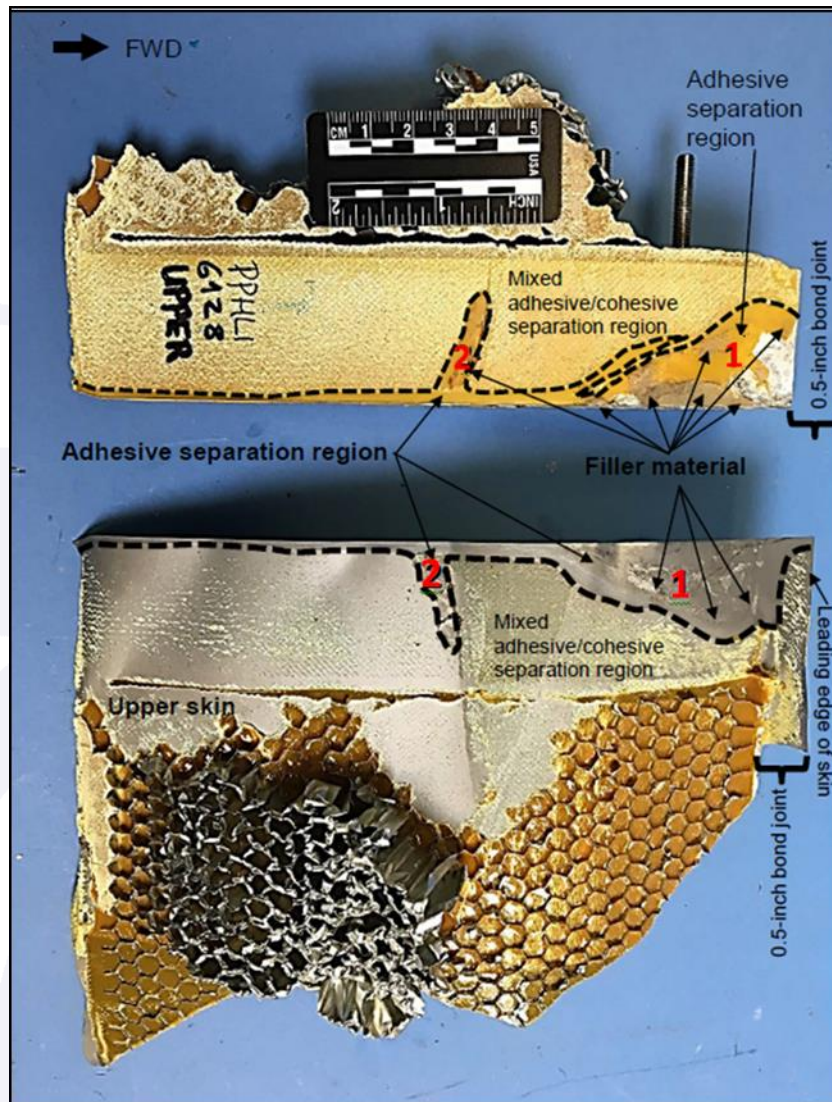
Figure 32 - Upper surface of the red blade (S/N 6128) after removal of the upper skin. Highlight for areas “1” and “2” where adhesive separation was found. (Source: Adapted from NTSB).

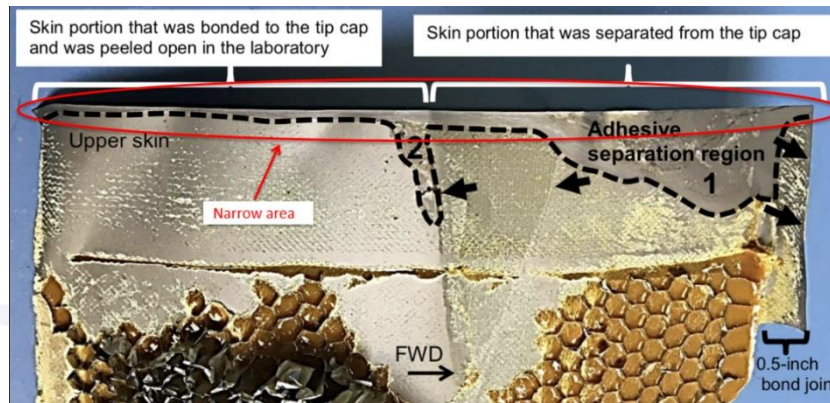
Figure 33 - Upper skin red blade (S/N 6128) after removal in the laboratory. Highlight for the narrow area in the outboard, including the skin-to-spar bond line.  
(Source: Adapted from NTSB).

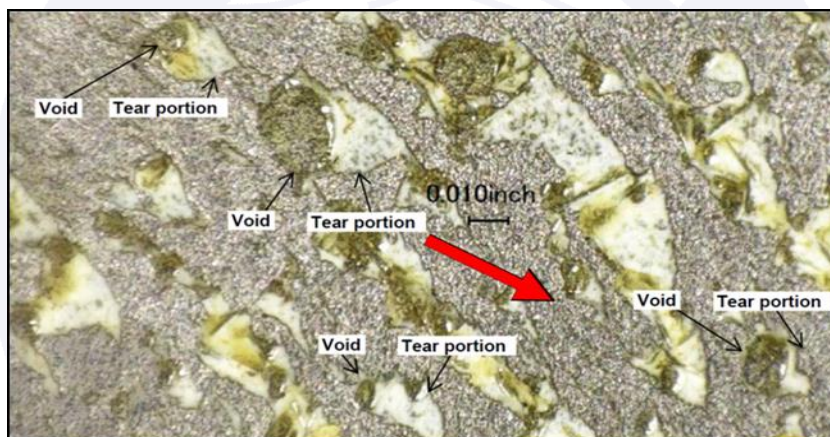
Figure 34 - General propagation direction of the adhesive fractures in the upper skin of the red blade (S/N 6128).  
(Source: Adapted from NTSB).

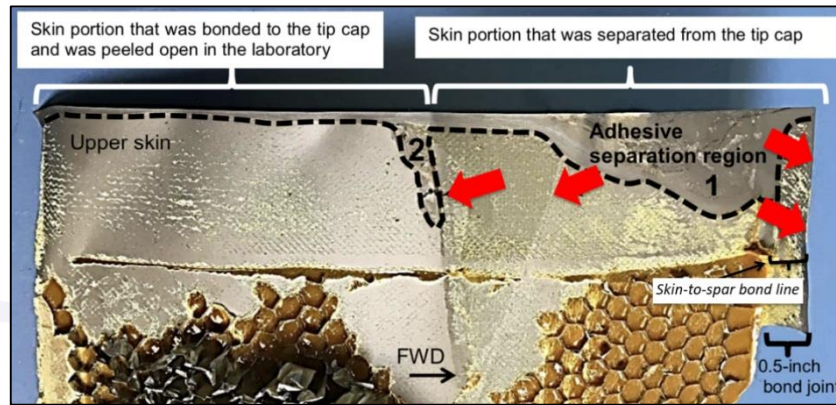
Figure 35 - Propagation of the adhesive fractures in the upper skin red blade (S/N 6128)  
(Source: NTSB).

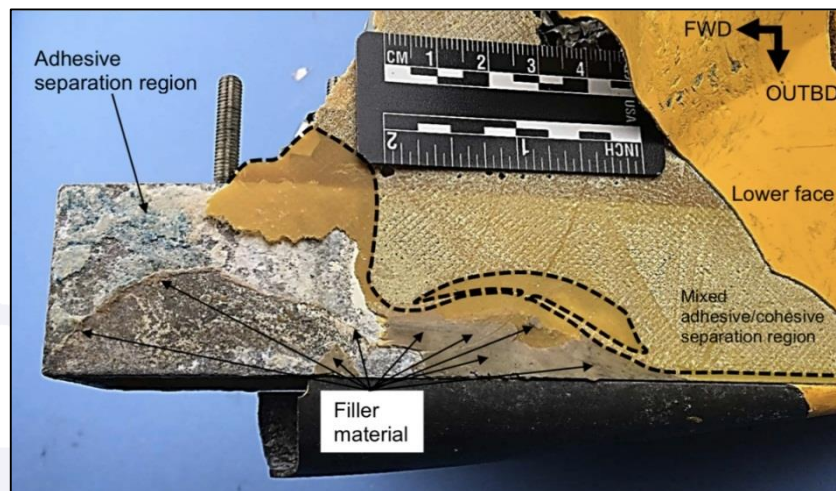
Figure 37 - Lower surface of the red blade (S/N 6128). Highlighting the demarcation of regions with adhesive separation and the presence of filler material.  
(Source: Adapted from NTSB).

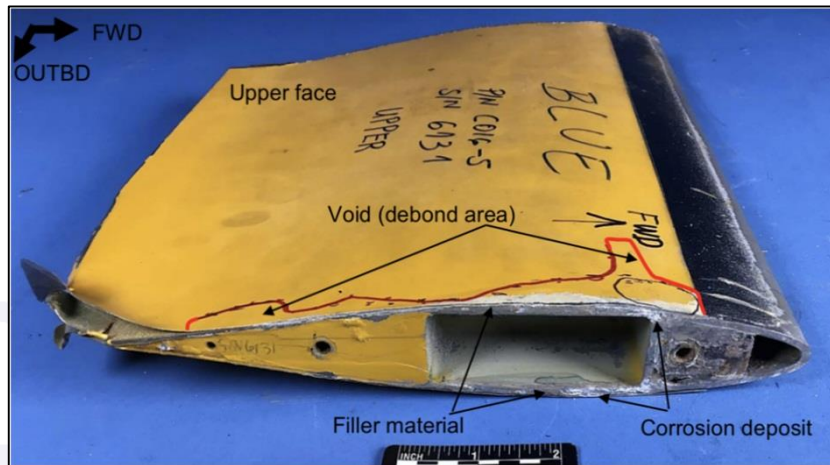
Figure 41 - Upper surface of the blue blade (S/N 6131) after the tap test. The void debond area was marked with a red line.  
(Source: NTSB).

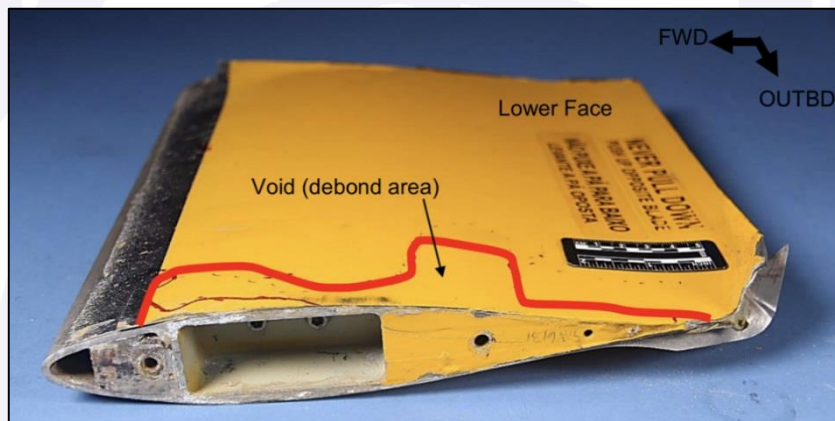
Figure 44 - Lower surface of the blue blade (S/N 6131) after the tap test. The debonding area was marked with a red line.  
(Source: Adapted from NTSB).

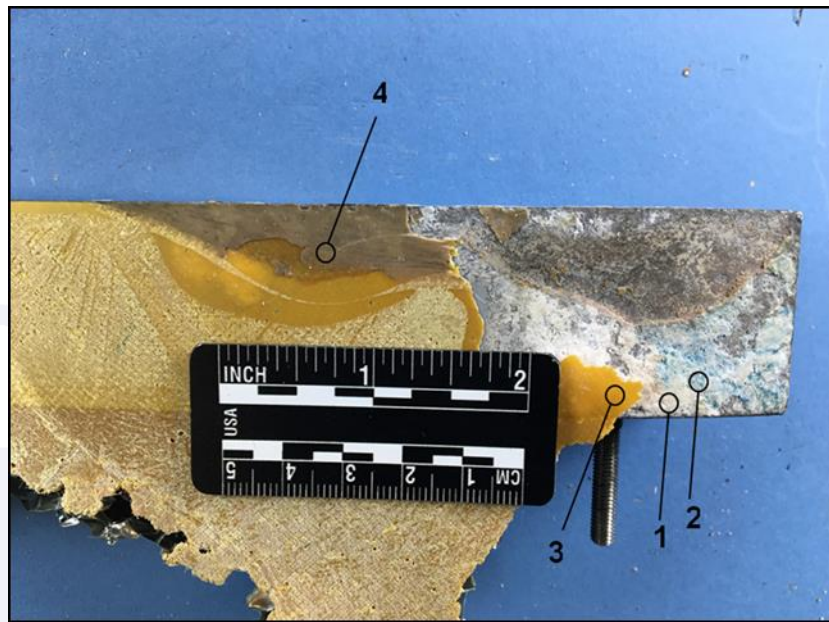
Figure 47 - Point 1 (whitish stain) and point 2 (bluish stain) from where the red blade (S/N 6128) corrosion samples were collected.  
(Source: Adapted from NTSB).

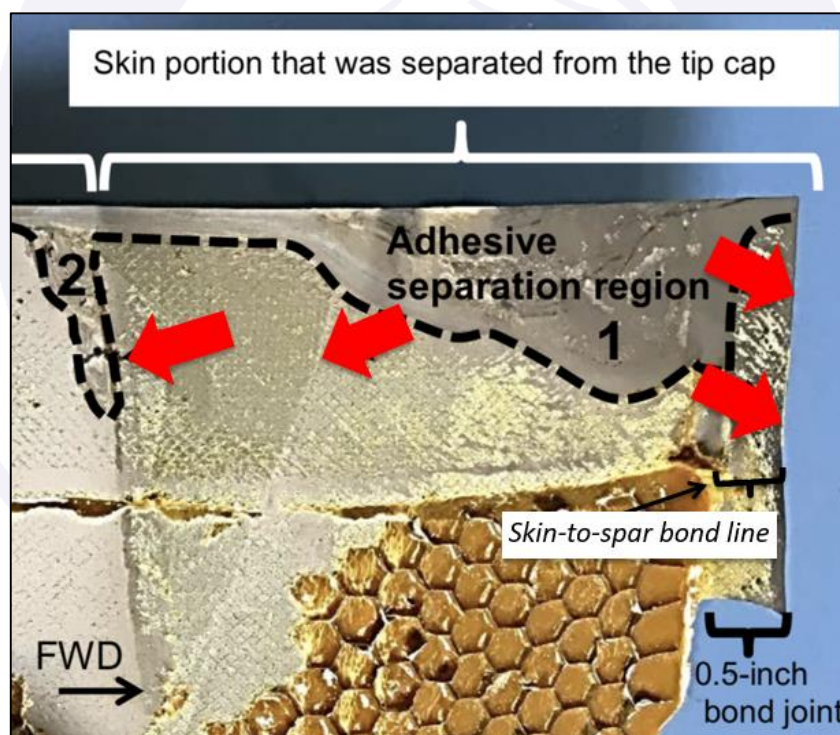
Figure 63 - Direction of the propagation of adhesive fractures in the upper skin region that was found debonded and folded backwards.  
(Source: Adapted from the NTSB).

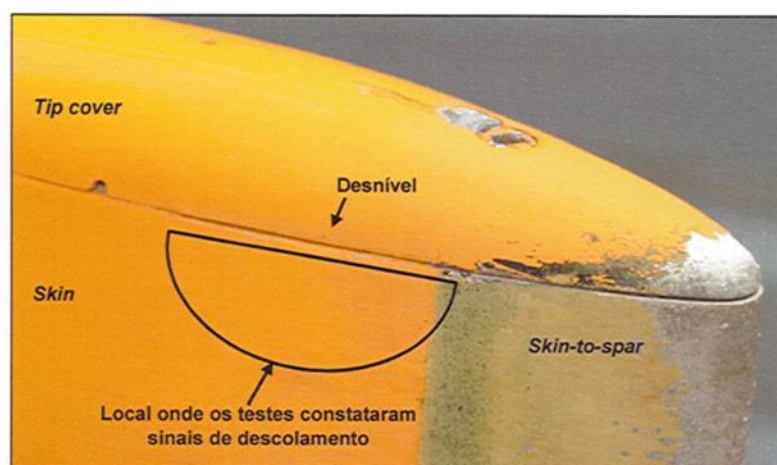
Figura 6 – Pá P/N C016-7 com sinais de descolamento.
