FINAL REPORT
A - 081/CENIPA/2015

OCCURRENCE:	ACCIDENT
AIRCRAFT:	PR-ADA
MODEL:	AS 355 N
DATE:	29MAY2015

This is the final report of the 29 May 2015 accident with the AS-355N aircraft, registration PR-ADA. The accident was classified as “controlled flight into terrain (CFIT)”.

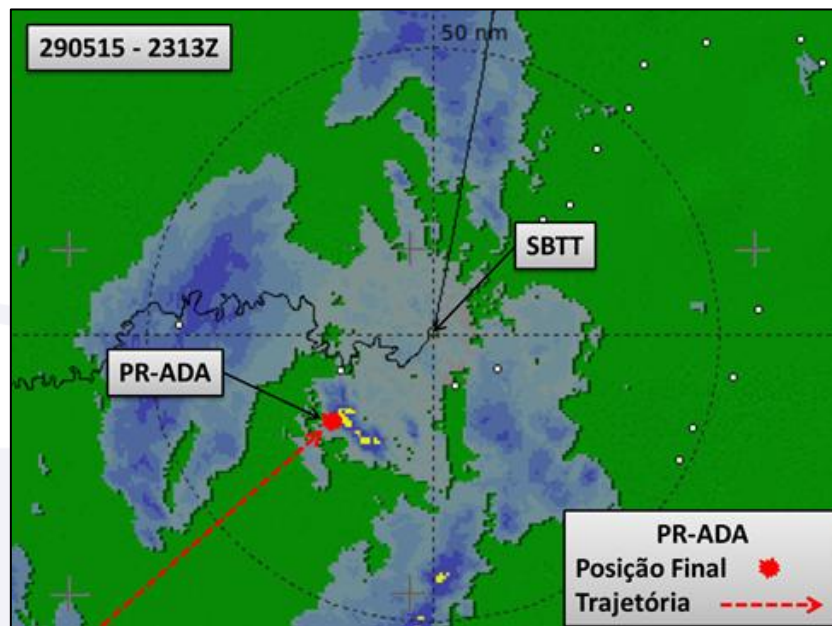
However, according to meteorological radar image of SBTT (provided by REDEMET), at 23:13 UTC, there were significant rain clouds at southwest sector of the aerodrome, such as *Towering Cumulus* (TCU) and *Cumulonimbus* (CB) (Figure 1).

Figure 1 – Radar image of *Tabatinga* at 23:13 UTC.

From the analysis of both the information on the aircraft provided by the GPS tracker and satellite images of the moment of occurrence, it is possible to infer that the pilot encountered adverse meteorological conditions along the route. Such conditions (confirmed by local dwellers) indicate that the presence of rain restricted visibility for the pilot.

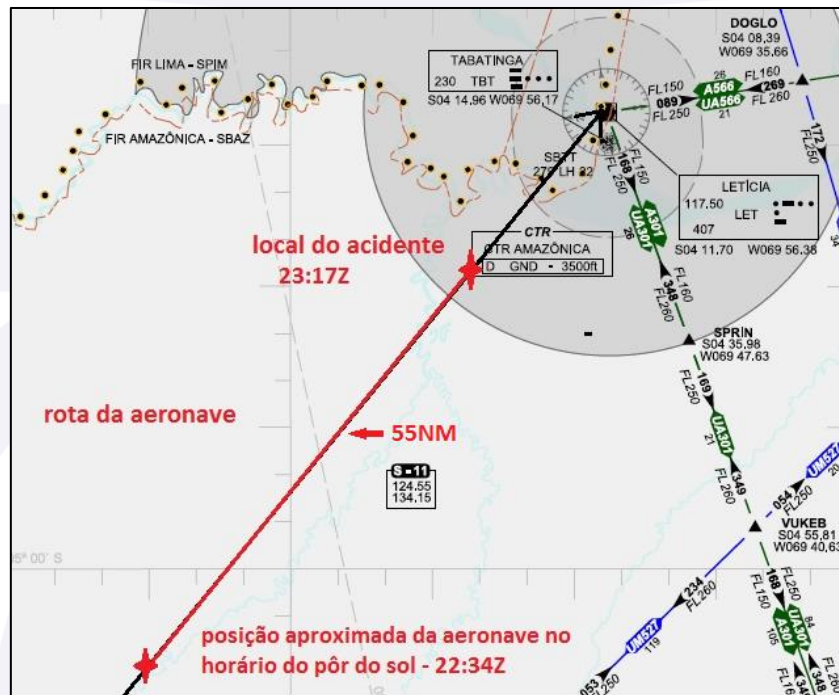
Considering the developed average speed, the estimated distance traveled during night-time period was about 55 NM. The pilot flew this distance under Visual Flight Rules, outside the “*Amazônica*” TMA.

Figure 3 - Route flown by PR-ADA at night time.
