COMANDO DA AERONÁUTICA
CENTRO DE INVESTIGAÇÃO E PREVENÇÃO DE
ACIDENTES AERONÁUTICOS

FINAL REPORT
A - 094/CENIPA/2016

OCCURRENCE:	ACCIDENT
AIRCRAFT:	PR-CBB
MODEL:	407
DATE:	26JUN2016

This is the Final Report of the 26JUN2016 accident with the 407 aircraft, registration PR-CBB. The accident was classified as “[CFIT] Controlled Flight Into Terrain”.

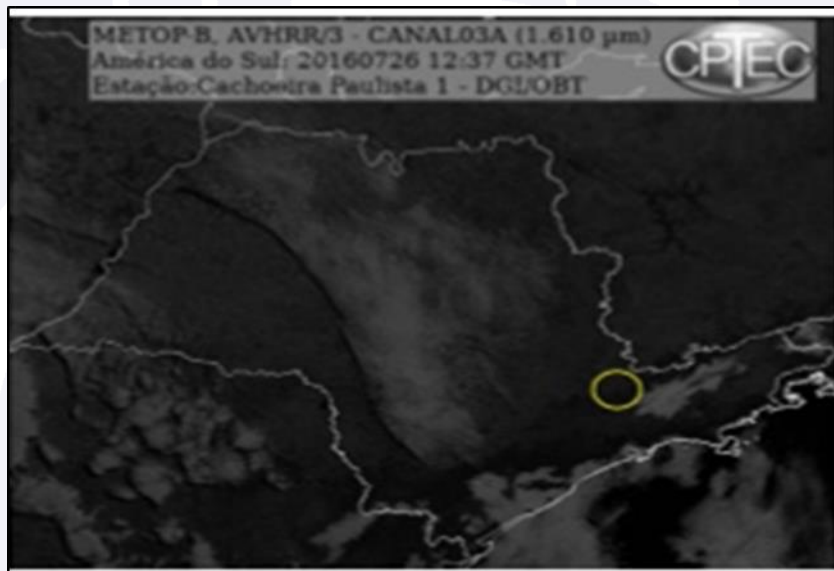
The satellite images at the frequencies visible (Figure 1) and Infrared (Figure 2) indicated low cloudiness (stratiform) over the accident region, but it was not possible to state through them, that the exact point where the aircraft crashed against the ground was covered by clouds, since the analysis of this type of image does not show precision for the point situation.

Figure 1 - Image at the visible frequency suggests possibility of stratiform clouds in the region under study.

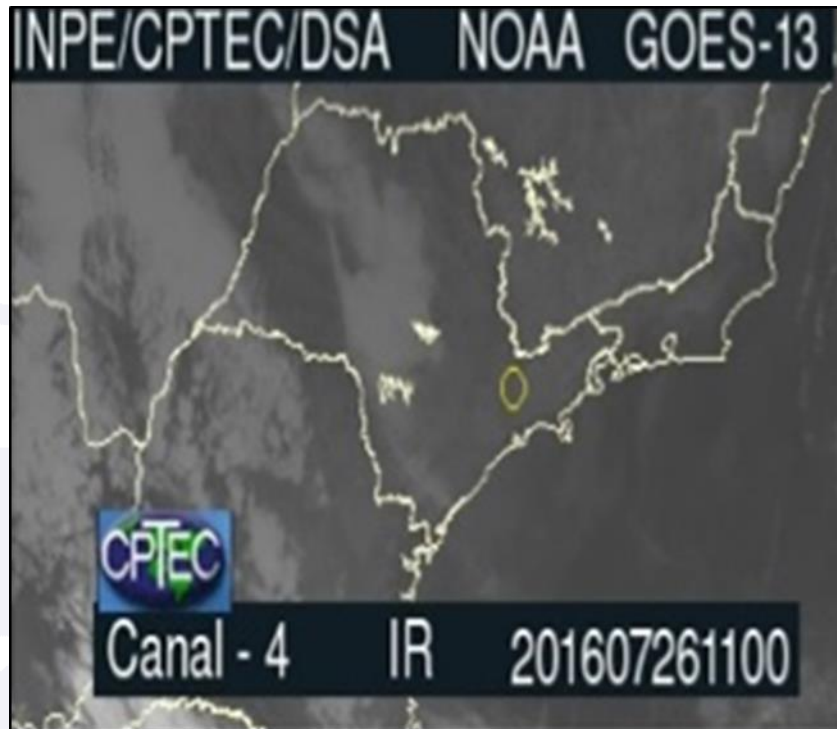
Figure 2 - Infrared image indicates, in the circle area, the possibility of clouds in the region.

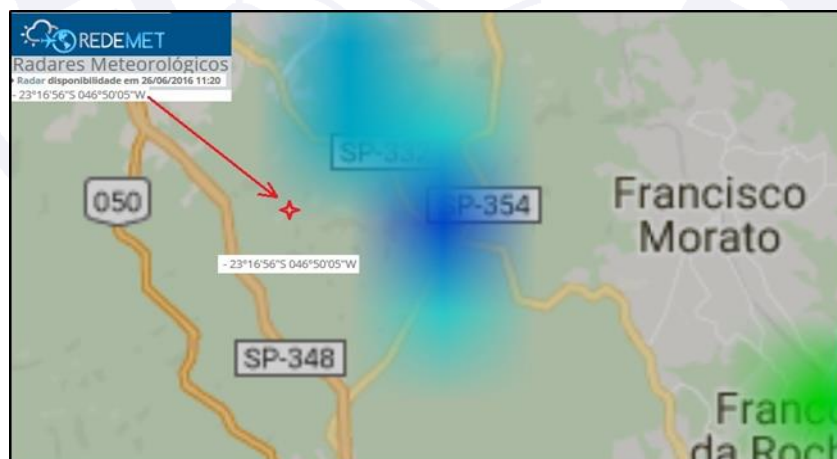
The bluish-toned region indicated that the radar detected precipitated water. The blue color indicated that it was of little intensity, with the possibility that they were clouds of the stratiform type. The red cross marks the impact site (Figure 3).

Figure 3 - Meteorological RADAR image of Pico do Couto and São Roque.

Thus, the cloud group of Figure 3 or some isolated cloud in the blue region had the tendency to move at a speed of about 10 kt to the site of the accident.

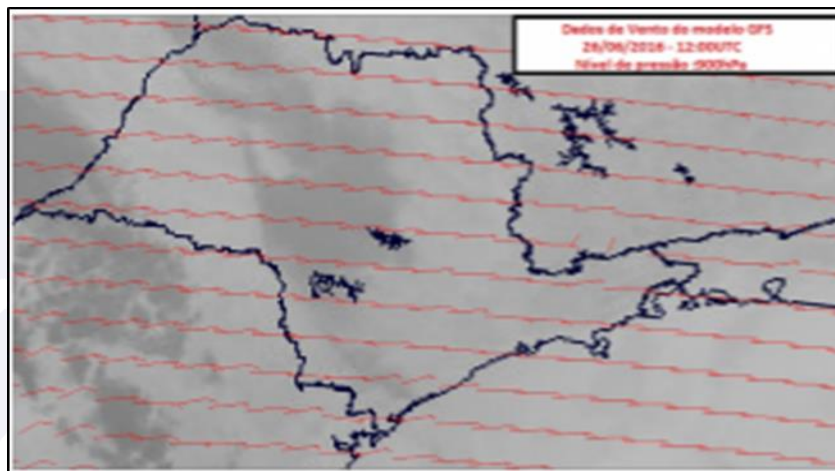
This showed that both the prediction model and the actual data had a common and predominant east (E) component, which consequently induced the clouds to move to the same direction, that is, from east to west.

Figure 4 - Windflow by the GFS numerical model.

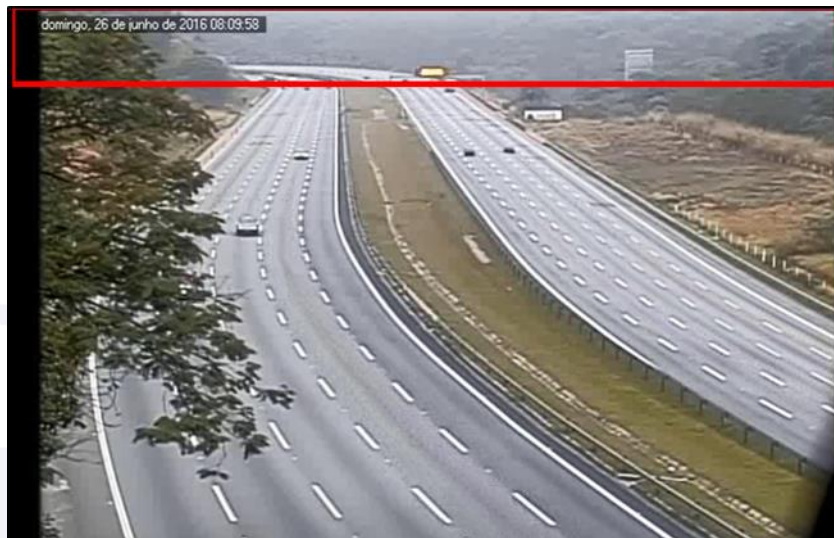
Figure 9 - Degradation of the meteorology evidenced in the Bandeirantes Highway - KM 043.

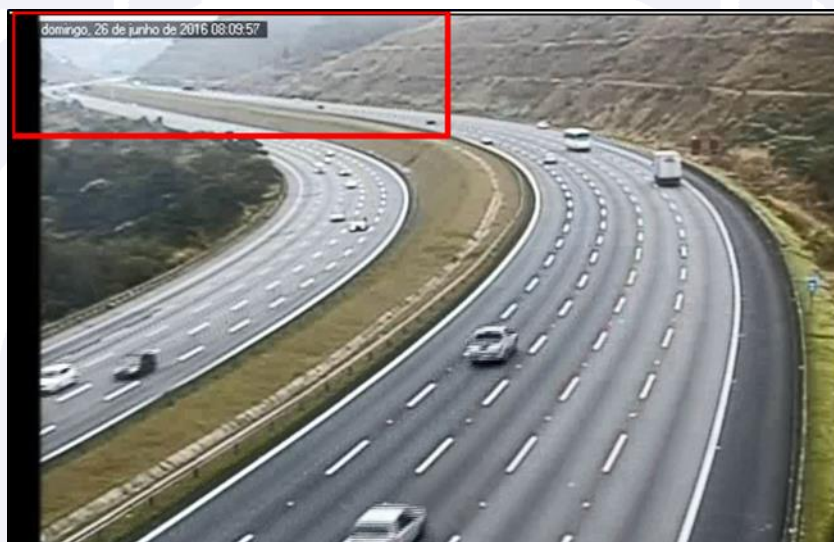
Figure 10 - Degradation of the meteorology evidenced in the Bandeirantes Highway - KM 045.

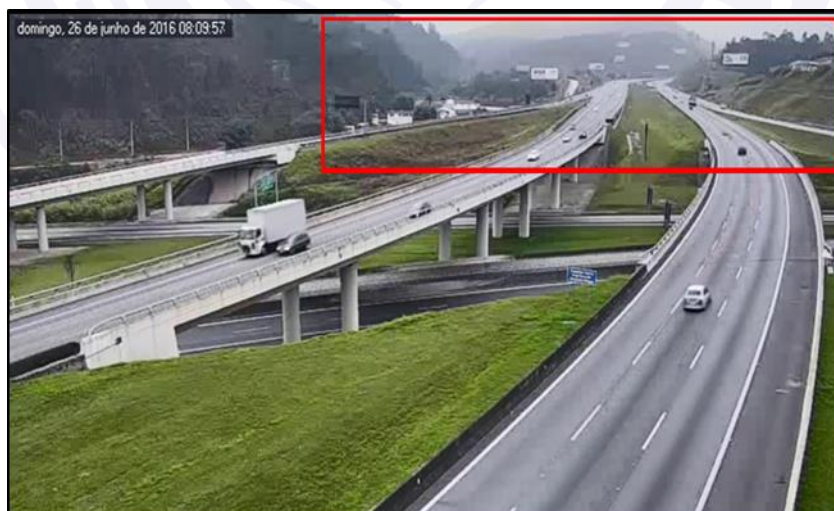
Figure 11 - Degradation of the meteorology evidenced in the Bandeirantes Highway - KM 047.

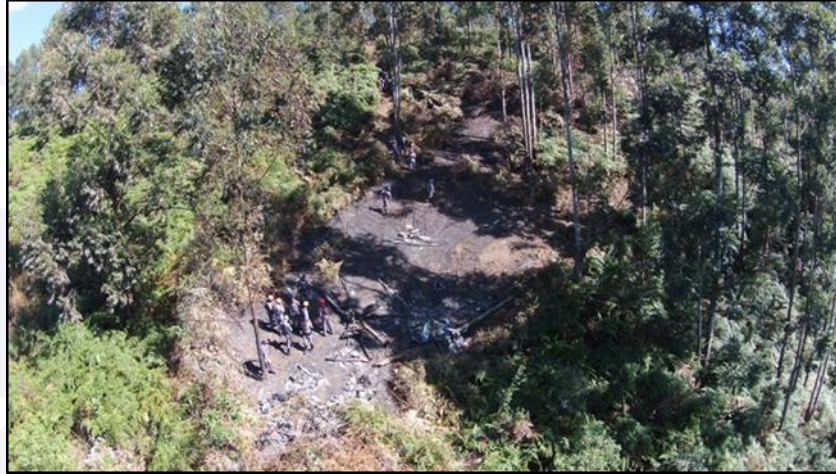
Figure 13 – Place of impact.

The aircraft collided with trees and crashed with the terrain at an approximate 15° angle and at high speed, without the possibility of exact determination. The wreckage had a linear trajectory and spread out 50 meters away from the point of impact.

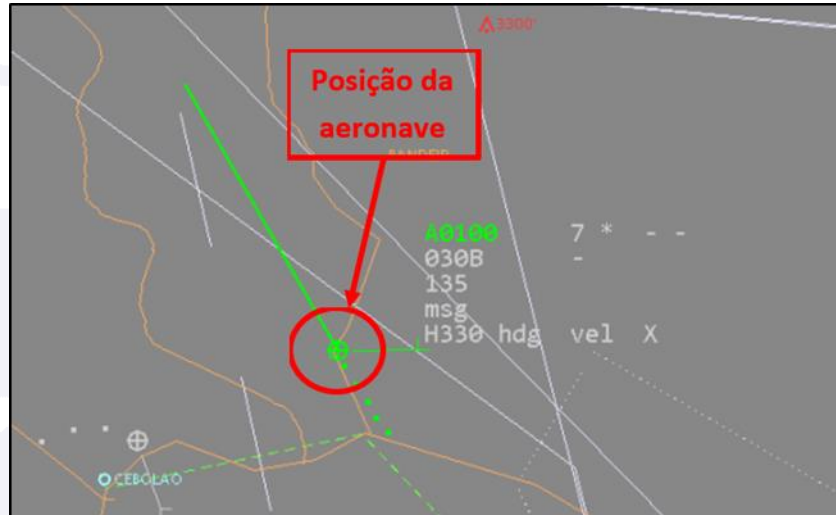
- at 11h00min29s (UTC) the PR-CBB was close to Marco Zero position. Instead of proceeding via REH ANHANGUERA SUL, as informed in the flight plan and to TWR-SP, the aircraft continued to fly over the Bandeirantes Highway (Figure 21);

Figure 21 - Radar image at 11h00min29s (UTC). Marco Zero Position. Aircraft continues to fly over the Bandeirantes Highway instead of following REH Anhanguera Sul according to flight plan.

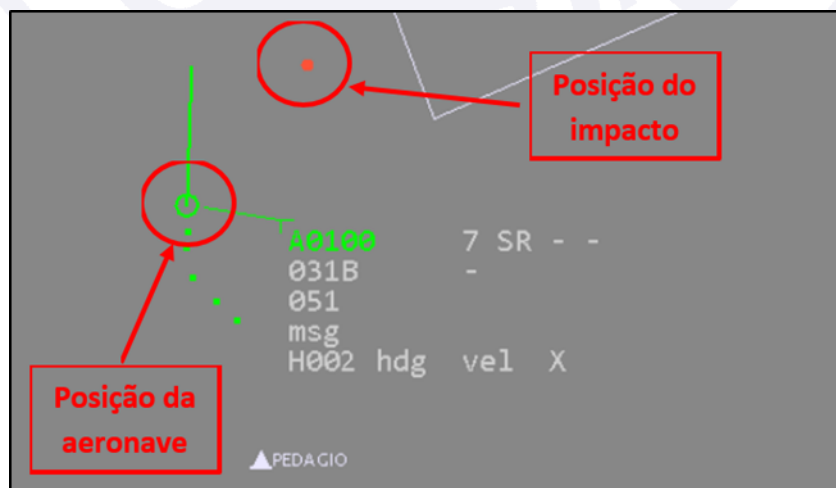
- at 11:09:00 (UTC), the aircraft left the route and, from this position, it was noticed that it started to make a conversion to the right of the initial route (Figure 22). This was the last visualization with the traffic; and

Figure 22 - Radar image at 11h09min00s (UTC). Aircraft initiating a conversion to the right of the route.

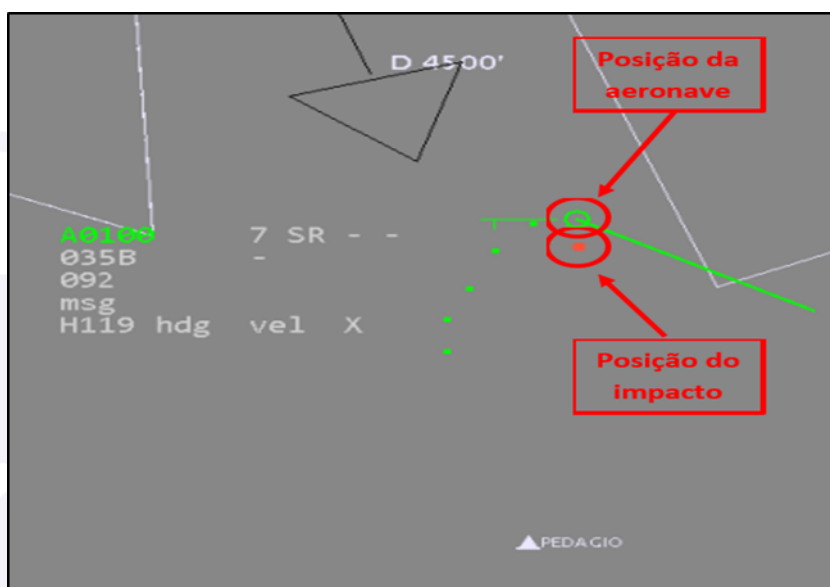
- At 11:09:57 (UTC) the last visualization was performed with the aircraft transponder in A/C modes, that is, with the primary and secondary radar. From this, it was not possible to determine that the radar plot was real, since it appeared only in the primary radar (asterisk) and with incompatible speed.

Figure 23 - Radar image at 11:09:57 (UTC). Last radar visualization.
