**COMANDO DA AERONÁUTICA**  
**CENTRO DE INVESTIGAÇÃO E PREVENÇÃO DE**  
**ACIDENTES AERONÁUTICOS**

**FINAL REPORT**  
**A-124/CENIPA/2018**

| <b>AIRCRAFT:</b> | <b>PR-DMC</b> |
| <b>MODEL:</b> | <b>PA-34-220T</b> |

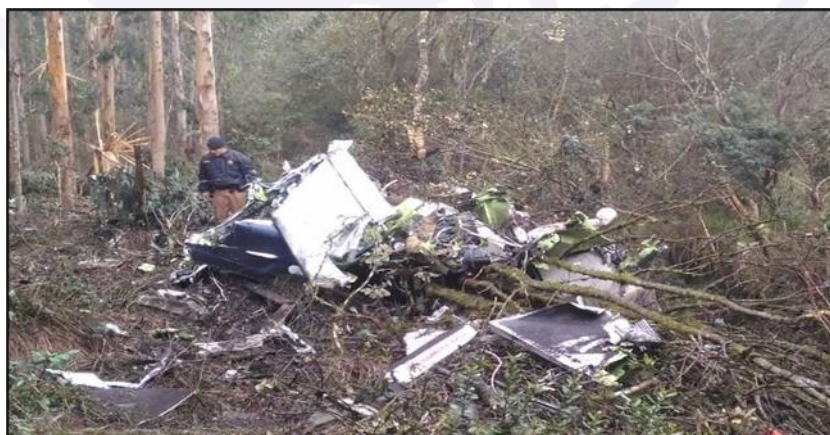
The engines detached from the wings. The right engine was found on the ground, among the trees, about 10m away from the fuselage and the left one was inside a stream, about 8m away from it.

The aircraft cabin and instrument panel were completely destroyed. The controls and instruments were scattered on the ground around the fuselage.

Figure 1 - Main concentration of debris after the accident.

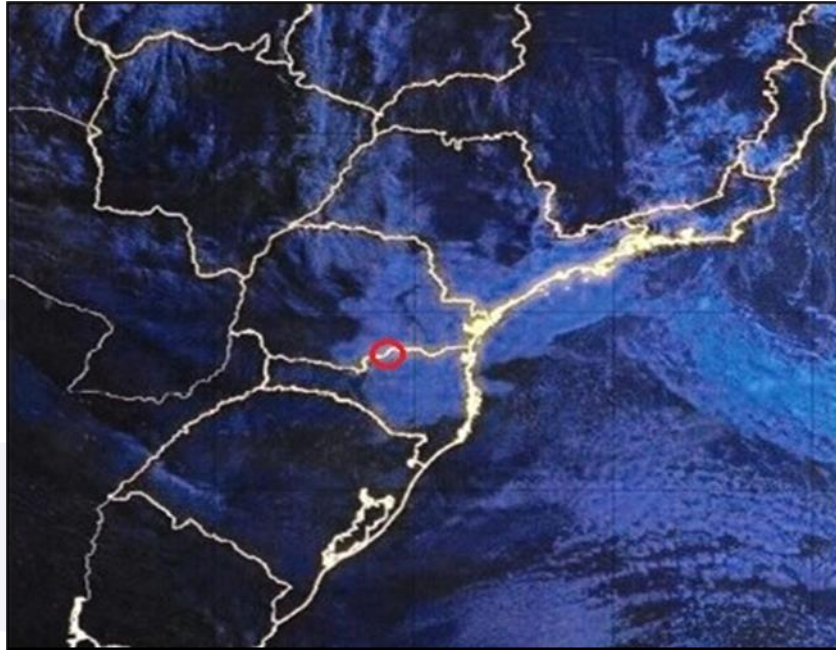
The synoptic analysis, carried out using the available satellite images, did not reveal the presence of frontal systems over the accident area. Likewise, no thunderstorm and/or lightning nucleus were identified in the region (Figures 2 and 3).

Figure 2 - Image of the Geostationary Operational Environmental Satellite 16 (GOES) of the visible spectrum at 1100 (UTC), on 22JUL2018, with an emphasis on the region of the accident.

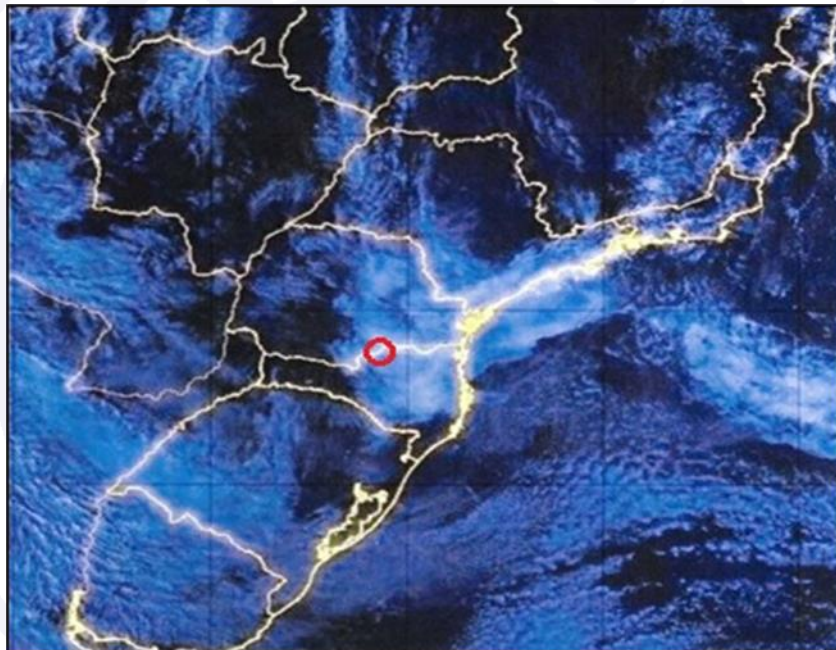
Figure 3 – Image of the GOES 16 satellite of the visible spectrum at 1245 (UTC), on 22JUL2018, with emphasis on the region of the accident.

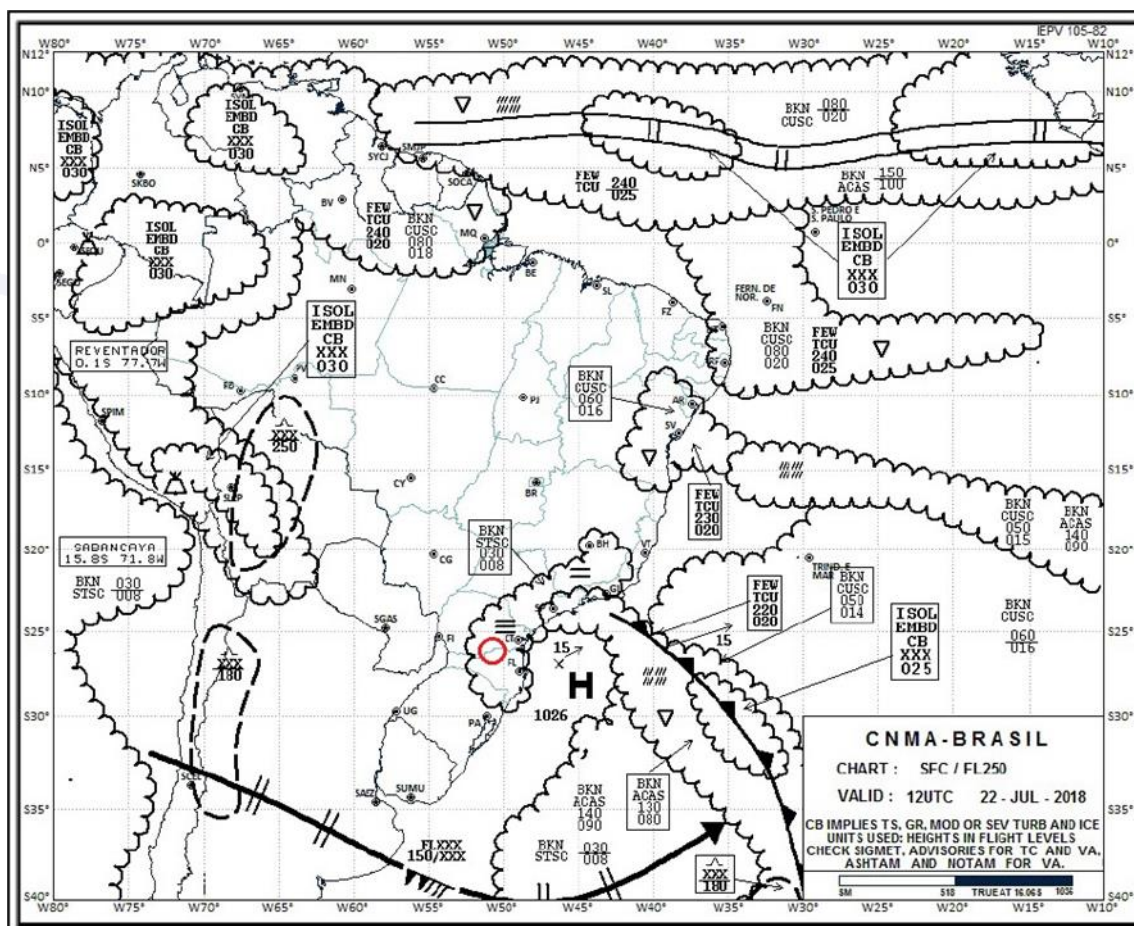
According to SIGWX from 1200 (UTC), valid from 9:00 am to 3:00 pm (UTC) for the region that included the accident site, fog was expected to occur in a large area, weather cloudy (BKN - 5 to 7 octaves coverage), Stratus (ST) and Stratus Cumulus (SC) clouds, with base at 800ft and top at 3,000ft (Figure 6).

Figure 6 - SIGWX chart dated 22JUL2018, from 1200 UTC, highlighting the region of the accident.

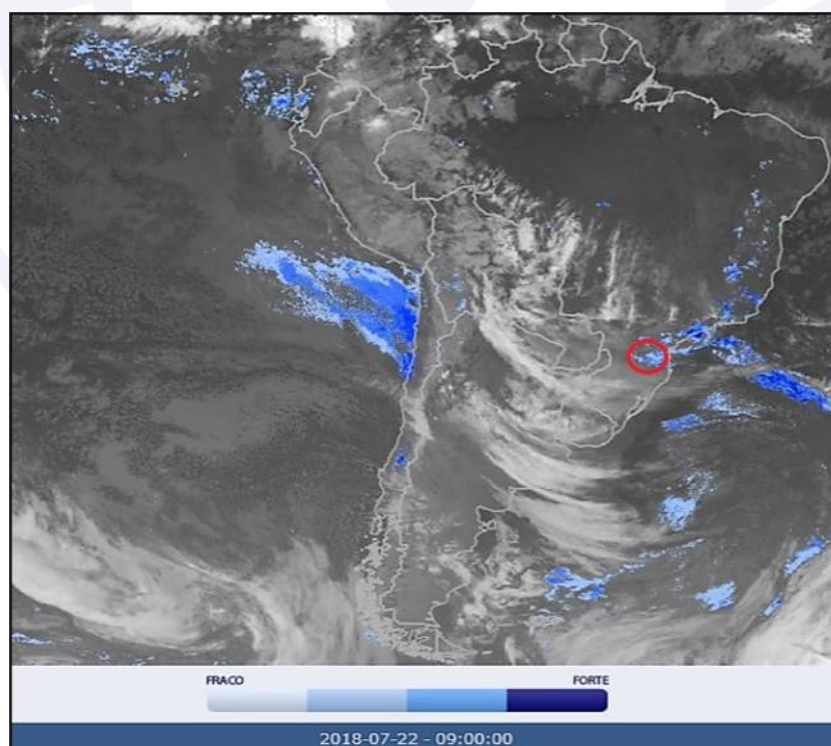
The GOES 16 satellite image, generated by the INPE and the CPTEC, indicated the occurrence of fog in the region that included the accident site (Figure 7).

Figure 7 - GOES 16 satellite image indicating the presence of fog at 9:00 am (local), available on the CPTEC/INPE website, highlighting the region of the accident.

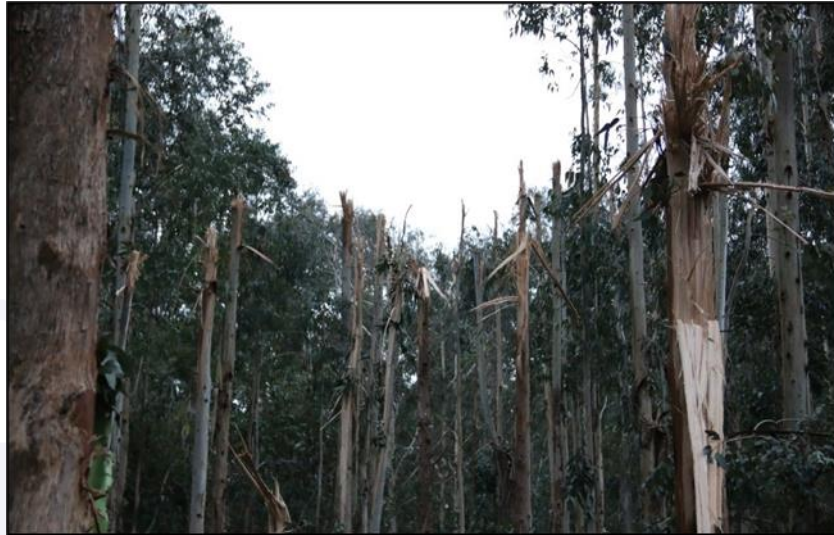
Signals of the aircraft crashing into vegetation and ground extended for about 60m from the site of the first impact against the eucalyptus trees to the complete stop of the main fuselage assembly. The degree of tree destruction suggests that the aircraft was at a high horizontal speed at the time of impact (Figure 8).

Figure 8 - View of damage caused to vegetation, from the opposite direction to the displacement of the aircraft.

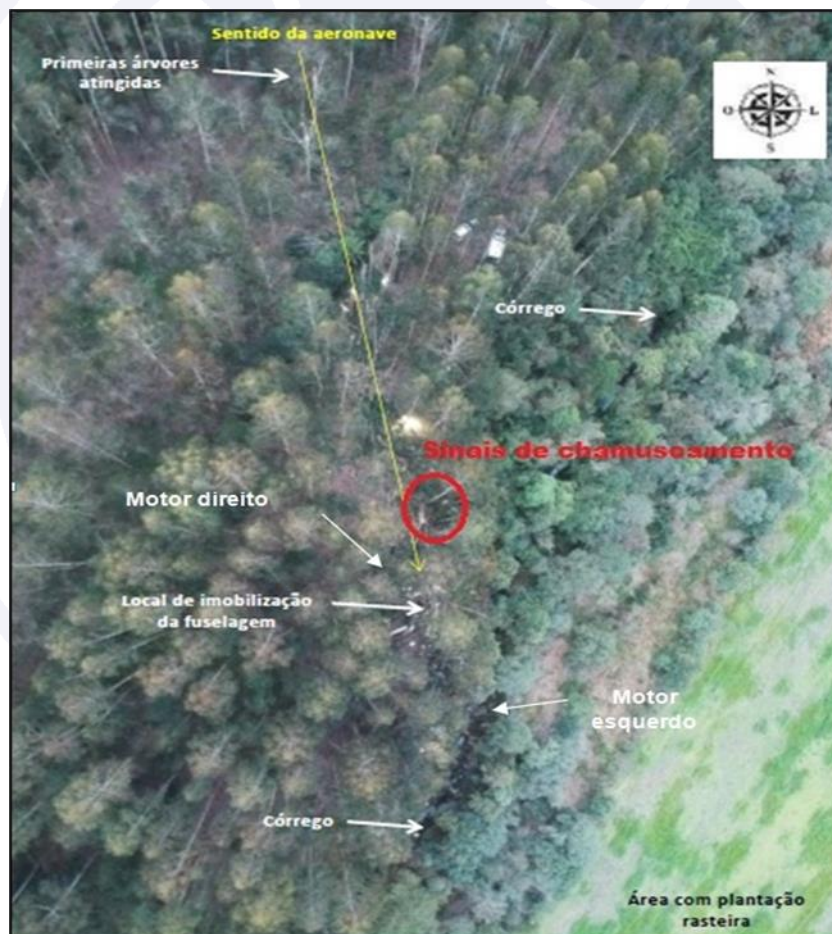
The engines detached from the wings. The right one was found on the ground among the trees, about 10m away from the fuselage. The left one was inside the stream, about 8m away from it (Figure 9).

Figure 9 - Final disposition of the wreckage.

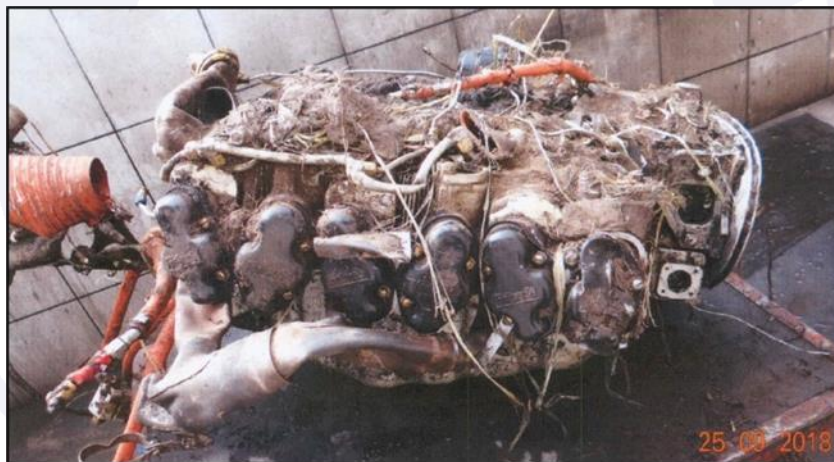
As a result of the impact against the trees and the ground, the left engine had severe damage. During the external inspection, the lack of a magnet, damage to the cylinder feed ducts, large amount of mud, damage to the turbocharger, damage to the exhaust duct and absence of other components were observed (Figure 10).

Figure 10 - Right side view of the left engine.

In the bench test, one of the magnets and the spark plugs, which could be analyzed, showed normal operation.

The lubrication system was showing evidence of good functioning and no signs of contamination or obstructions were found. The turbocharger was manually turned and was not stuck, even with the presence of earth inside the turbine.

In the fuel supply system, it was possible to examine only two injection nozzles and they were not clogged. The others had a rupture on the face with the cylinder and it was not possible to remove them. The fuel distributor had a normal diaphragm, despite the impacts resulting from the accident. The fuel pump had several fractures and this made its functional testing and analysis impossible.

The engine cylinders were analyzed and revealed no damage that could have caused the engine to malfunction. In the crankshaft flange, it was observed that part of it broke and became attached to the propeller flange. This was due to the strong impact that the propeller suffered at the time of the accident.

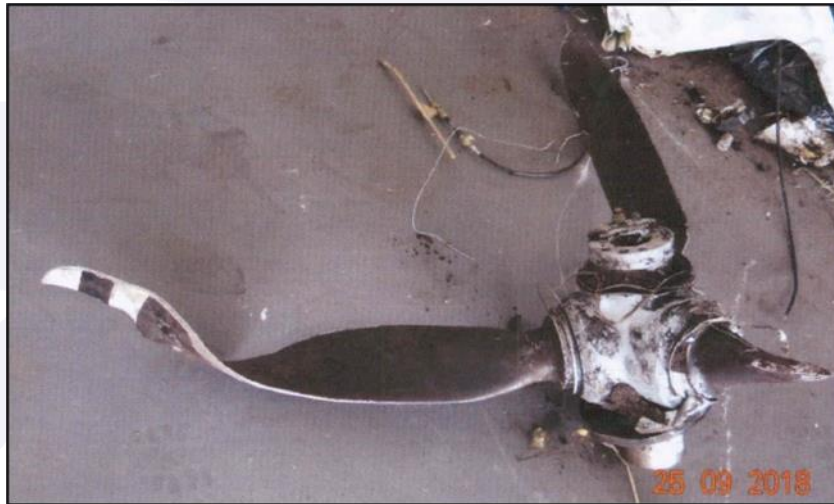
The propeller assembly had fractures and deformations in the three blades, which evidenced the normal functioning of the engine with power development. There were characteristic impact deformations against soft ground or tree, with characteristics of an operating engine with power (Figure 11).

Figure 11 - Detail of fractures and deformations in the three propeller blades of the left engine.

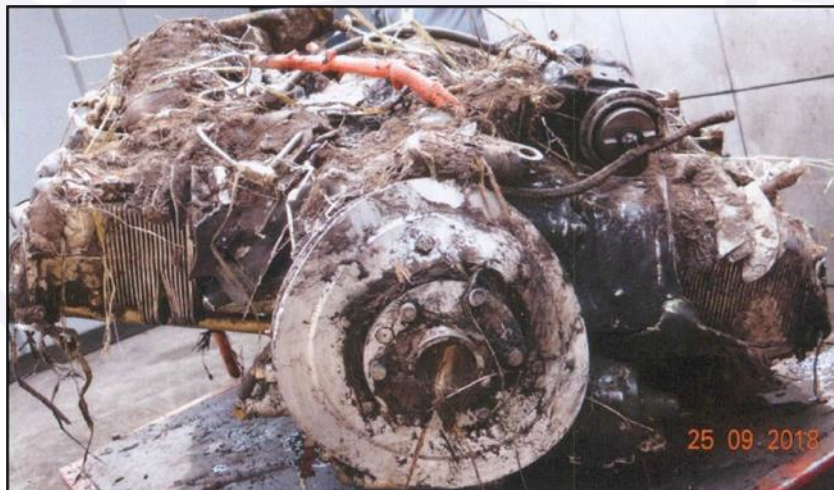
As a result of the series of impacts, the right engine was also severely damaged. It was observed the lack of a magnet, damage to the cylinder feed ducts, large amount of clay, damage to the turbocharger, exhaust duct and lack of other components (Figure 12).

Figure 12 - Front view of the right engine.

In the ignition system, a magnet was observed and tested, which showed normal functioning. The spark plugs were free of contamination, showing normal functioning.

The lubrication system was showing evidence of good functioning and no signs of contamination or obstructions were found. The turbocharger was manually turned and was not stuck, even with the presence of earth inside the compressor turbine.

In the fuel supply system, it was possible to examine four injection nozzles, which were not clogged. The others had a rupture on the face with the cylinder and it was not possible to remove them. The fuel distributor was with a normal diaphragm and the presence of fuel was observed when disassembled.

The fuel pump was not fractured, however, its pressure adjustment screw had deformation by impact, which made its functional test impossible. It was verified that its drive shaft was intact and not stuck. The servo injection fuel inlet filter was removed to be inspected when it was found to be clean and had fuel in its housing.

The cylinders were analyzed and no damage that could have caused the engine to malfunction was found. The crankshaft flange was deformed due to the impact of the propeller at the time of the accident, but without rupture.

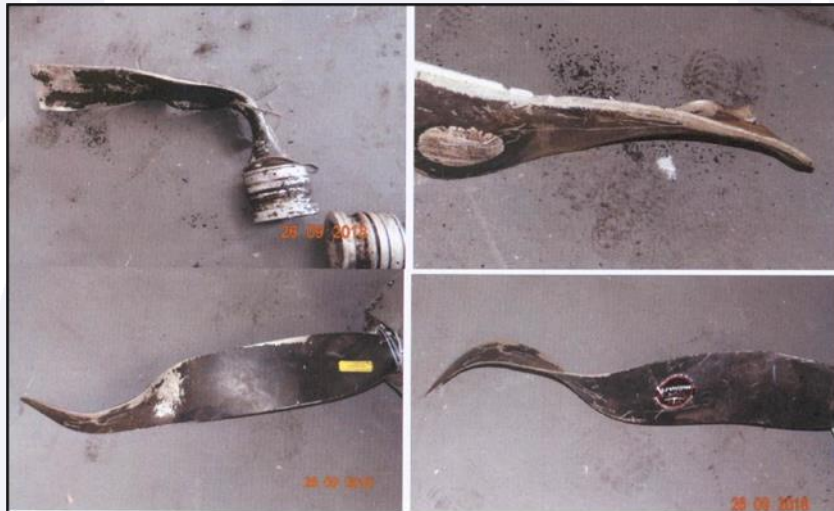
Similar to the left engine, the right engine propeller set had fractures and deformations that were found in the three blades, showing the normal functioning of the engine with power development. The blades also exhibited characteristic deformations from impact against soft ground or trees, and the forward-facing bending, characteristic of an operating engine with power development (Figure 13).

Figure 13 - View of the right propeller blades with forward-facing folds.

Thus, from what could be observed, the evidence indicated that the engines were in operation and that they developed high power at the moment of impact.

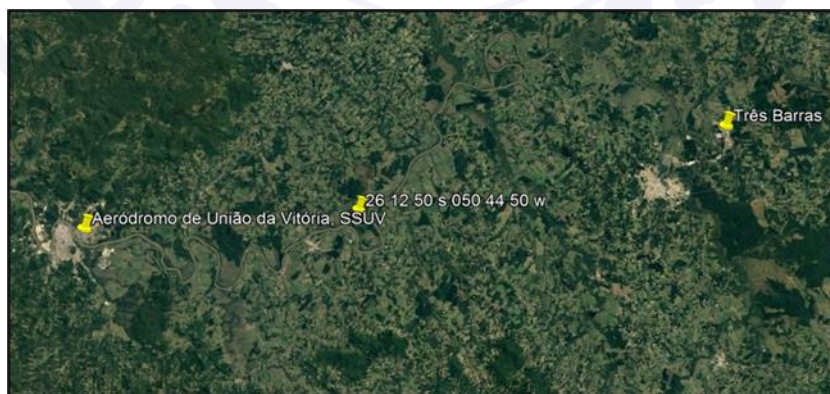
The pilot would then have stated that, if he encountered fog en route, he would fly through the Três Barras location until he found visual conditions and then follow the Iguaçu River to the SSUV (Figure 15).

Figure 15 - Planning mentioned by the pilot for the case of fog conditions en route.

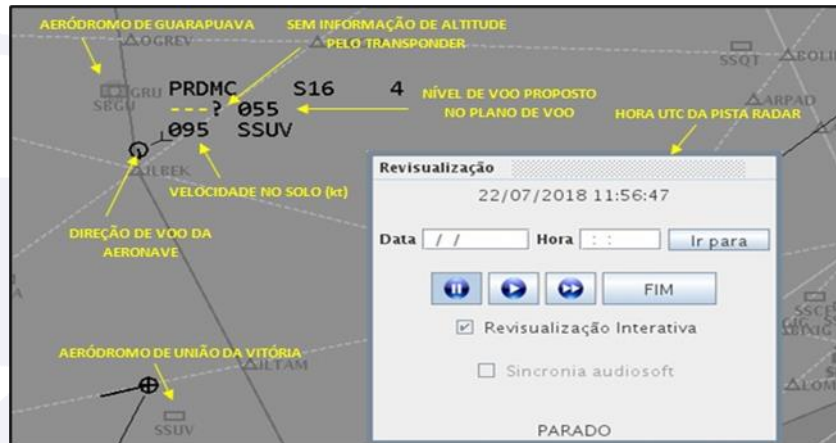
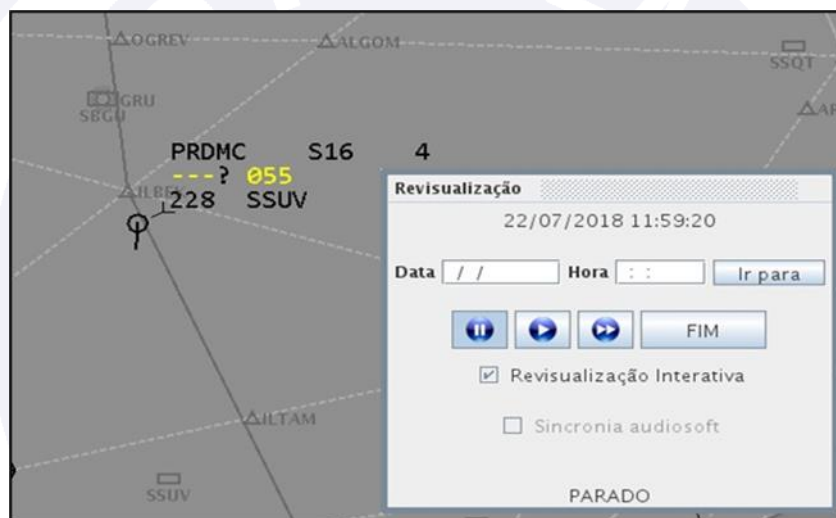
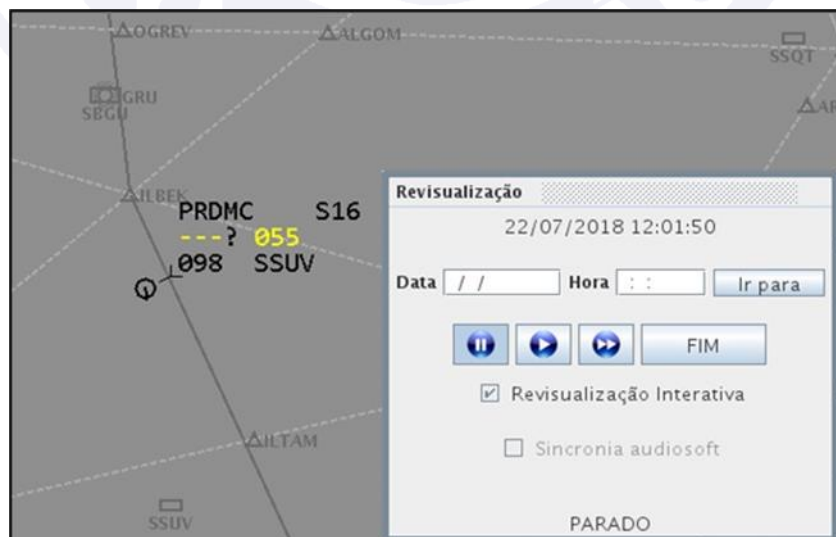
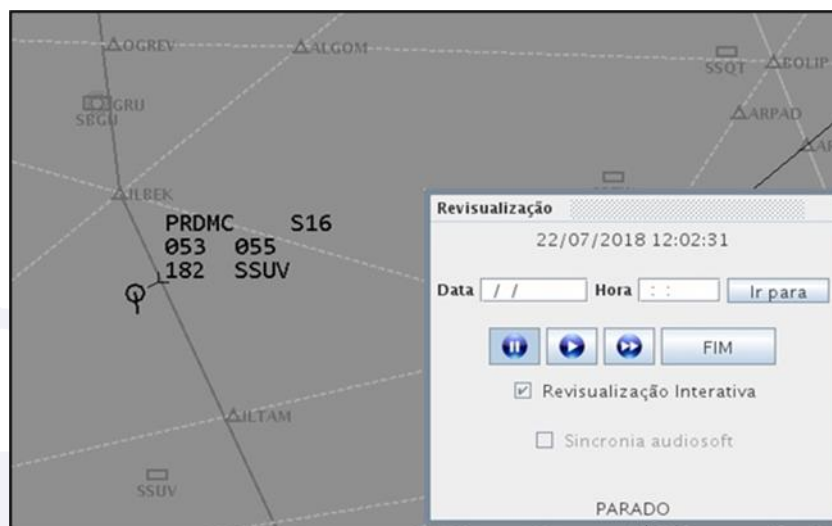
The aircraft continued the flight without informing for its descent and the last RADAR contact occurred at 1209 UTC, according to the following sequence (Figures 16, 17, 18 and 19):

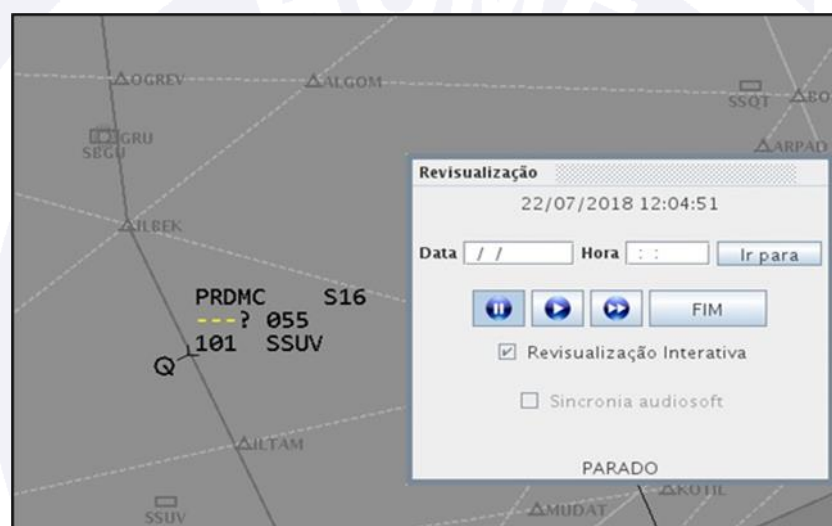
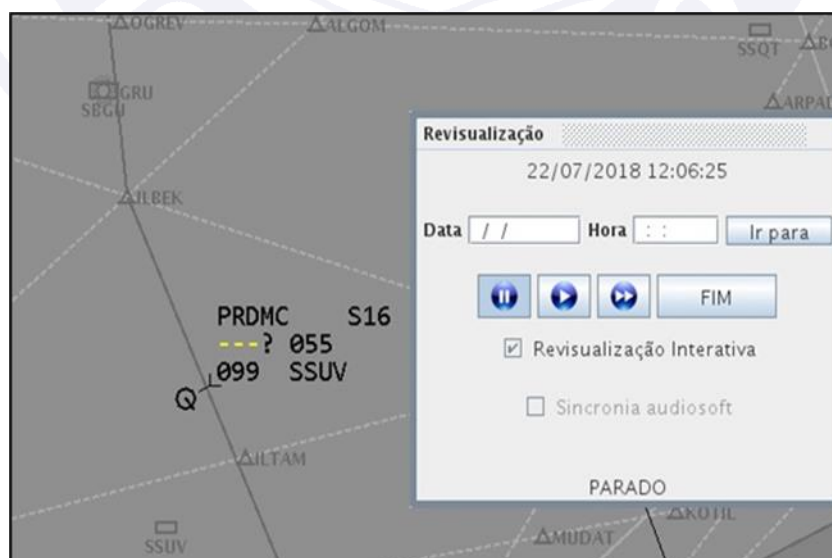
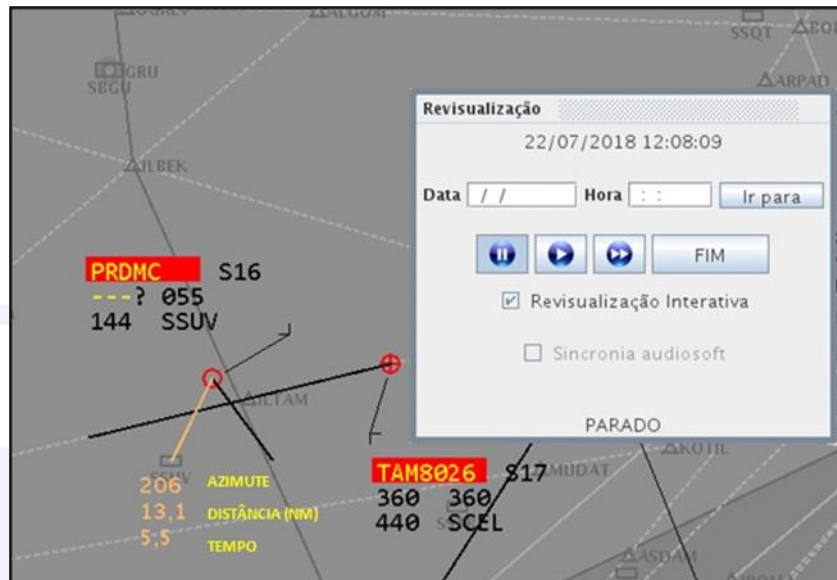
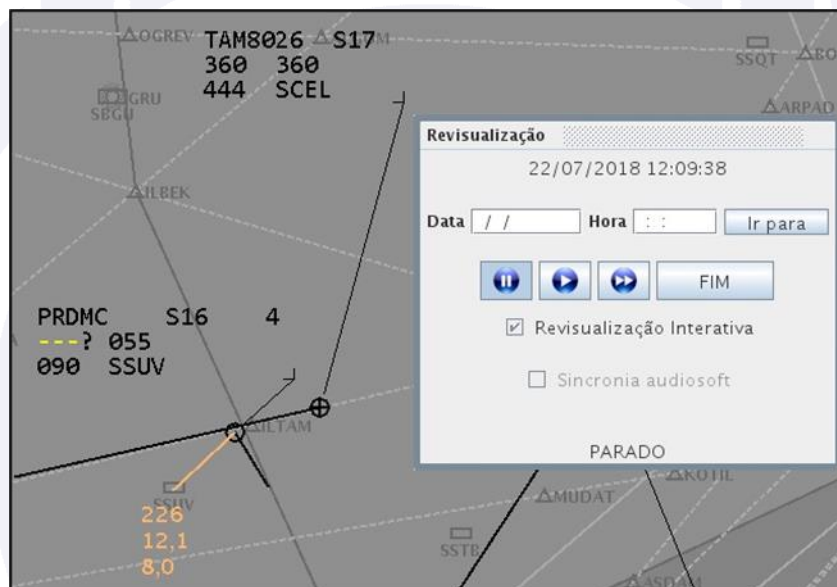
By analyzing the sequence of the RADAR images, it is observed that, from 1204 UTC, there was a change of course of the aircraft, which initially flew with the heading of SSUV and then took a heading more to the left of the initial route (Figures 20, 21, 22 and 23).

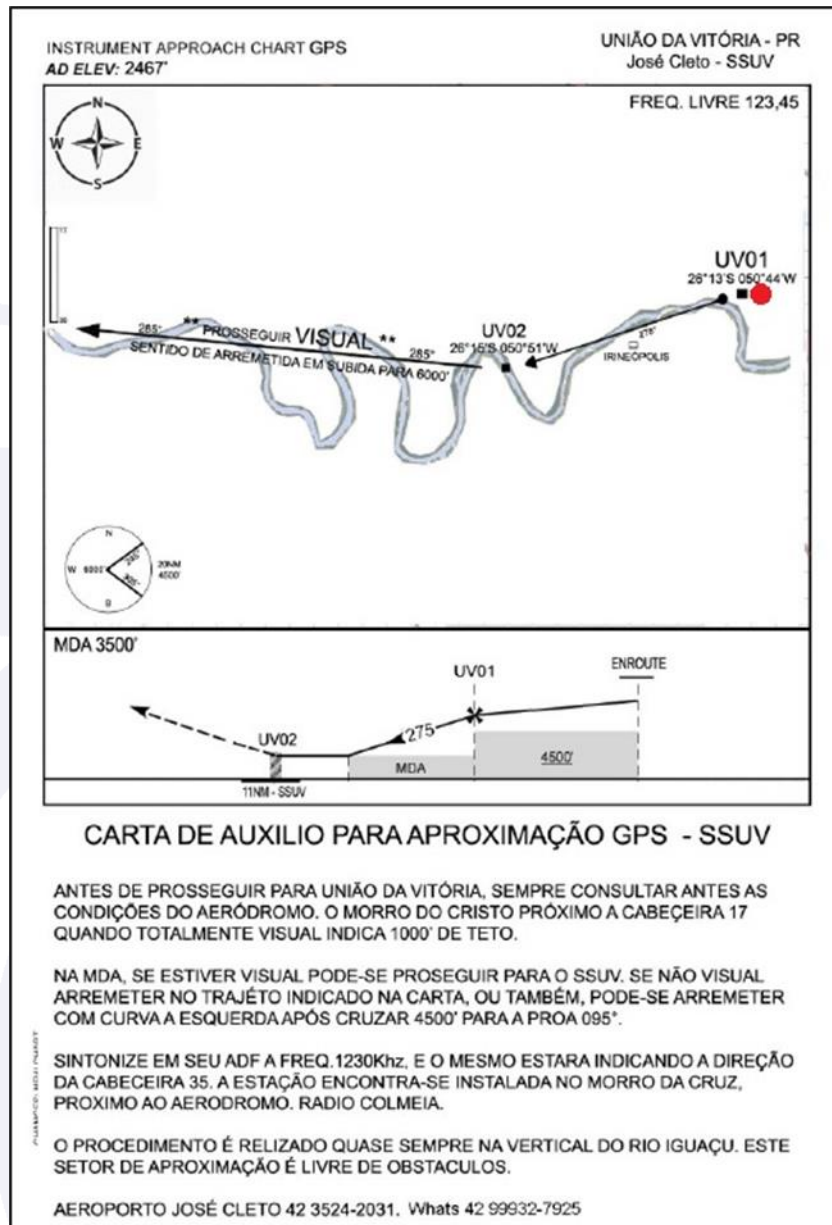
The accident site was 0.86 NM away from the first point of the unofficial procedure for descent into SSUV (Figure 24).

Figure 24 - Unofficial procedure for União da Vitória (the red dot indicates the location of the aircraft crash).

Amidst the wreckage, several procedures for approaching by unofficial instruments were found. Among them, there was a descent procedure for SSUV, which prevised a starting point at a geographic position of 0.86 NM distant from the place where the aircraft impacted the ground. This fact indicated that the aircraft could be fitting the profile of this procedure at the time of the crash.
