**COMANDO DA AERONÁUTICA**  
**CENTRO DE INVESTIGAÇÃO E PREVENÇÃO DE**  
**ACIDENTES AERONÁUTICOS**

**FINAL REPORT**  
**A - 090/CENIPA/2014**

<b>OCCURRENCE:</b>	<b>ACCIDENT</b>
<b>AIRCRAFT:</b>	<b>PR-FPL</b>
<b>MODEL:</b>	<b>EC-120B</b>
<b>DATE:</b>	<b>02MAY2014</b>

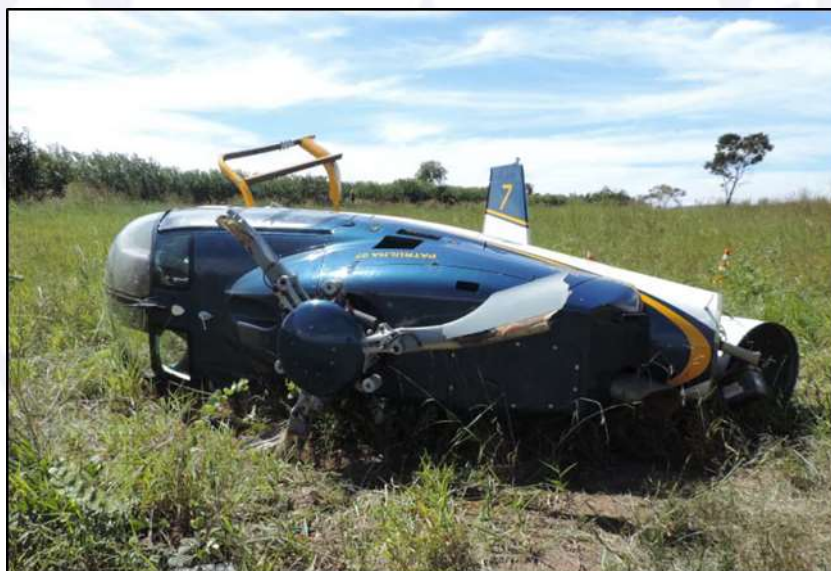
Figure 1 - View of the aircraft after impact.

There was a rupture in the root of the three blades of the main rotor, damage to the rotating components, skis and disconnection of the tail cone.

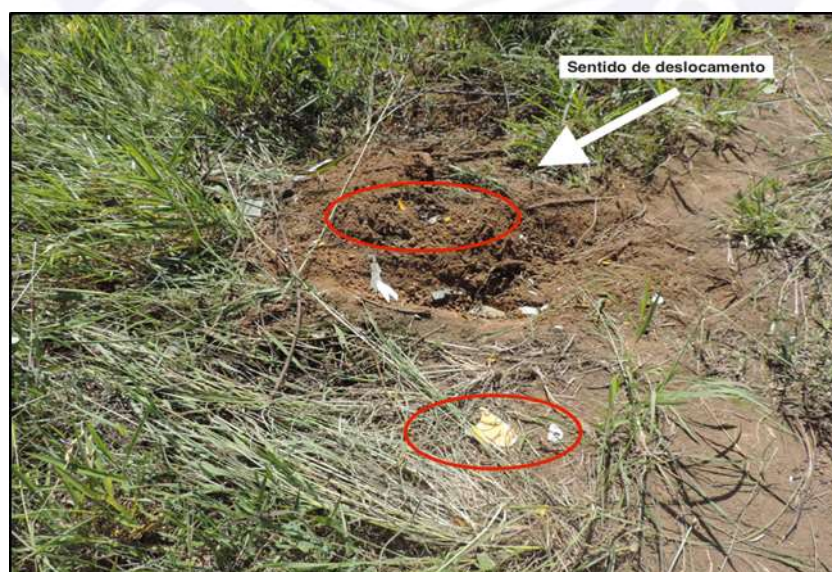
The first impact on the ground occurred with the left rear part of the aircraft (Figure 3).

Figure 3 - First impact. In highlight, yellow ski ink and pieces of the fenestron-type tail rotor guard.

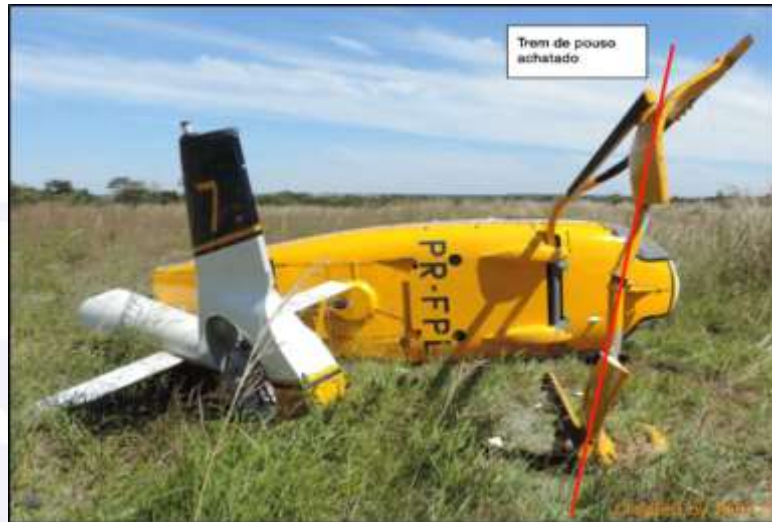
The skis (landing gear) were flattened in the rear due to the collision with the terrain (Figure 4).

Figure 4 - Flat landing gear, highlighted.

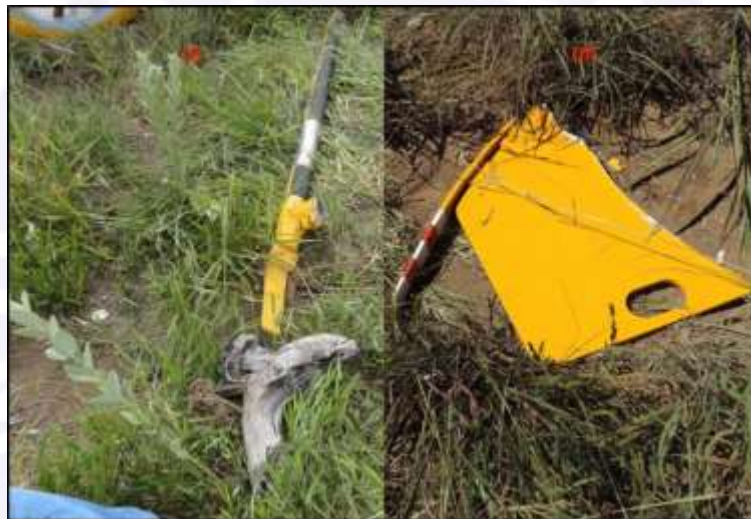
There was the left rear ski break and the fenestron-type tail rotor guard break (Figure 5).

Figure 5 - (I) Left ski broken and disconnected. (II) Fenestron tail rotor guard disconnected from the aircraft.

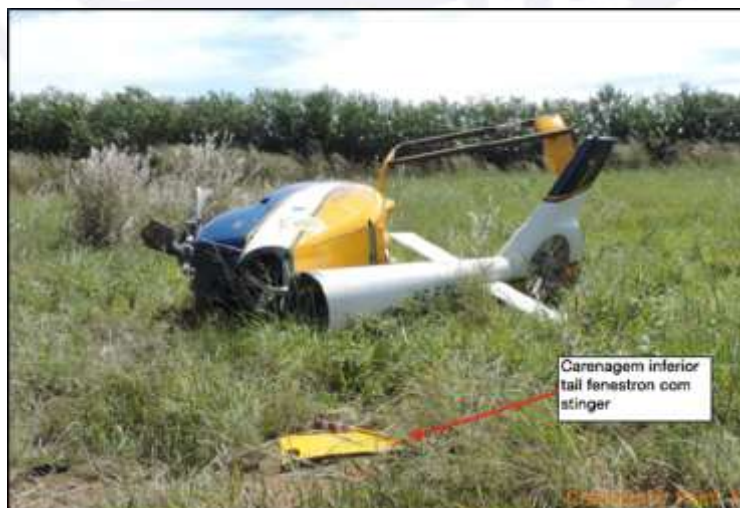
After the total stop, the aircraft was tipped, lying on its left side (Figure 6).

Figure 6 - The lower protection fennel shield was disconnected.

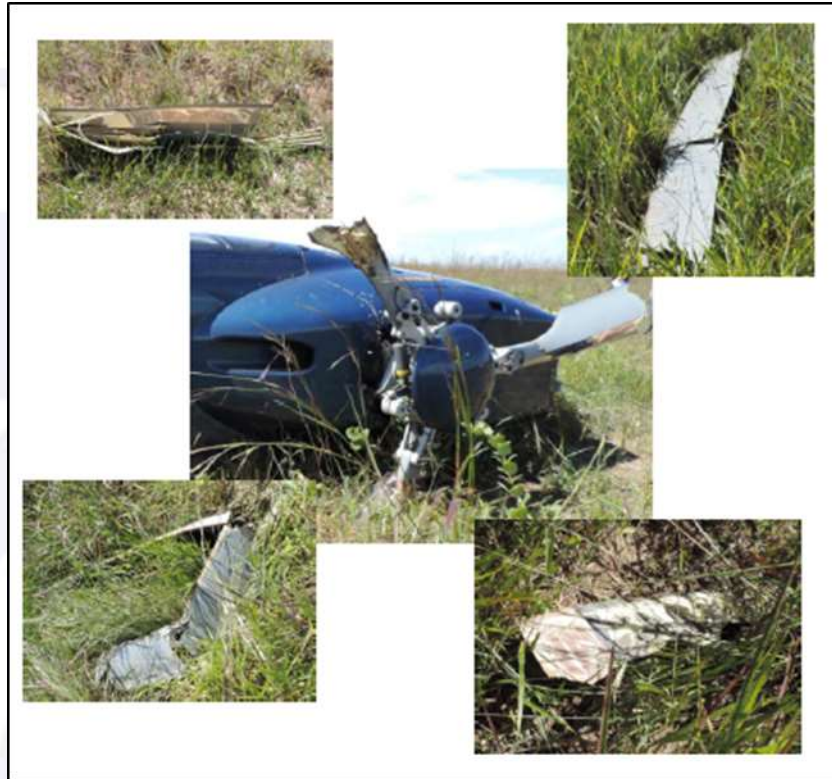
The three blades of the main rotor collided against the ground and were fractured near their connections with the main rotor head. The tail cone was completely sectioned from the junction with the main fuselage, remaining connected through the transmission rod of the controls.

Dozens of small fragments of the blades were found around the wreckage (Figure 7).

Figure 7 - Fragments of blades scattered on the wreckage site.

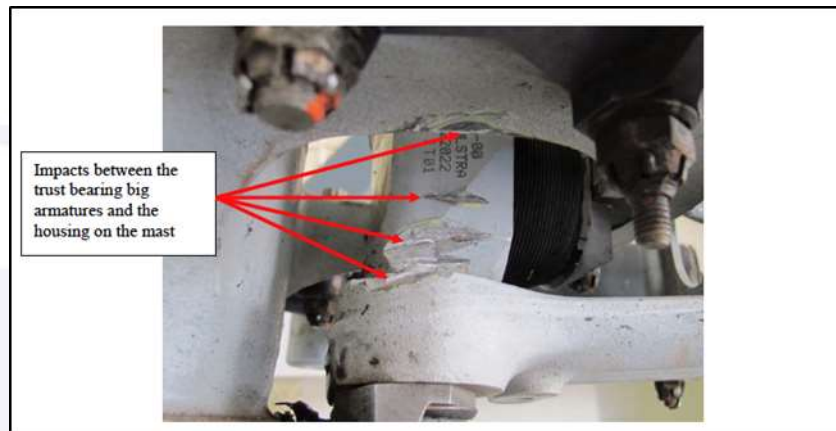
- impact between the components identified as "spherical trust bearing large armatures and their housing" on the mast. This phenomenon was a consequence of rotation and drag effects on polyurethane protection of the blades when they impacted the ground with power and pitch (Figure 11);

Figure 11 - Impacts on the mast.

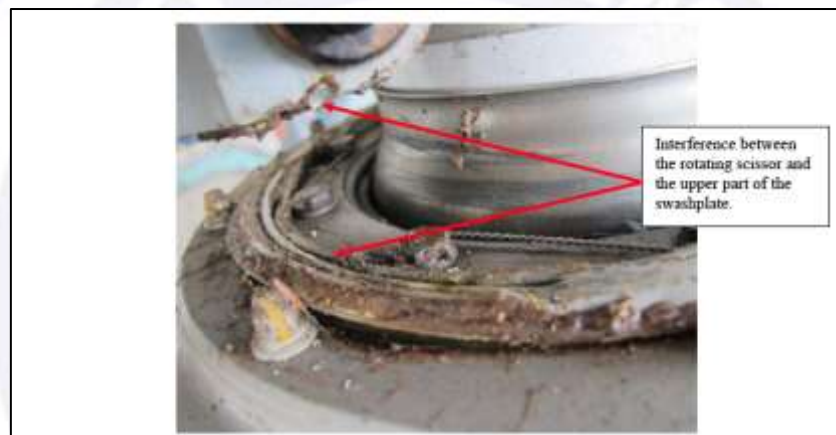
- interference between the plate and the rotating scissors due to the significant rotation of the plate resulting in flapping during impact of the blades against the ground (Figure 12);

Figure 12 - Damage at the top of the rotating plate.

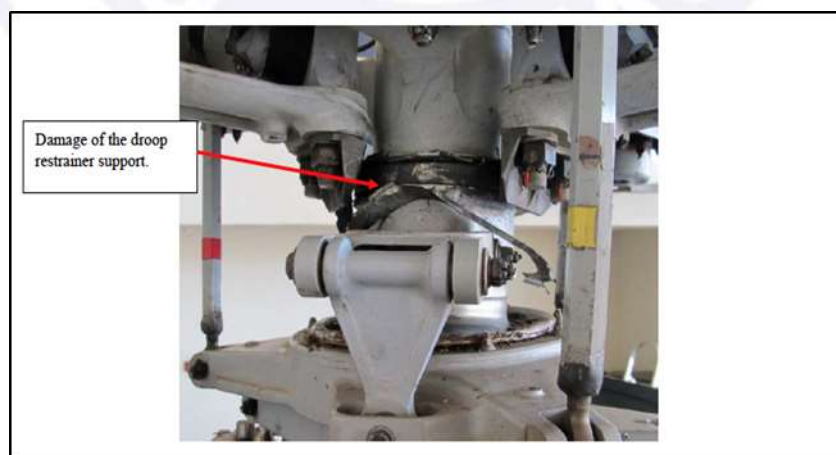
- damage at the droop restrainer support, due to overload resulting from flapping, during impact of blades against the ground (Figure 13);

Figure 13 - Damage to the mast holder.

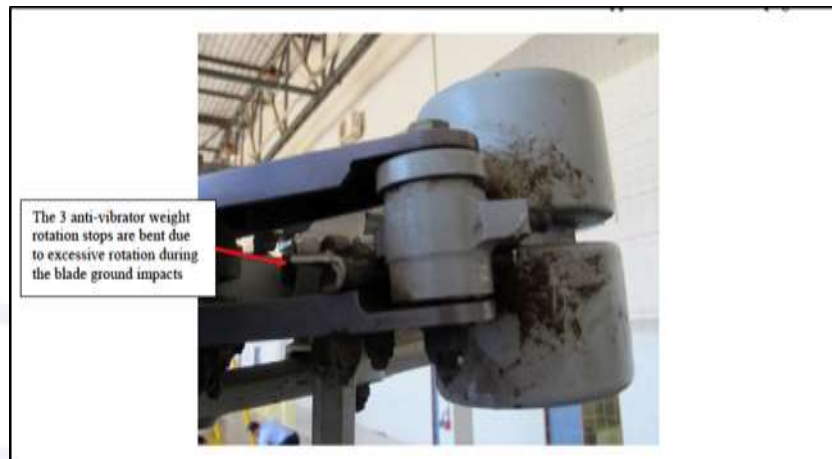
- damage to the three anti-vibrator weight rotation stops, due to the overload resulting from the impact of the blades against the ground (Figure 14);

Figure 14 - Shock absorbers twisted, due to ground impact.

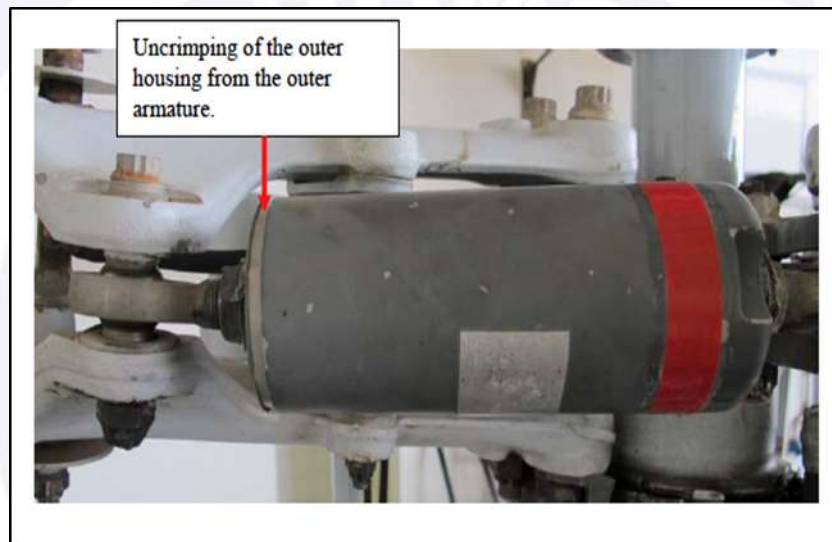
- one of the outer shells of the frequency damper (red) has been detached from the outer armature (this phenomenon is commonly observed as a result of drag overloads when the main rotor blades impact the ground with energy as the aircraft rolls). The absence of wear at the interface confirms that this phenomenon is a sudden effect, due to the overload resulting from the contact of the blade; and

Figure 15 - Slight separation of the outer housing from the outer armature.

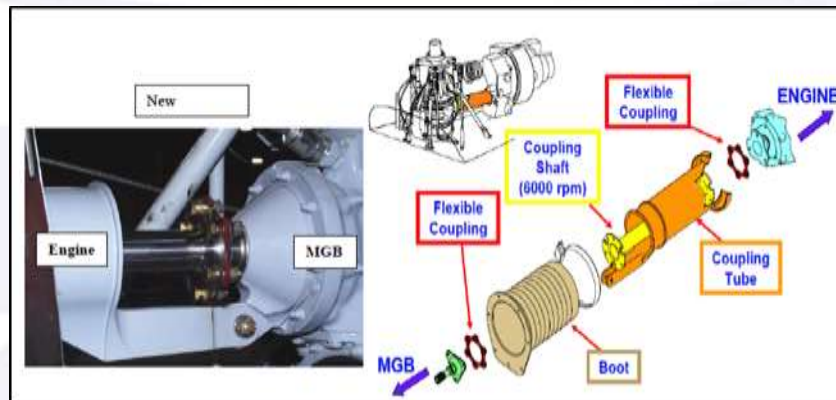
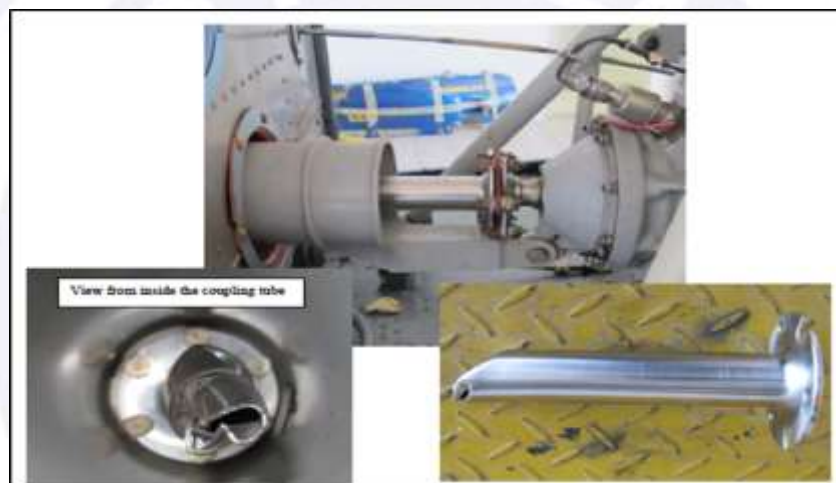
The engine drive shaft for the MGB (internal to the coupling tube) was broken in the turning motion (by overload), in its median position, as a consequence of the over torque resulting from the impact of the main rotor blades against the ground with power (Figures 19 and 20).

Figure 20 - Internal view of the coupling tube and broken drive shaft.

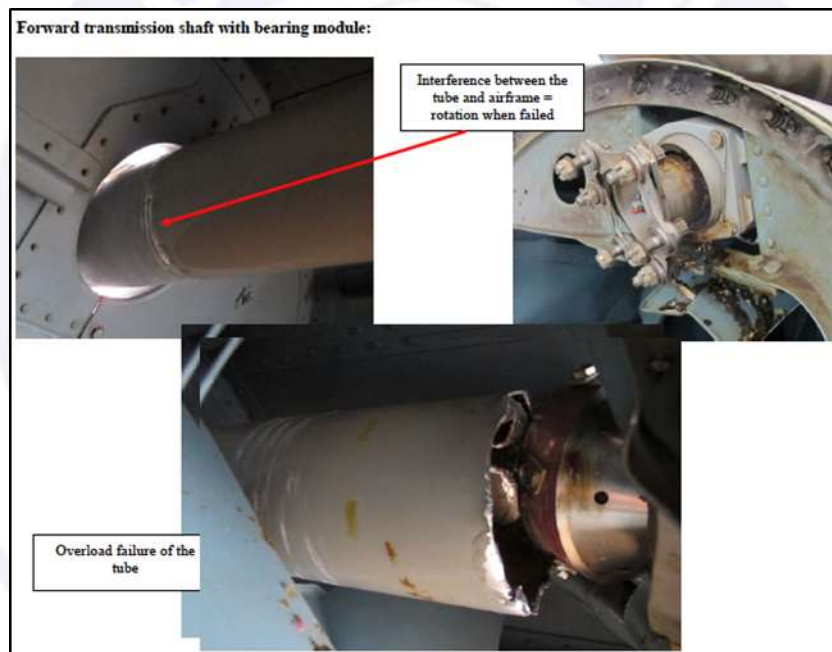
This shaft was broken in the riveted coupling (overload failure), with its flange in the bearing affixing of the bearing module. This failure probably occurred as a result of the twisting during the tail disconnection on the ground impact (Figure 23).

Figure 23 - Overload failure view.

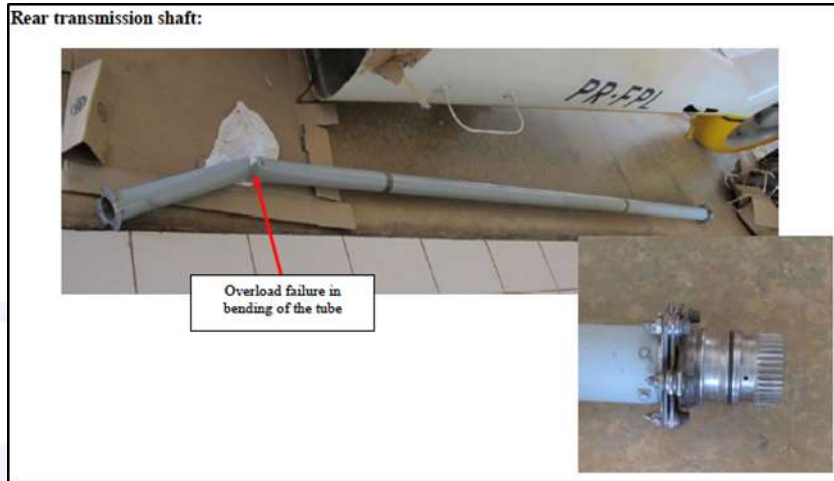
The inlet flange of the rear transmission case has been disengaged from the rear transmission case during the tail separation. No pre-impact failure was observed (Figure 24).

Figure 24 - View of the shaft folding associated with overload failure. On the detail, the inlet flange of the rear transmission box disengaged from the box.

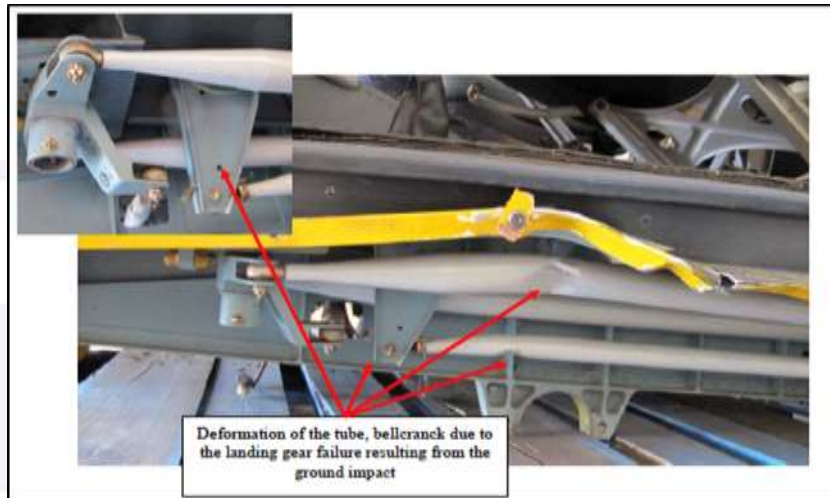
A hard point was observed on the cyclic stick that was identified as a result of the deformation seen in the rod and bellcrank as deformation resulting from ground impact (Figure 30).

Figure 30 - Deformation of the tube and bellcrank due to the failure of the landing gear resulting from the ground impact.

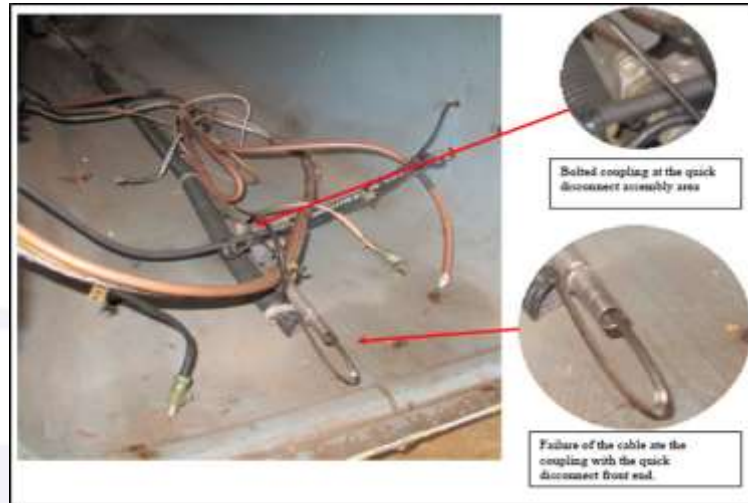
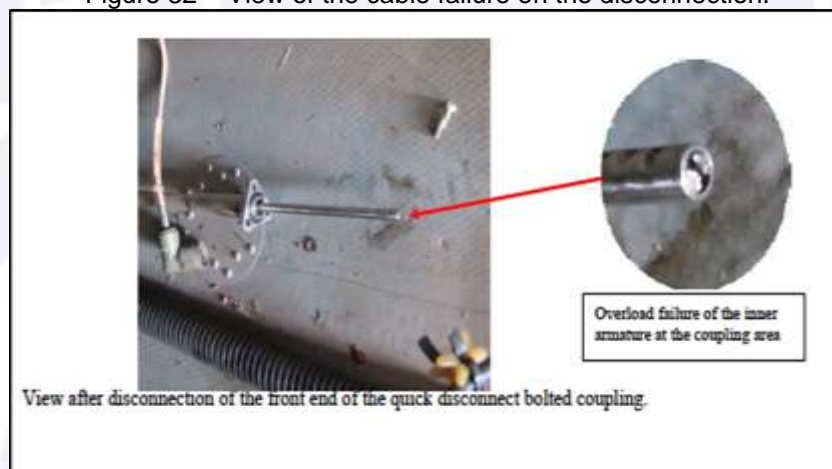
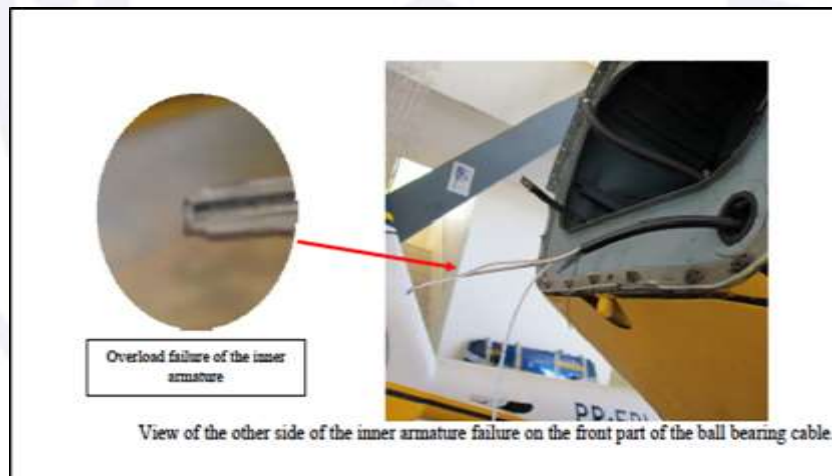
The pedals moved freely and the ball-bearing cable (teleflex) ran inside the armature. The cable was broken in its rear connection. The failure of the cable and armature was due to overload, whose main probability was the detachment of the tail cone from the fuselage during the ground impact of the aircraft. (Figures 32, 33 and 34).

Figure 32 – View of the cable failure on the disconnection.

Figure 33 – On detail, overload failure of the inner armature in the coupling area.

Figure 34 – On detail, the internal overload fault.

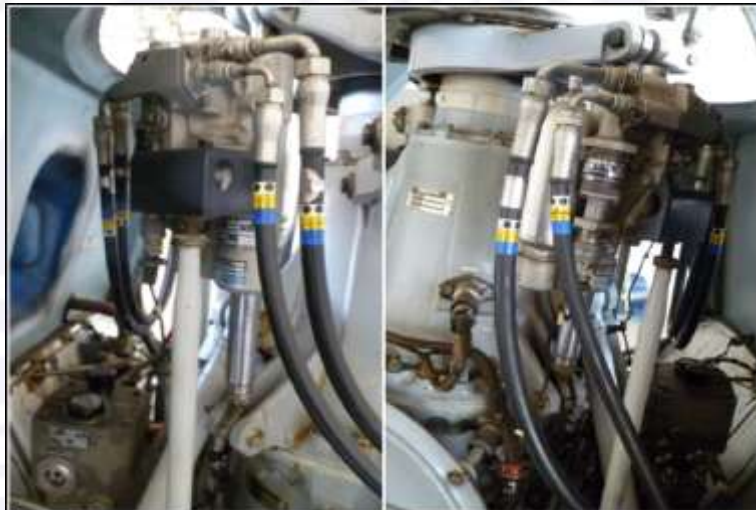
When the flight commands were moved in all directions, there was forward and side movement restriction in the servocontrols (Figure 41).

These tests showed that two of the three main servocontrols could not be displaced throughout their course, which was probably a consequence of internal damage resulting from the accident. However, to confirm this hypothesis, it was decided to remove and ship these components to the manufacturer to identify the source of the constraints.

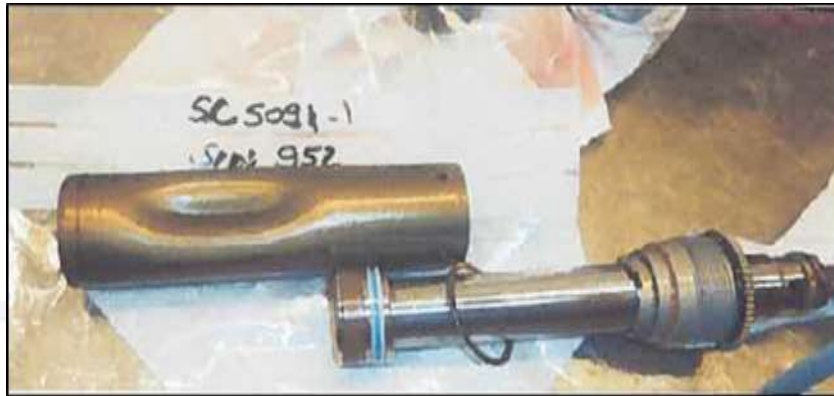
The servocontrols with serial numbers (S/N) 952 and (S/N) 943 presented characteristic damages resulting from the impact, due to the overpressure generated at the actuator. The polyurethane protection was deformed by this overpressure and the displacement of the piston rod was limited, due to the deformation (Figures 44 and 45).

Figure 44 - Deformation of the S/N 952 servocontrol protection, due to the overpressure generated on the impact.

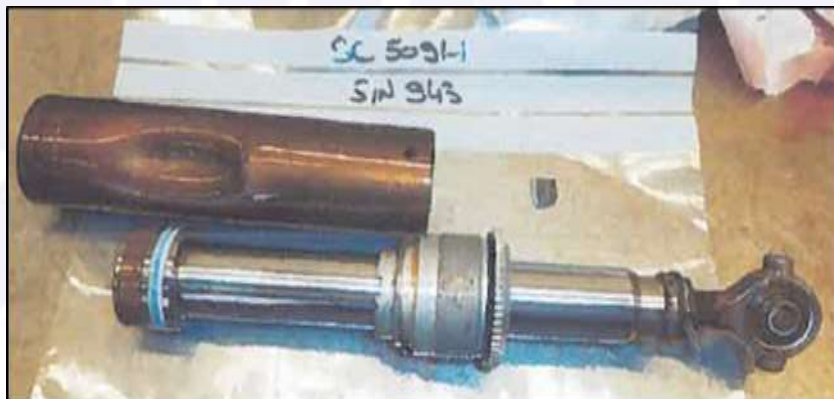
Figure 45 - Deformation of the S/N 943 servocontrol protection, due to the overpressure generated on the impact.

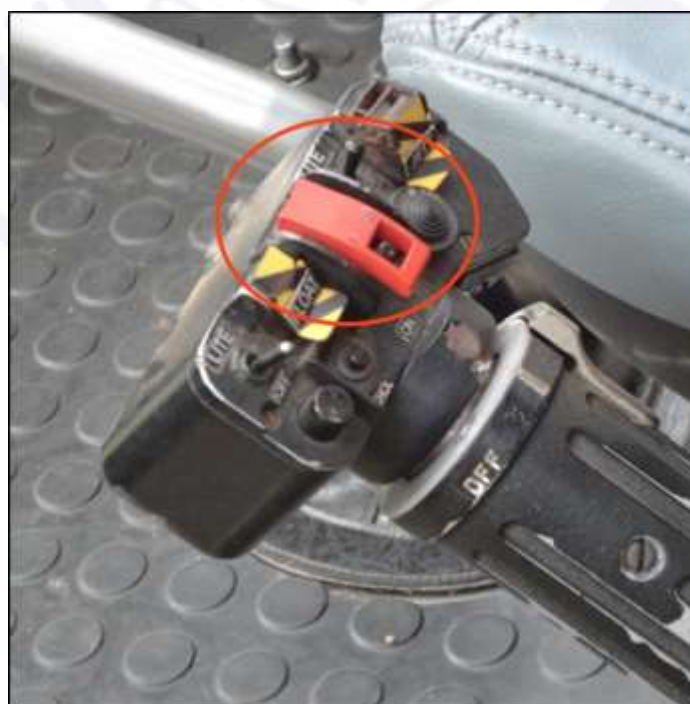
According to the crew, the hydraulic system was not reconnected at any time. On the first action carried out by the Investigation team, it was identified that the hydraulic switch in the collective was in the ON position (Figure 50).

Figure 50 - Hydraulic switch triggered, registered after the accident.
