COMANDO DA AERONÁUTICA
CENTRO DE INVESTIGAÇÃO E PREVENÇÃO DE
ACIDENTES AERONÁUTICOS

FINAL REPORT
A-119/CENIPA/2018

OCCURRENCE:	ACCIDENT
AIRCRAFT:	PR-GGD
MODEL:	737-8EH
DATE:	16JUL2018

This is the Final Report of the 16JUL2018 accident with the 737-8EH aircraft model, registration PR-GGD. The accident was classified as “[SCF-NP] System/Component Failure or Malfunction Non-Powerplant – with Landing Gear”.

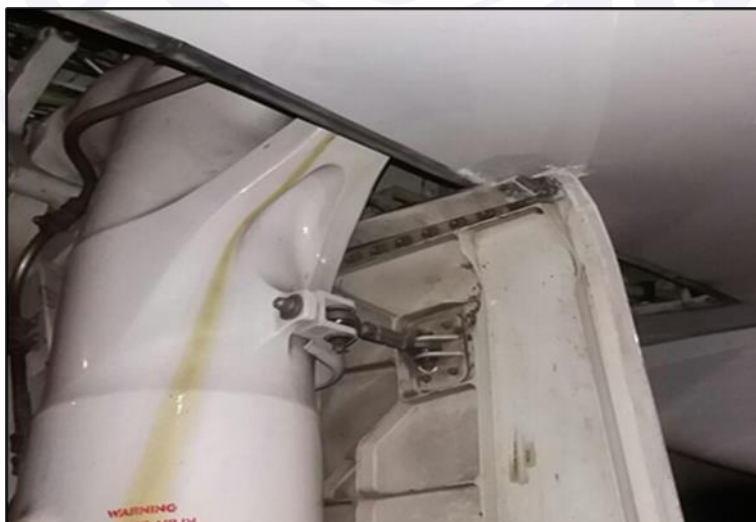
After landing, during an inspection by the maintenance team, damage was found to the Aft Pressure Bulkhead sealant and in the hydraulic pipes causing fluid leakage (Figure 1).

Figure 1 - Leakage of hydraulic fluid on the right landing gear.

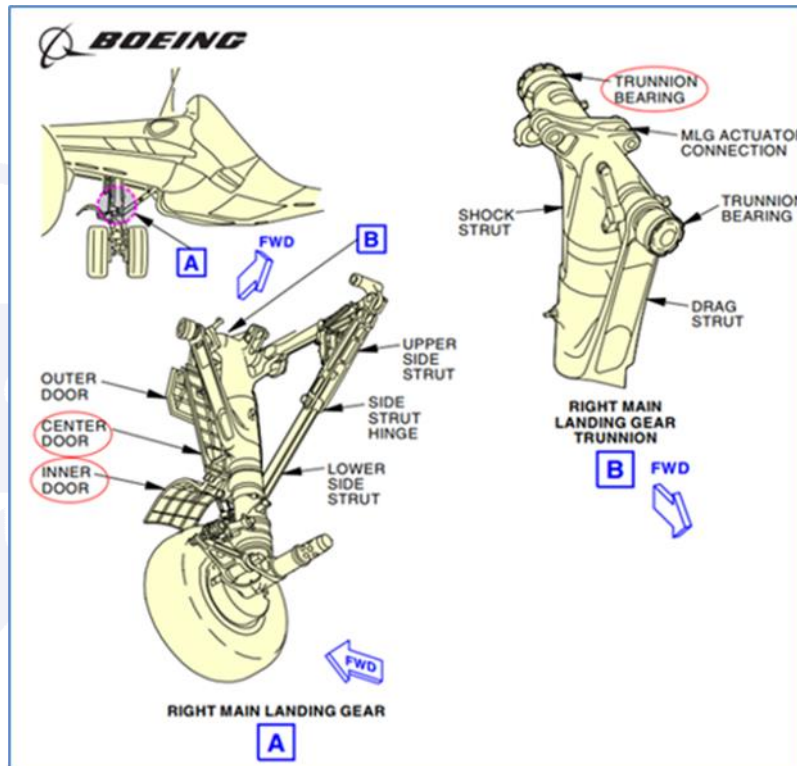
Figure 2 - Location of the damaged components (red circles) of the right main landing gear.

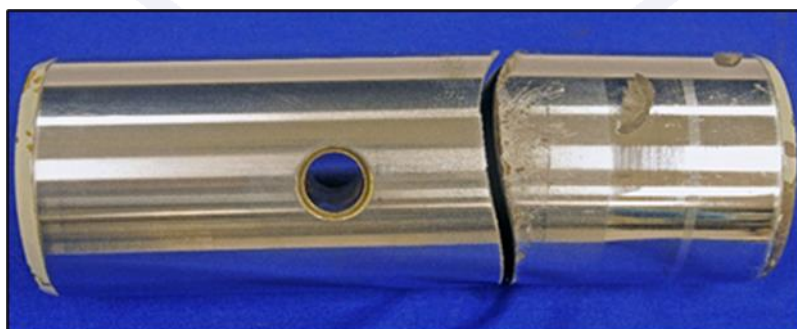
Figure 4 - Aft trunnion pin fractured.

A part of the fractured aft trunnion pin was located on the SBCF runway.

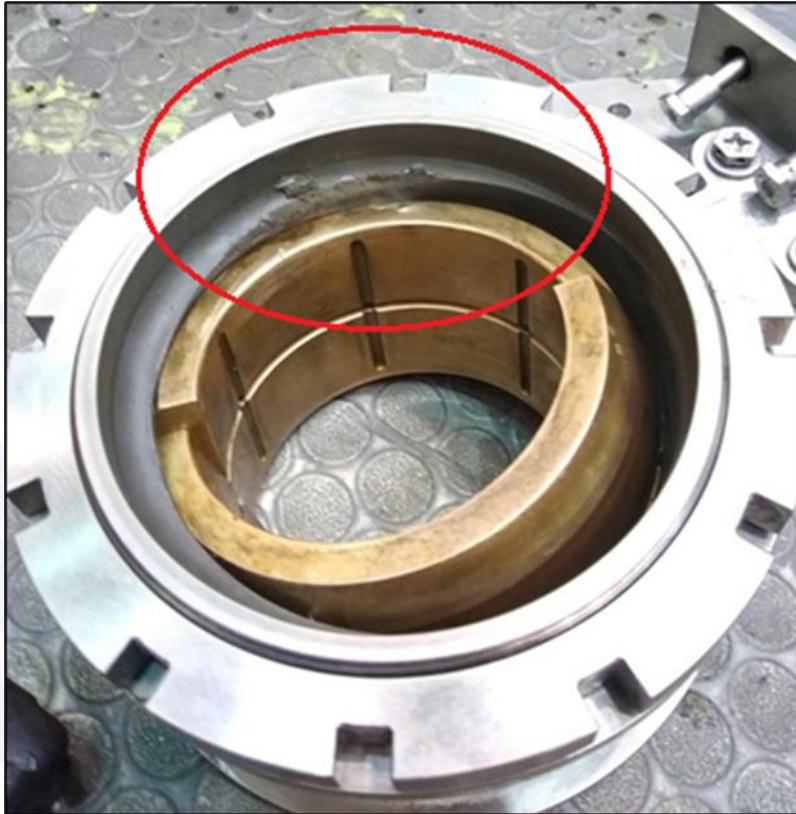
Figure 5 - Damage to the aft trunnion bearing.

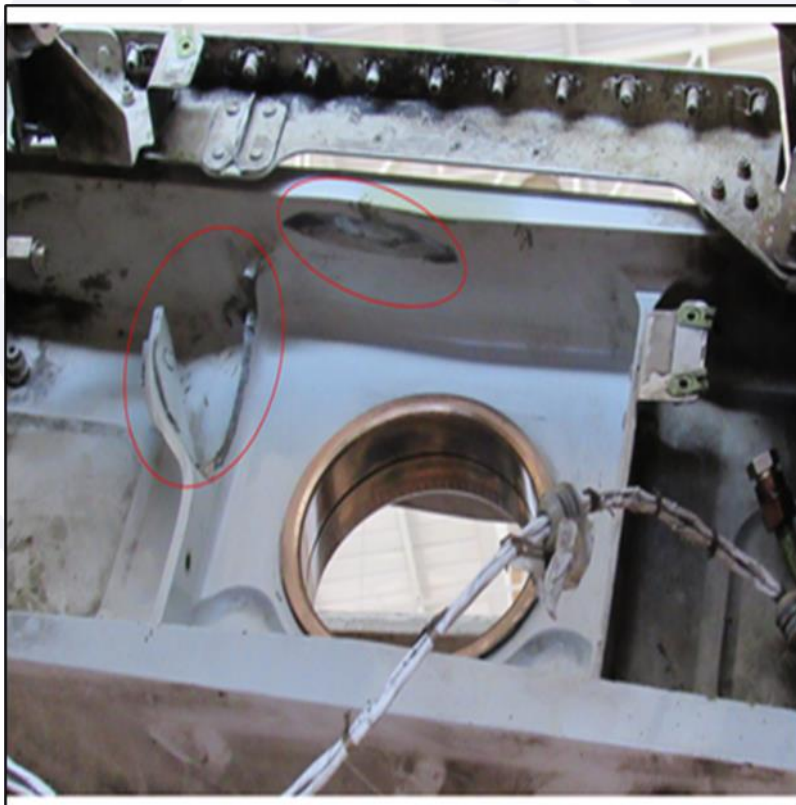
Figure 6 - Damage to the wing structure (stringer), highlighted.

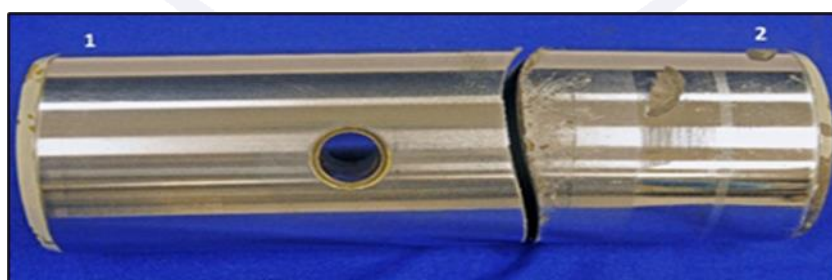
The two portions of the aft trunnion pin were identified with the numbers 1 and 2, with the number 1 being the front and the number 2 the rear (Figure 16).

Figure 16 - Aft trunnion pin fractured.

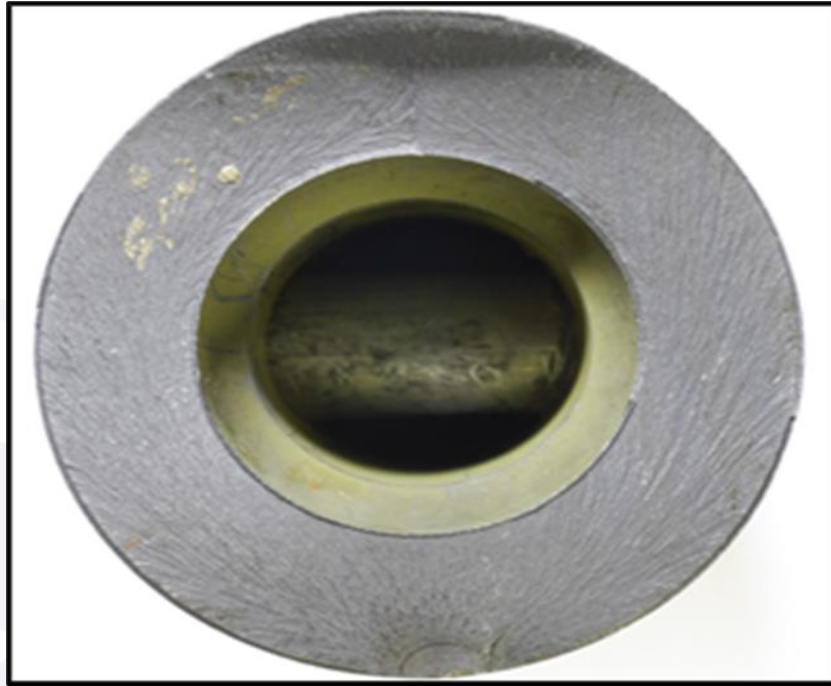
Figure 17 – Fractured face of part 1 of the aft trunnion pin.

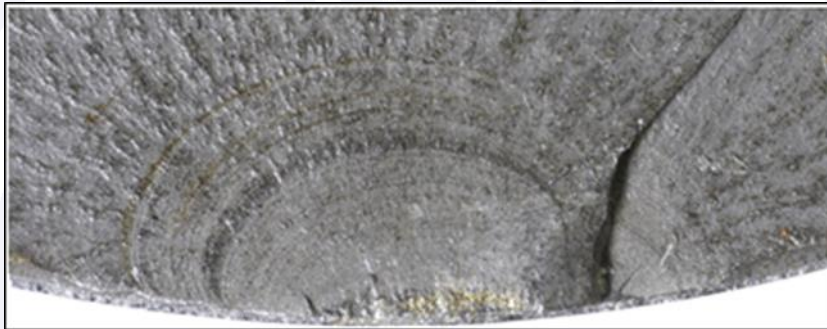
Figure 18 - Detail of the part 1 fracture of the aft trunnion pin.

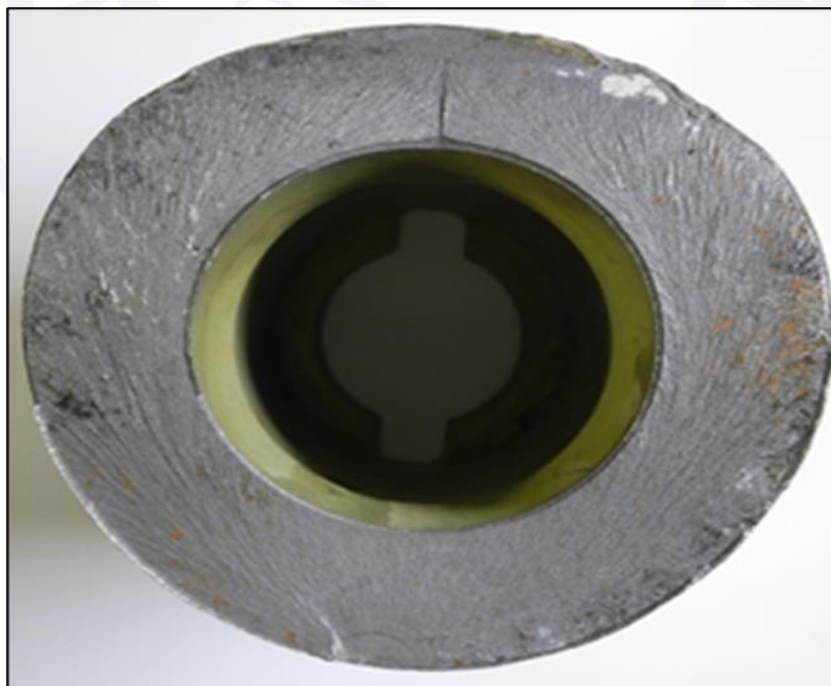
Figure 19 - Fractured face of part 2 of the aft trunnion pin.

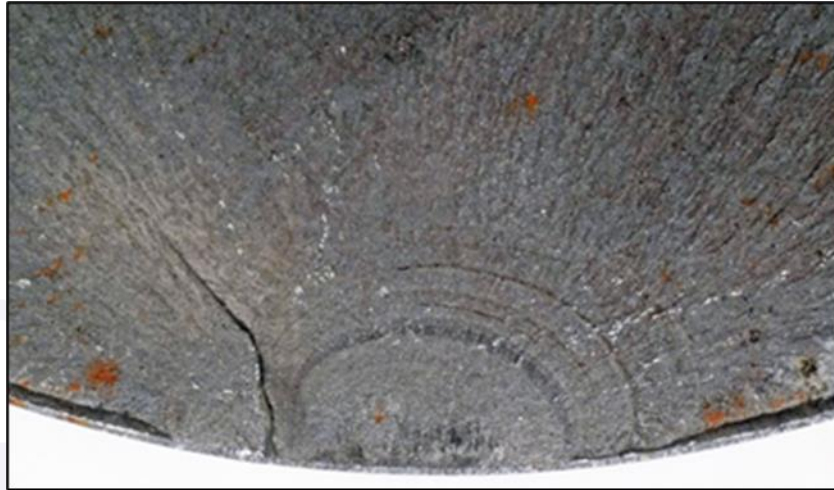
Figure 20 - Detail of the part 2 fracture of the aft trunnion pin.

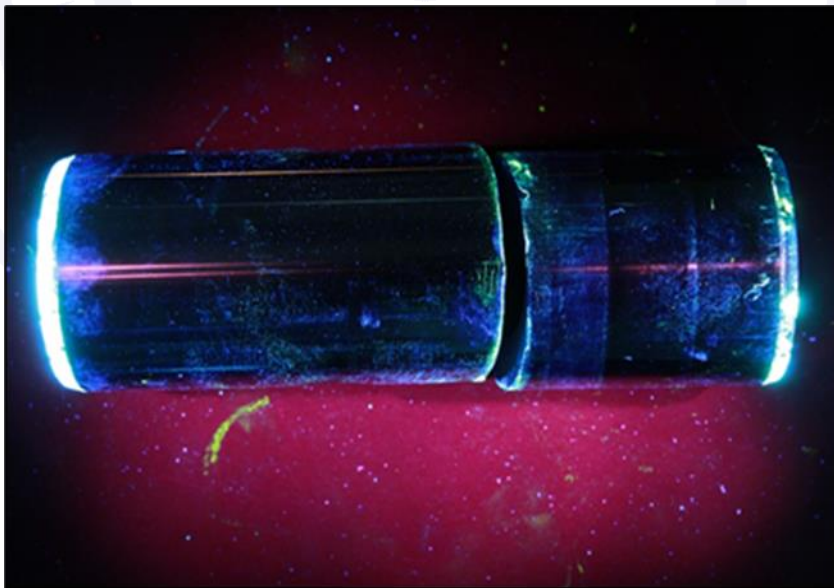
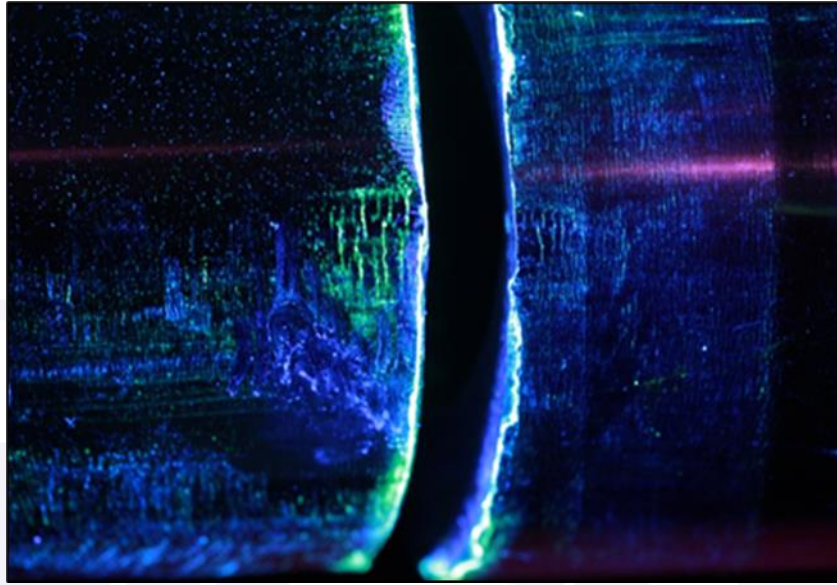
The inspection by penetrating liquid revealed several accumulations along the entire fracture diameter. In particular, a crack indicative was found in an area of approximately 1.0 pol^2 close to the region shown in Figure 23 and Figure 24.

Figure 23 - Overview of the penetrating liquid inspection on the aft trunnion pin.

Figure 24 - Detail of the inspection by penetrating liquid in the aft trunnion pin.

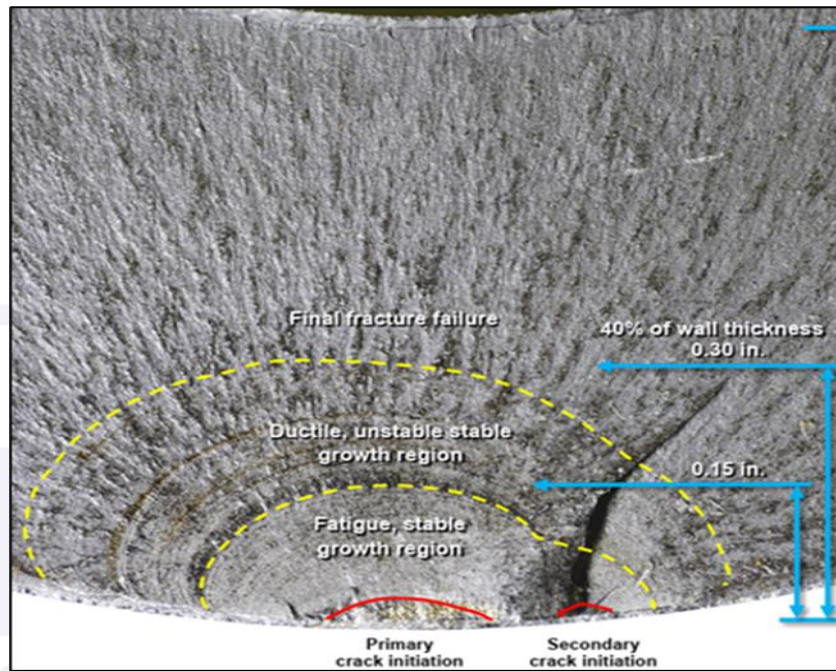
- two intergranular crack start points, with dimensions of about 0.025 inches;
- the first crack portion showed stable growth with fatigue characteristics, approximate dimensions of 0.15 inches (about 20% of the pin section's thickness);
- the remaining portion showed unstable but cyclical growth, with characteristics of ductile fracture. Approximate dimension of 0.30 inches (about 40% of the pin section's thickness); and
- the final fracture showed characteristics of ductile and abrupt fractures.

Figure 26 - Fracture characteristic of the aft trunnion pin SN E4798.

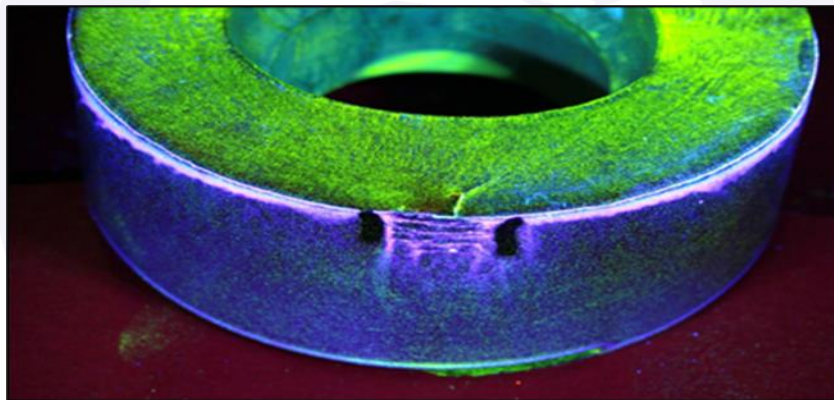
A crack was observed on the surface of the pin with characteristics similar to those observed in the inspection by penetrating liquids (Figure 27).

Figure 27 - Inspection by magnetic particles in the sectioned portion of the aft trunnion pin.

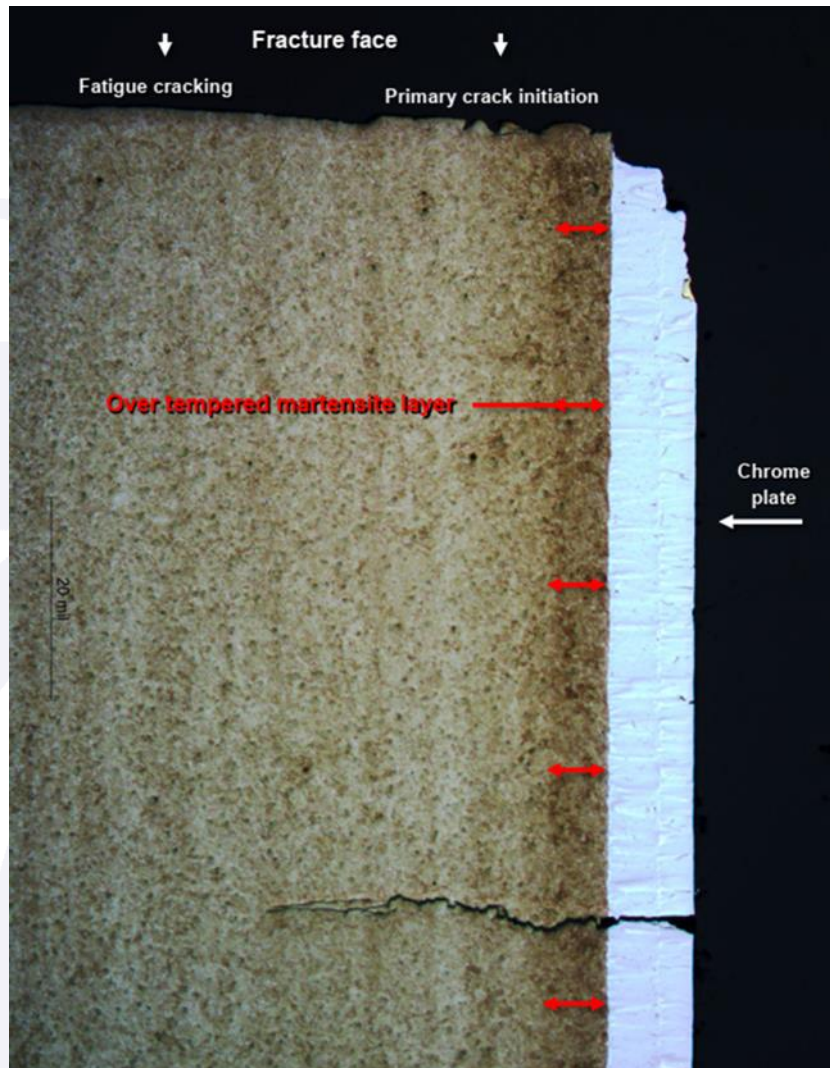
Figure 29 - Sample for metallographic examination at the origin of the failure.

The darkened region, highlighted by the red arrows in Figure 29, indicates a region that has been subjected to an excess temperature of Martensite (form of the crystalline structure of the iron-carbon alloy) or Over Tempered Martensite (OTM). This condition can also be referred to as burning the base metal.

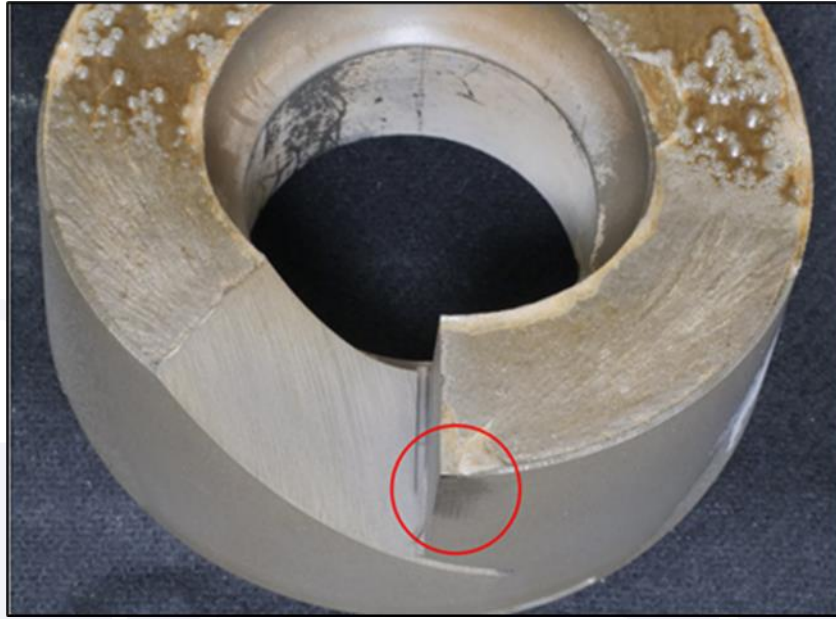
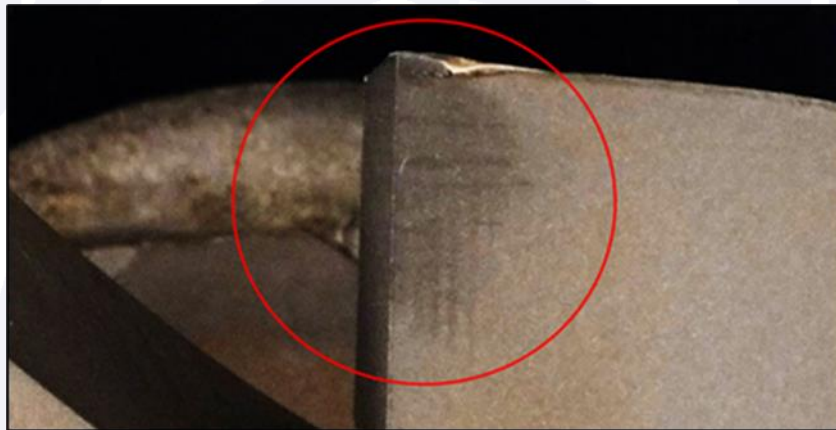
The surface of the part was then inspected for heat damage by the Nital-Etch process, using a solution of nitric acid and alcohol. The result of this inspection showed a region with damage from excessive heat, highlighted by the red circles in Figures 30 and 31.

Figure 30 - Result of the inspection with Nital-Etch.

Figure 31 - Detail of the result of the inspection with Nital-Etch.

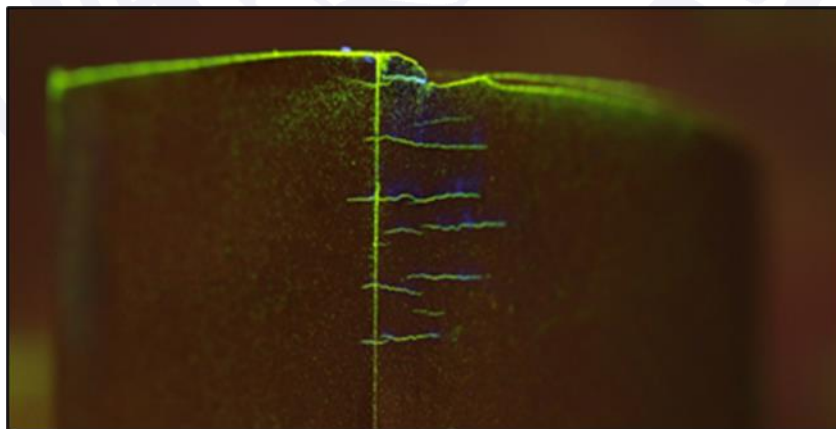
A new inspection by magnetic particles was performed on the sectioned portion of the base metal revealing cracks, as shown in Figure 32 below:

Figure 32 - Cracks revealed in the inspection by magnetic particles.

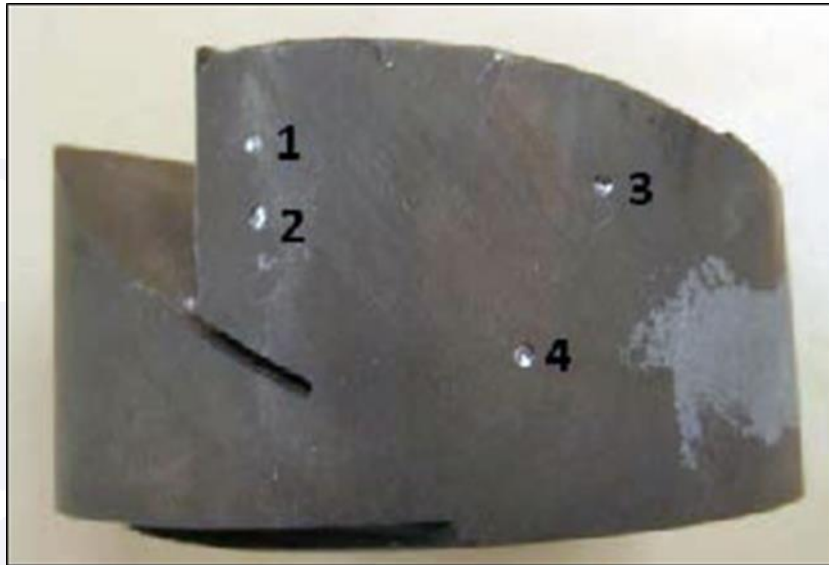
The microhardness test resulted in an average value of 50.1 on the Rockwell C scale of hardness, Hardness Rockwell C (HRC) in the dark areas highlighted in the inspection by Nital-Etch (Figure 33).

In areas where the inspection for heat damage did not change, the average hardness value found was 54.6 HRC. The expected value range for the base metal alloy of the aft trunnion pin was between 52 to 56 HRC.

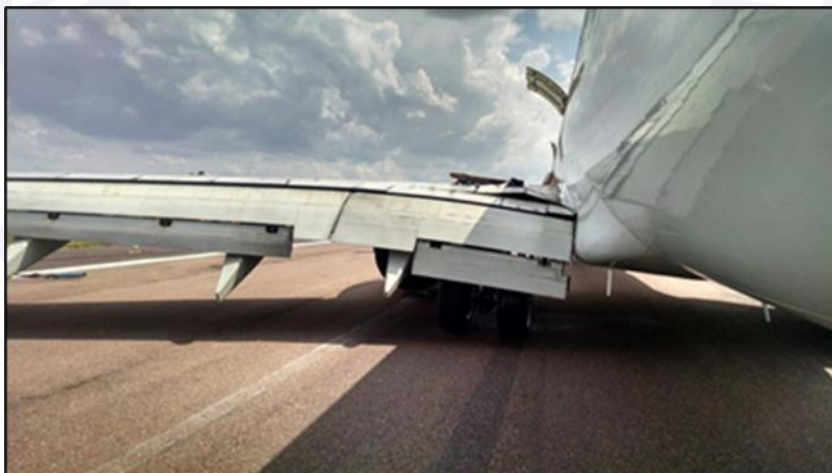
Figure 35 - Damage to the wing of the VT-JGA aircraft after the break of the aft trunnion pin.

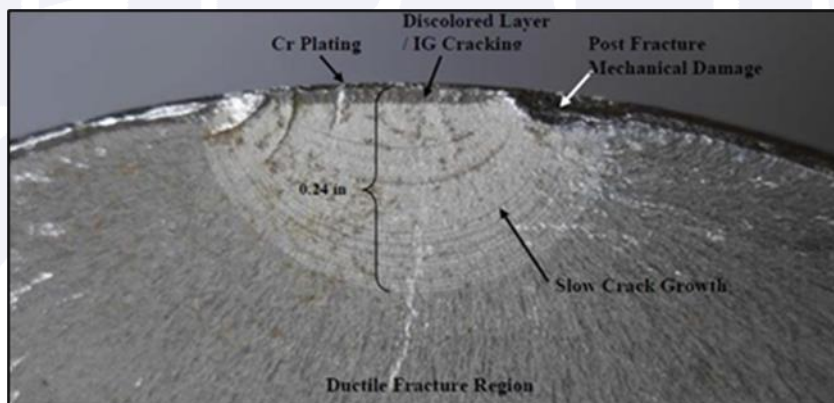
Figure 36 - Fracture characteristic of the aft trunnion pin SN: E2410 that was installed on the VT-JGA aircraft.

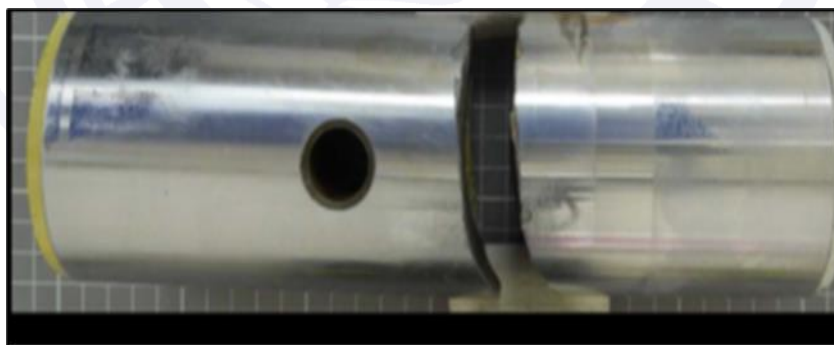
In this event, when the aircraft was about to clear the runway after landing, the aft trunnion pin SN 2430 (Figure 37), installed on the right landing gear, broke.

Figure 37 - Detail of the fractured aft trunnion pin SN 2430 that was installed on the right landing gear of the VT-JGD aircraft.

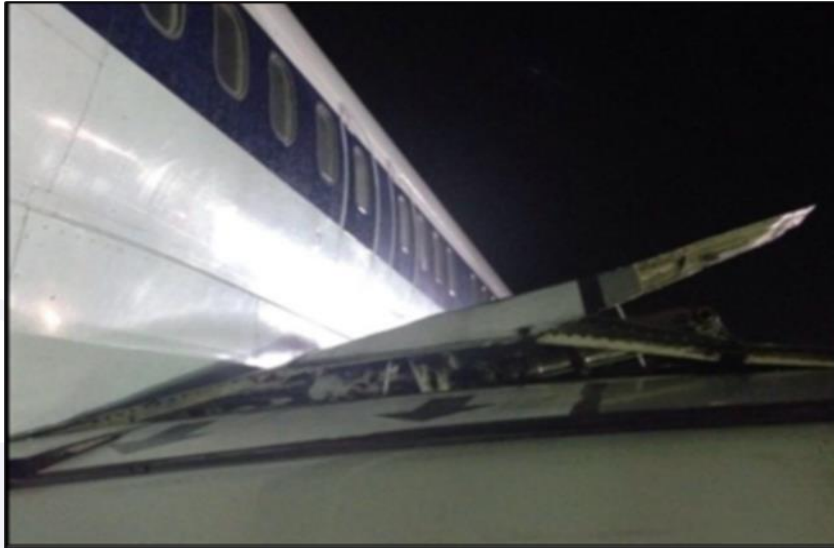
As a consequence, subsequent damage was caused to the upper surface of the right wing of the VT-JGD aircraft (Figure 38).

Figure 38 - Damage caused to the right wing's upper surface of the VT-JGD aircraft as a result of the break of the aft trunnion pin.

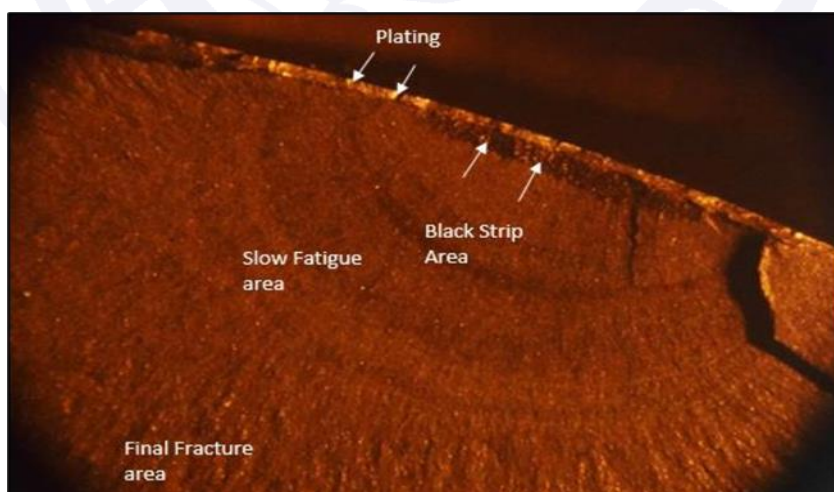
The VT-JGA Final Report showed that the right landing gear aft trunnion pin failed due to damage from burning the base metal as a result of excessive grinding of the chromium layer, which probably occurred during the last general overhaul.

Figure 39 - Fracture characteristic of the aft trunnion pin SN E2430 that was installed on the VT-JGD aircraft.
