**FINAL REPORT**  
**A - 128/CENIPA/2014**

| <b>AIRCRAFT:</b> | <b>PR-HSC</b> |
| <b>MODEL:</b> | <b>AS 350 B2</b> |
| <b>DATE:</b> | <b>25JUL2014</b> |

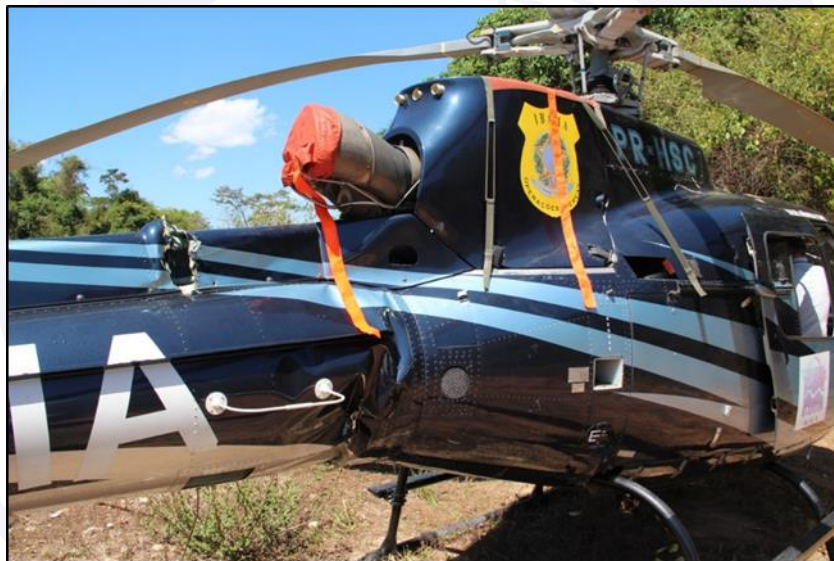
At landing, the tail collided against the ground, damaging the tail cone.

The damage caused misalignment between the rear drive shaft and the front coupling shaft.

This misalignment damaged the benders and caused the decoupling between the axles, which consequently ripped the fairing of the tail rotor drive shaft (Figure 1).

Figure 1 - Tail cone and fairing of the tail rotor drive shaft damaged.

Tail cone damage was caused by touching the ground at landing.

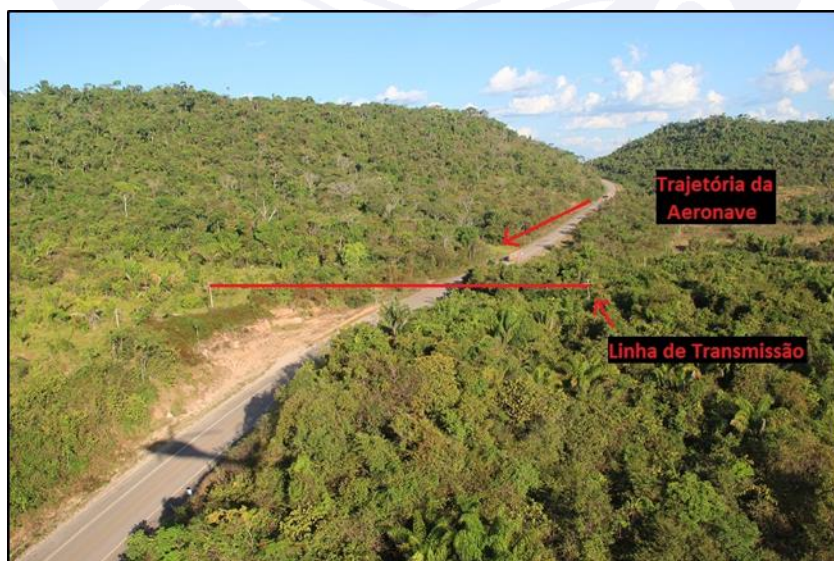
The terrain around the road was surrounded by elevations covered by forest vegetation (Figure 2).

Figure 2 - Terrain around the road and trajectory of the aircraft.
