**FINAL REPORT**  
**A - 103/CENIPA/2015**

<b>OCCURRENCE:</b>	<b>ACCIDENT</b>
<b>AIRCRAFT:</b>	<b>PR-ITO</b>
<b>MODEL:</b>	<b>210D</b>
<b>DATE:</b>	<b>20JUL2015</b>

This is the Final Report of the 20JUL2015 accident with the 210D aircraft, registration PR-ITO. The accident was classified as “[LOC-I] Loss of Control in Flight”.

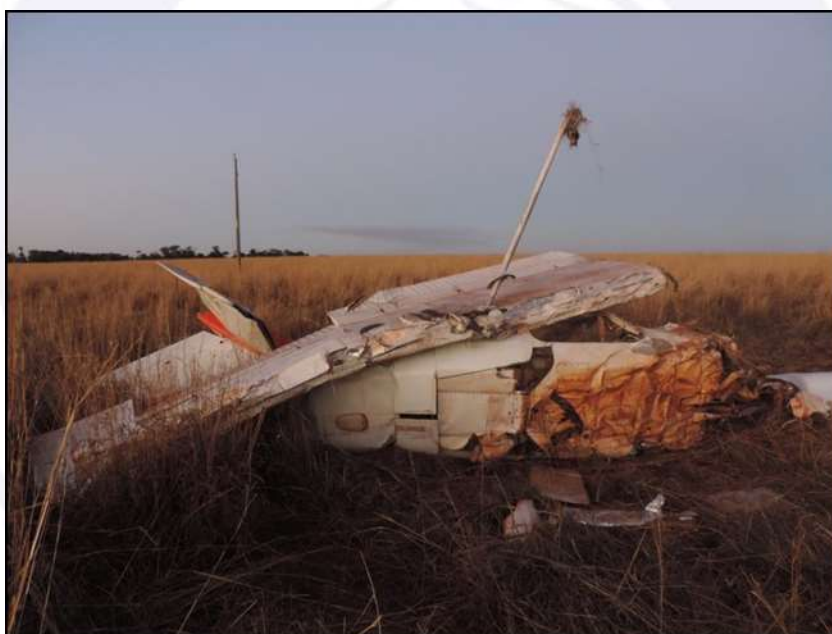
Figure 1 - Side view of the aircraft after collision against the ground.

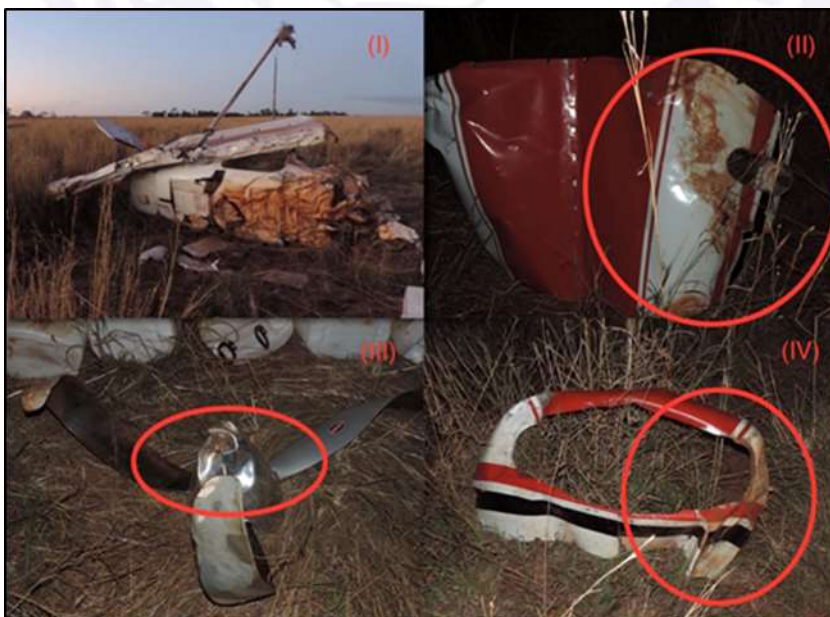
The impact marks of the aircraft revealed that it collided against the ground laterally and in a downward attitude, as evidenced in Figure 2.

Figure 2 - (I) impact on the lower front part of the fuselage. (II) marks of the terrain on the left side of the engine fairing. (III) deformations on the propeller assembly and impact on the spinner. (IV) marks of the terrain on the left side of the front fairing of the engine.

According to the evidence found in the wreckage, it was possible to identify marks on the ground and significant deformations in the aircraft, which suggest that the impact occurred in a downward attitude and with a lateral slope to the left.

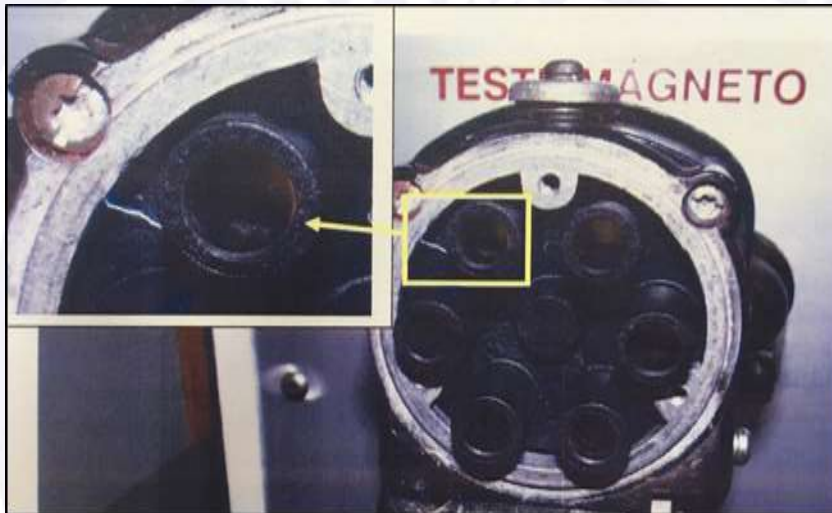
On the left magneto, it was observed in the bench test that there was spark leakage at the base of one of the spark plugs outlet terminals (Figure 4).

Figure 4 - View of the spark leak observed during the magneto test.

These faults can cause the cylinder to malfunction, if there is no spark in one of the spark plugs, as fuel burns out.

The research report of the powertrain components pointed out that both magnetos failed. Electrical leakage or lack of spark has been identified during the operation.

Thus, it could be inferred that the lack of power reported by the pilot had as a contributing factor the malfunction of the magnetos, which possibly caused irregular cylinder operation and consequent loss of engine power.

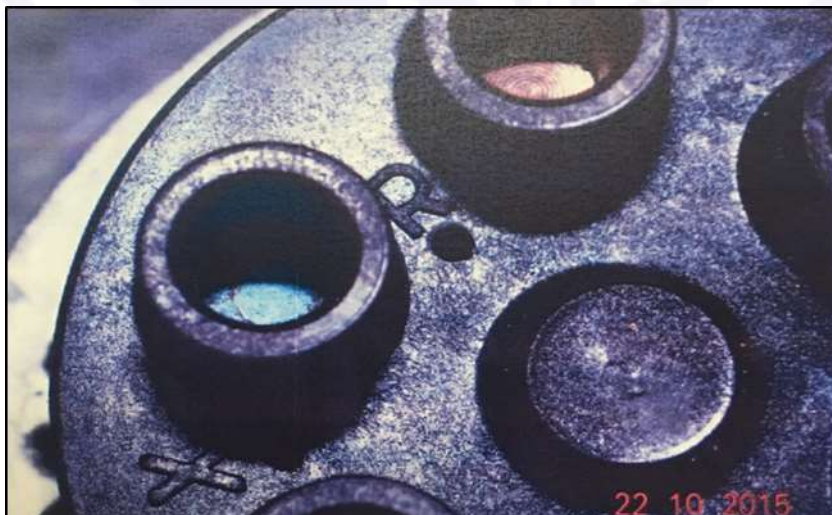
On the right magneto, oxidation was observed at the outlet end of the spark cable (Figure 5).

Figure 5 - View of the terminal of the oxidized magneto.

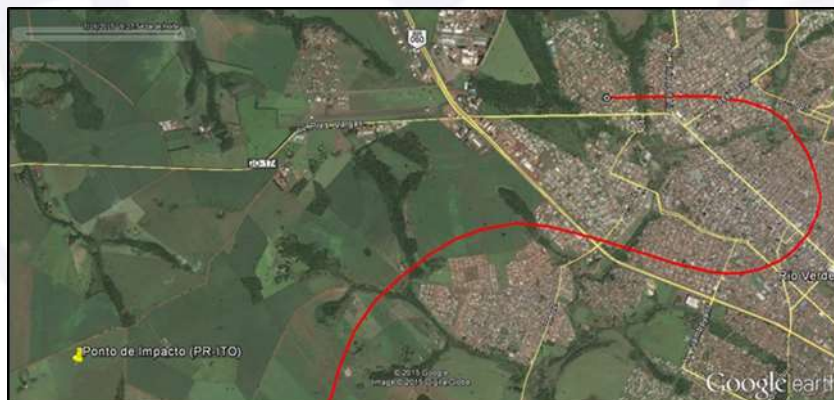
Next to the arrival at the Aerodrome, it was observed that the aircraft performed the entry on the wind leg of runway 21 and rotated base for approach (Figure 5).

Figure 5 - Reconstitution of the traffic circuit of the aircraft recorded in the on-board GPS.

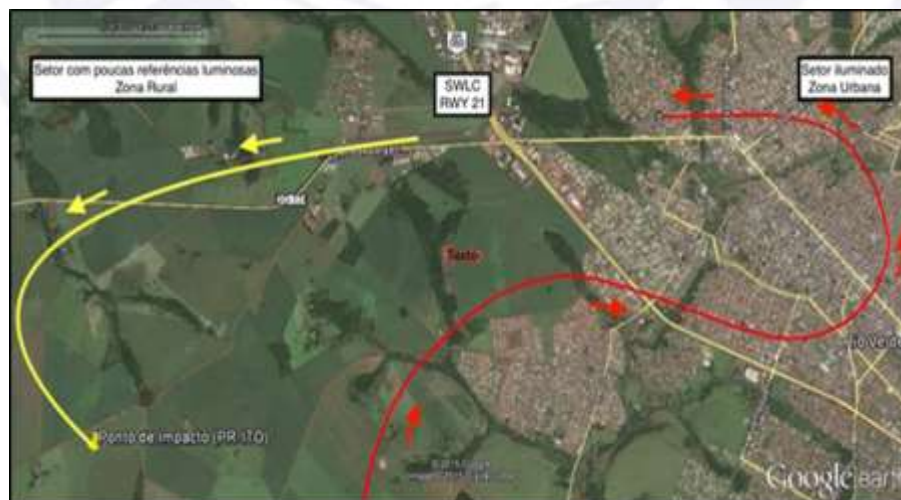
However, according to the pilot's report, it is estimated that the aircraft covered a left turn path for re-entry into the wind leg (Figure 6).

Figure 6 - Reconstruction of the aircraft traffic circuit recorded in the on-board GPS (in red) and the probable trajectory of the aircraft after the go-around procedure (in yellow).
