COMANDO DA AERONÁUTICA
CENTRO DE INVESTIGAÇÃO E PREVENÇÃO DE
ACIDENTES AERONÁUTICOS

FINAL REPORT
A - 149/CENIPA/2013

OCCURRENCE:	ACCIDENT
AIRCRAFT:	PR-IVE
MODEL:	EC120B
DATE:	21AUG2013

This is the Final Report of the 21AUG2013 accident with the EC120B aircraft, registration PR-IVE. The accident was classified [SCF-PP] "System/Component Failure or Malfunction (Powerplant)|Engine Failure in Flight".

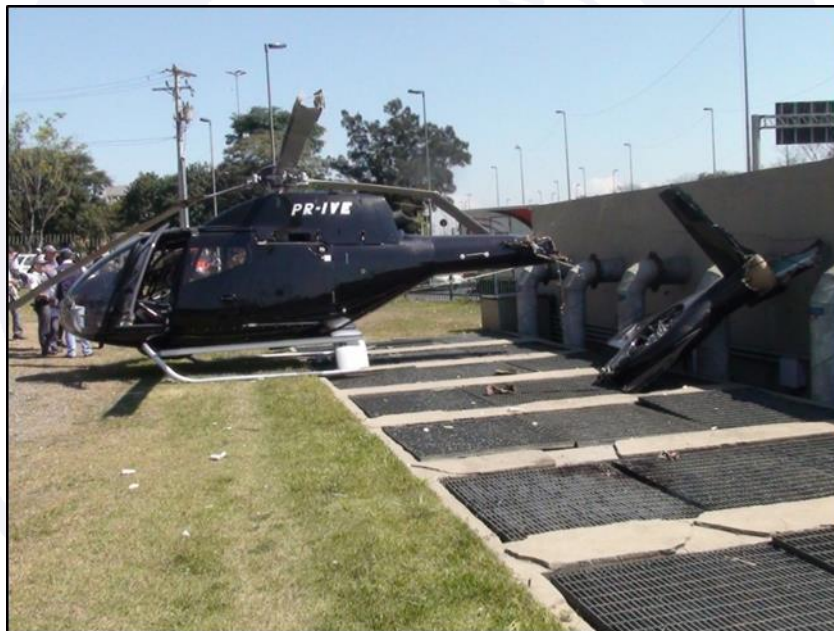
During the flare, the aircraft crashed into a concrete wall causing the tail cone to rupture.

Figure 1 - View of the aircraft after the collision against a concrete wall.

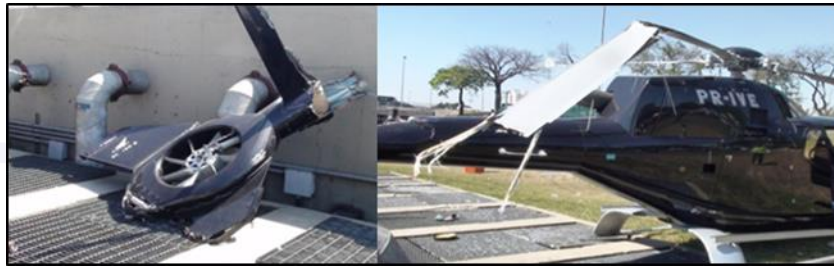
The aircraft had substantial damage in the main rotor blades as well as sectioning of the tail cone (Figure 2).

Figure 2 - View of the fenestron and the main rotor sectioned.

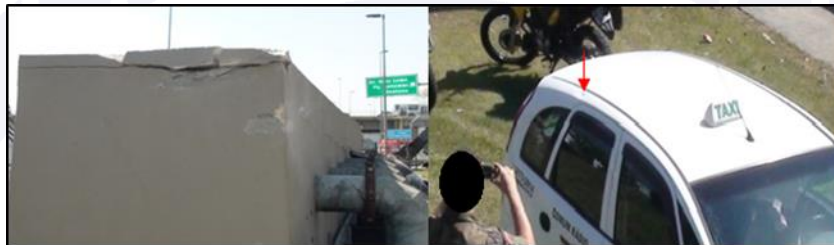
Damaged concrete wall, broken telephone wiring and dents on the roof of a vehicle, due to detachment after the impact of the aircraft against the wall (Figure 3).

Figure 3 - Damages to the concrete wall and the car.

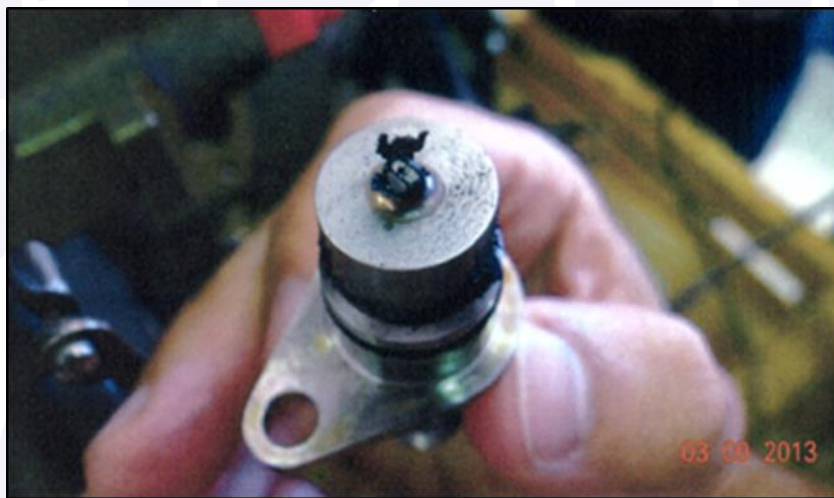
The work was started by inspecting the engine lubrication system, where a large amount of particles was observed in the magnetic plugs and inside the crankcase (Figures 4 and 5).

Figure 4 - Magnetic Plug of the M01 with particles.

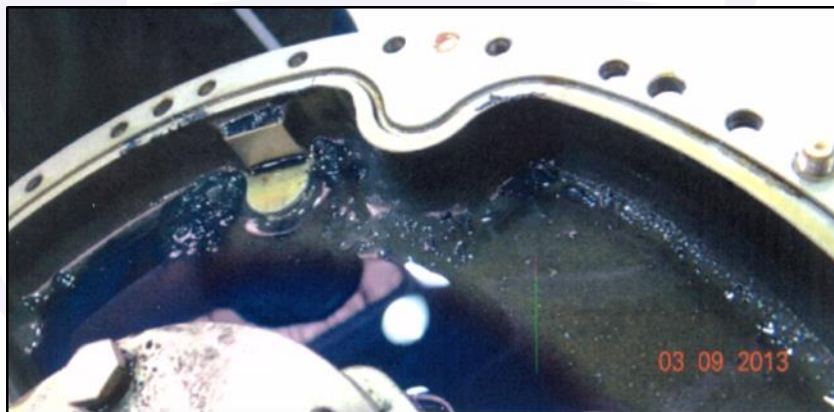
Figure 5 – Presence of particles inside the crankcase.

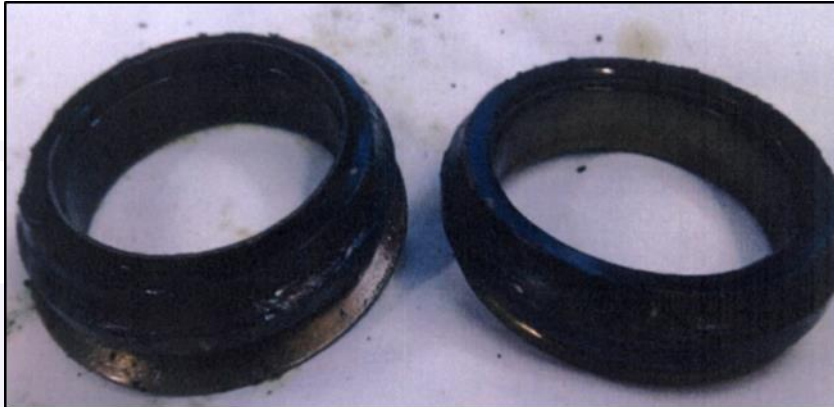
The coloring and marks found on the M02 front bearing roller tracks indicated that the bearings have suffered high temperature (Figure 6).

Figure 6 - M02 front bearing roller tracks with differentiated coloration in the track contact region.

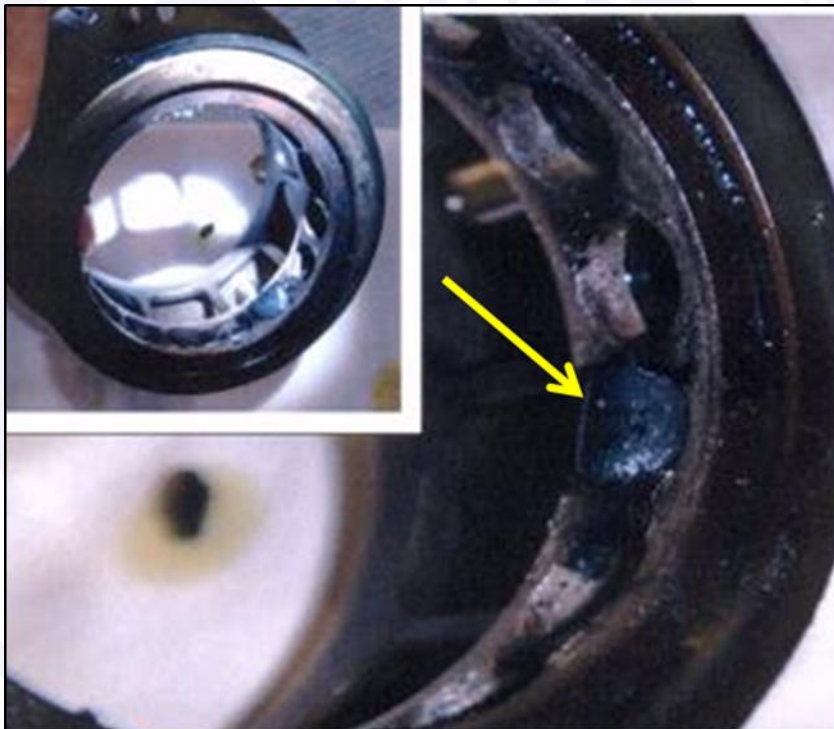
Their rollers were oval and darkened (Figure 7).

Figure 7 - Detail of the deformed rollers attached to the front bearing spacer of the gas generator. In highlight an overview of the bearing housing.

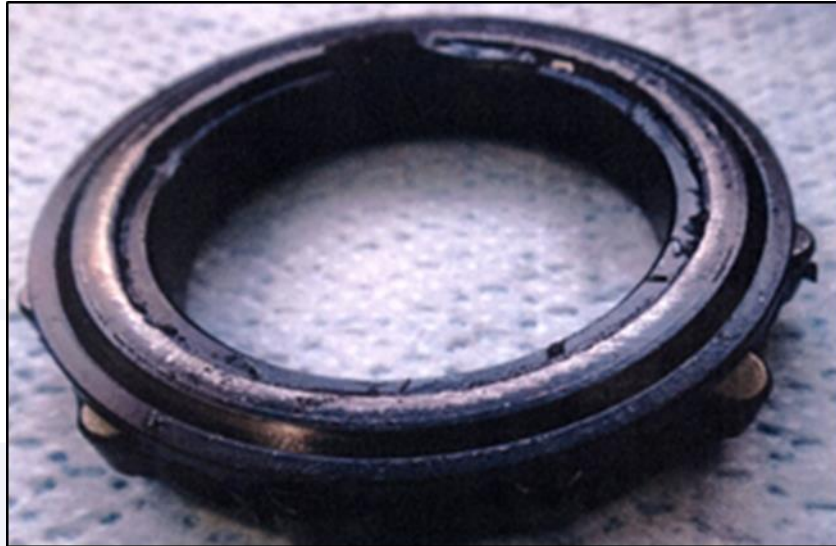
The rear bearing of the gas generator had friction and carbonization marks. Their rollers were not deformed (Figure 8).

Figure 8 - General view of the rear bearing of the gas generator.

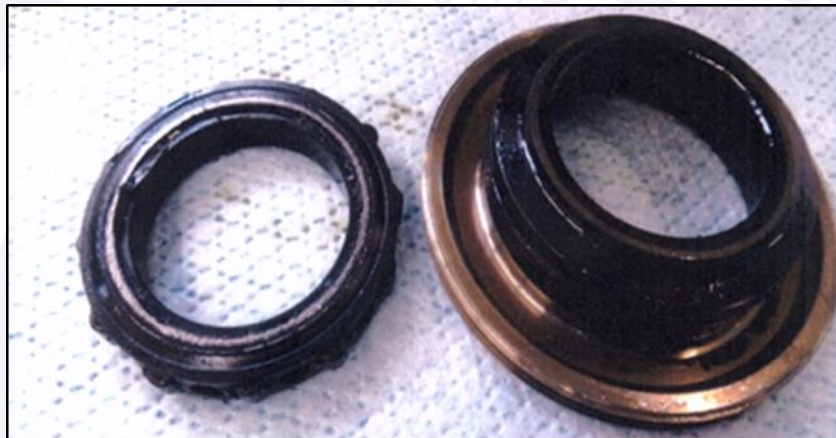
The rear bearing of the power turbine also presented carbonization, with dark coloration and friction marks on its spacer (Figure 9).

Figure 9 – Overview of the engine power turbine rear bearing.

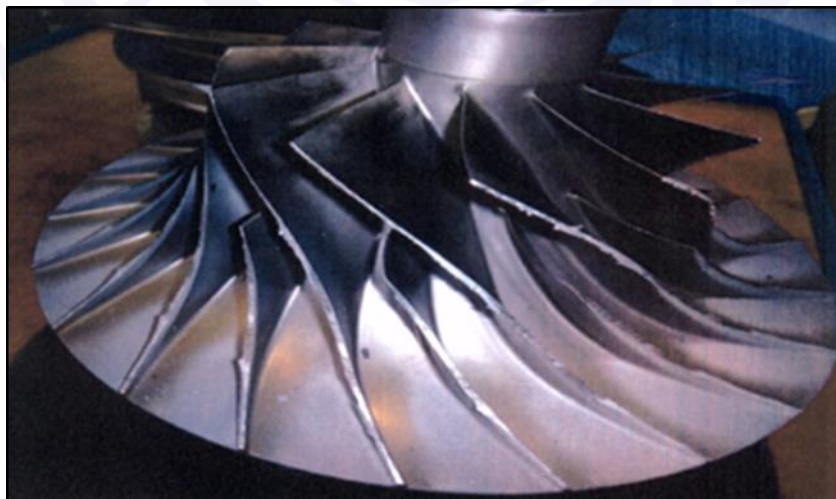
The centrifugal impeller blades contained strongly bent marks with centrifugal compressor cover (Figure 10).

Figure 10 - Overview of impeller with brush marks on its blades.

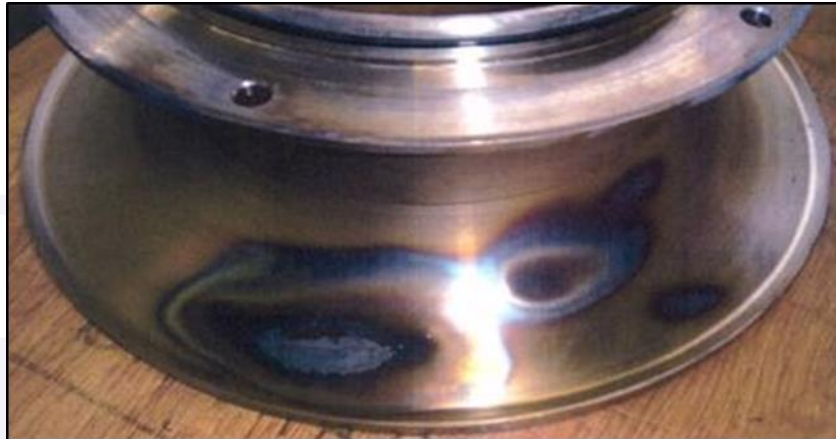
The image of the centrifugal compressor cover showed the overtemperature due to the contact of the blades with the cover (Figure 11).

Figure 11 - External view of the compressor housing.

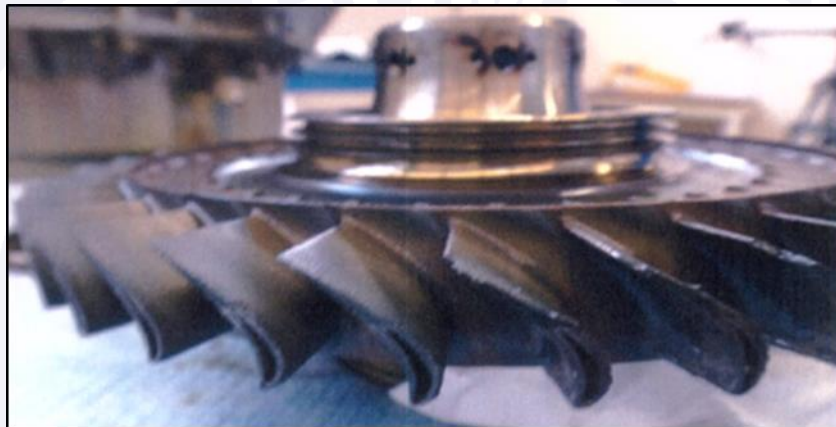
HP turbine blades had slight bends at the ends as well as small fractures at their trailing edges (Figure 12).

Figure 12 - View of the end of the vanes with brush marks.

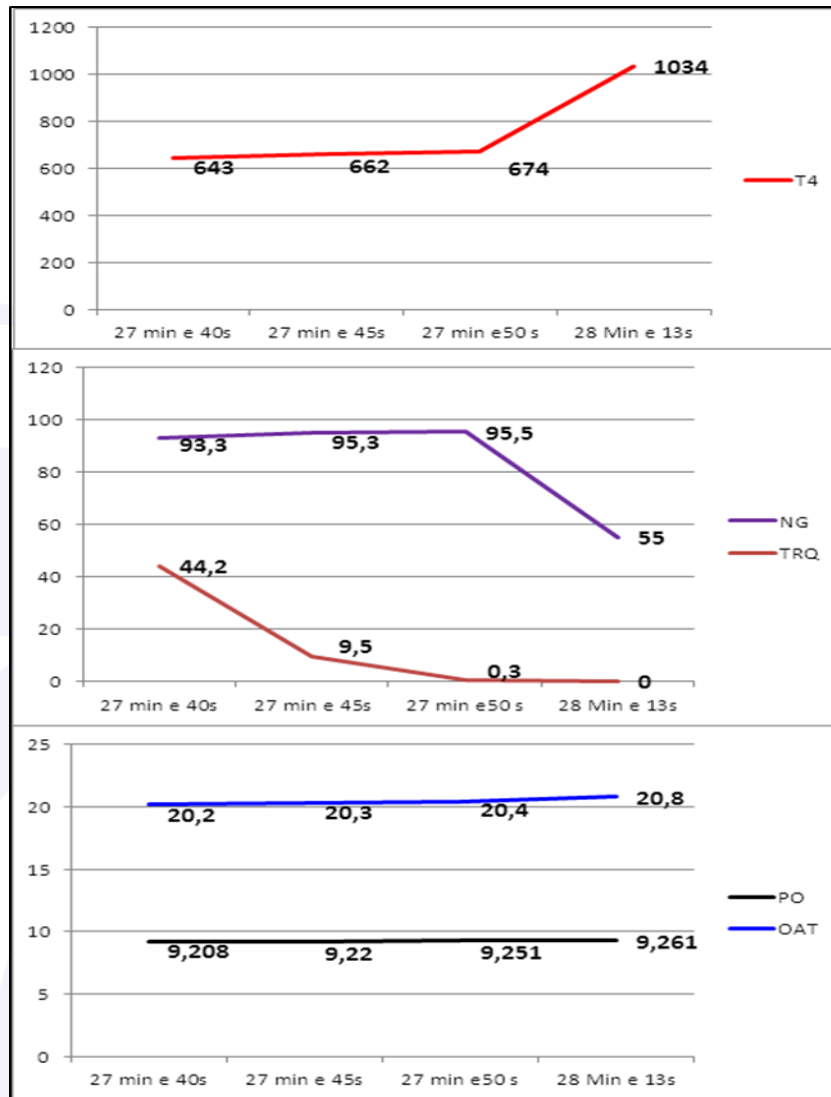
Figure 13 - Data chart of the VEMD.

The Data obtained through the Vehicle Engine Monitoring Display (VEMD) showed that the first recorded event, from 27 minutes and 45 seconds, indicated that the engine's TQ (torque) dropped to 9.5%.

Then, at 27 minutes and 50 seconds, the Flight Limit Indication (FLI LOSS) illumination occurred, when TQ reached 0.3%.

Finally, at 28 minutes and 13 seconds, it was also observed that the T4 temperature reached 1034° C, the TQ dropped to 0.0% and the Engine Gas Generator Speed (NG) reached 55%, which represents a value below ground idle. (Figure 13).

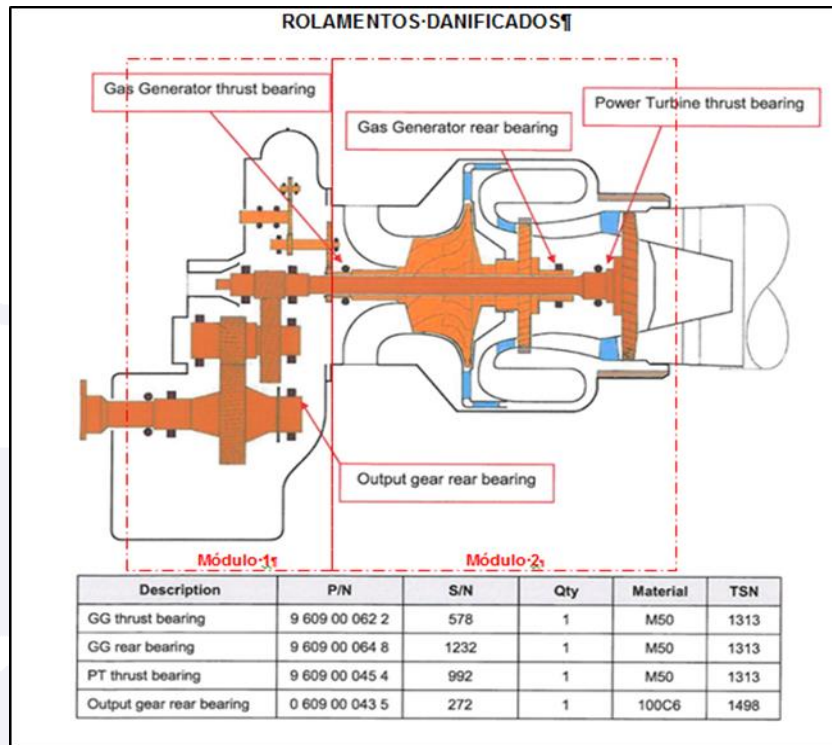
The signs of deterioration found in the bearings of the Gas Generator, revealed that there was rupture of the lubricating oil film.

The Generator Gas and Power Turbine bearings were damaged, due to the lack of lubrication or operation at high temperatures (Figure 14).

Figure 14 - Damaged bearings.

The investigation of the engine components carried out by SAFRAN Turbomeca revealed that the rear bearing of the Generator Gas and the thrust bearing of the Power Turbine presented degradation, which originated from the lack of lubrication and operation with overtemperature (1034°C).

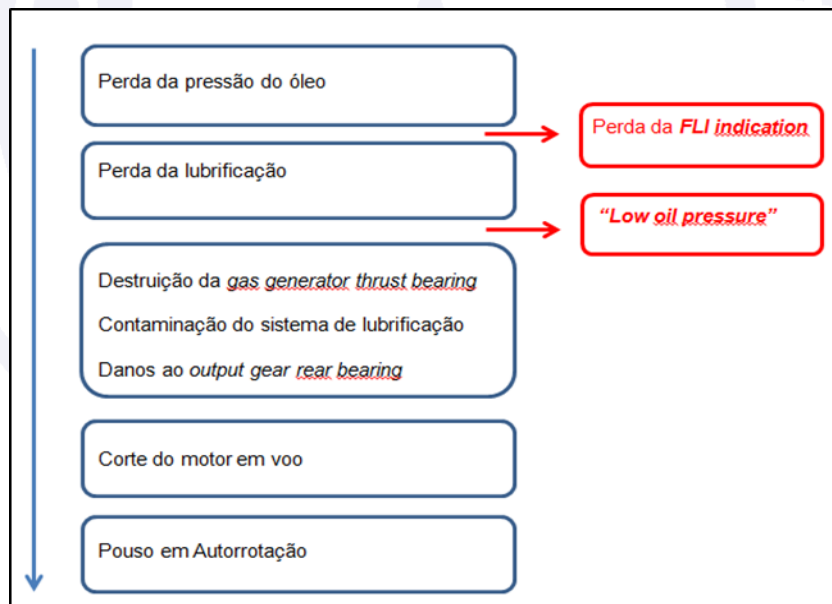
Figure 15 - Scenario containing the probable chain of events.
(Source: SAFRAN HE Investagion Review)

Based on the data collected in the VEMD, a scenario was elaborated, containing the probable chain of events that resulted in the landing in autorotation (Figure 15):

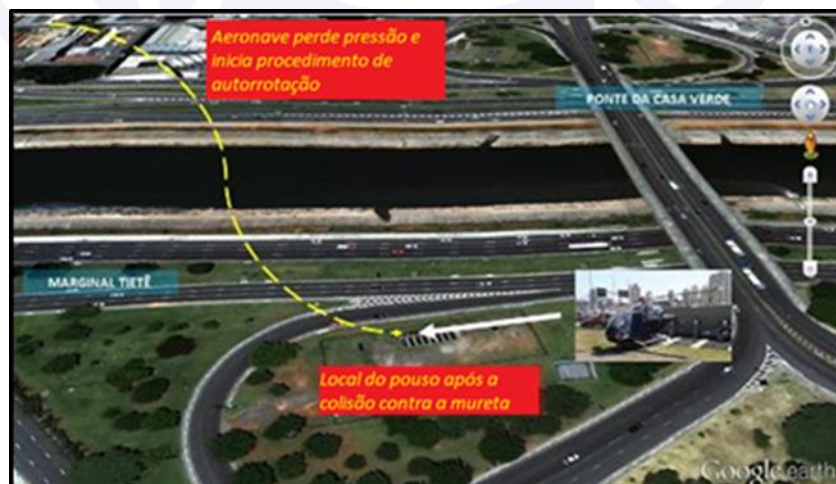
Figure 16 - Sketch of the trajectory and location of the accident.

Due to the intense vehicular traffic on the way and the presence of an electrification network, the pilot decided to turn to the right, in search of a more suitable place to make an emergency landing safely (Figure 16).

At the final moment of the autorotation maneuver, after the flare, the fenestron collided with the wall of a water pumping station in the city of São Paulo, which caused the cone to break.

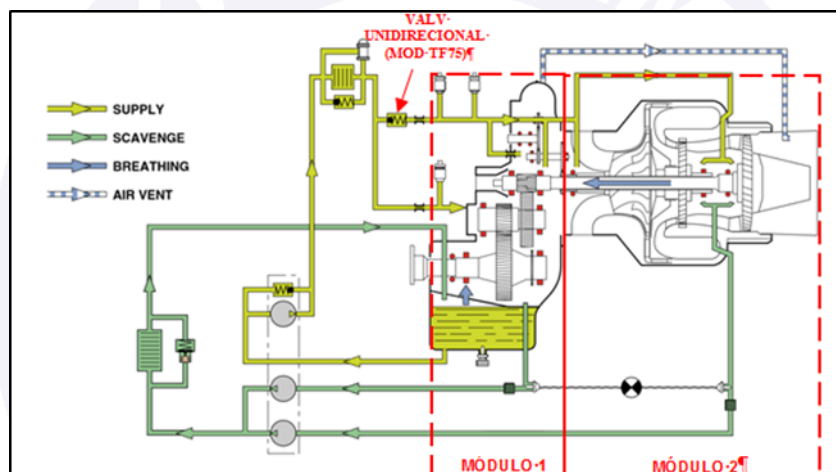
Figure 17 - Diagram of the engine lubrication system ARRIUS 2F.

This modification consisted of replacing the check valve of the engine lubrication system with a piston valve free of seal (Figure 17).

The change aimed at eliminating the possibility of locking the one-way valve by failure of the seal. This failure could result, due to lack of lubrication, in damage to the bearings, leading to an engine failure.
