**FINAL REPORT**  
**A - 509/CENIPA/2018**

**PR-LJL**

**SR20**

**26NOV2011**

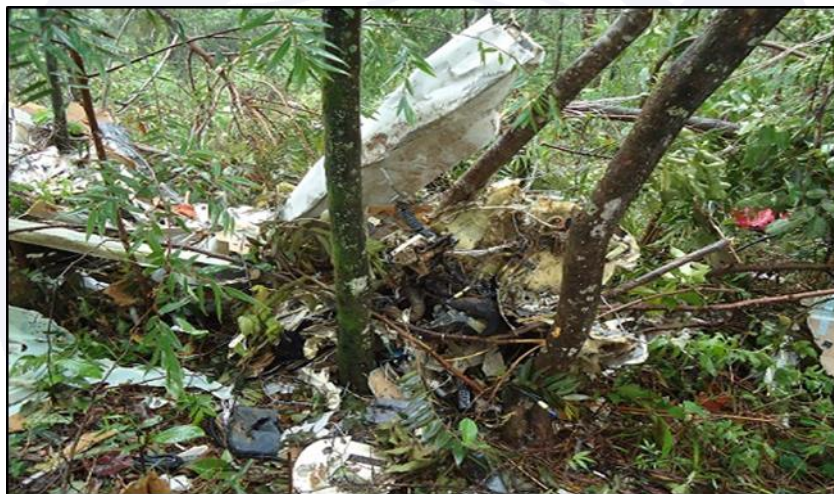
Figure 1 - Aircraft wreckage.

The aircraft crashed into the terrain with low trajectory angle and high speed, spreading the wreckage within a radius of 150m.

The great energy of the impact against the ground caused damage, deforming and fragmenting the components of the aircraft.

The propeller was located separate from the engine, exhibiting characteristic of high rotation impact damage, indicating that it was in operation.

The marks left on the ground, the distribution of the wreckage and damage to the vegetation showed that the aircraft collided with the ground at high speed and practically on the horizontal.

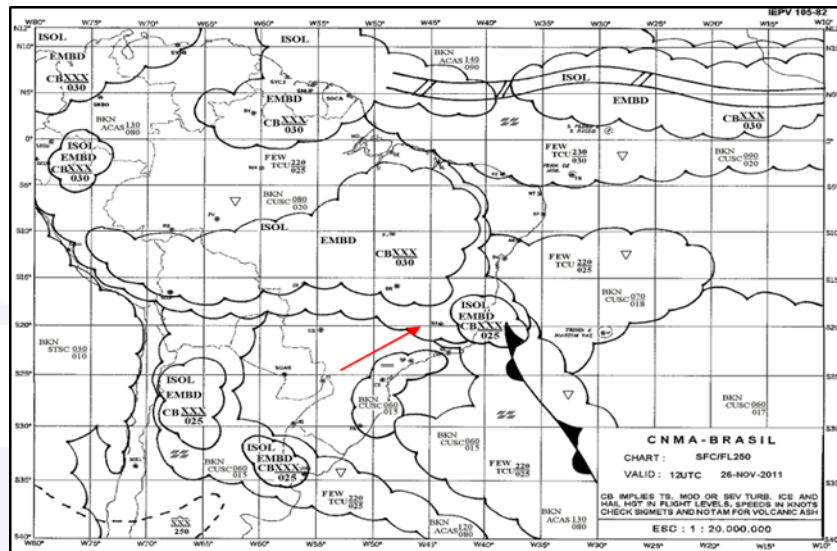
The SIGWX, valid until 1200 (UTC), illustrated the presence of isolated Cumulonimbus (CB) clouds based on 2,500ft.

Figure 2 - REDEMET 26NOV2011 SIGWX chart.

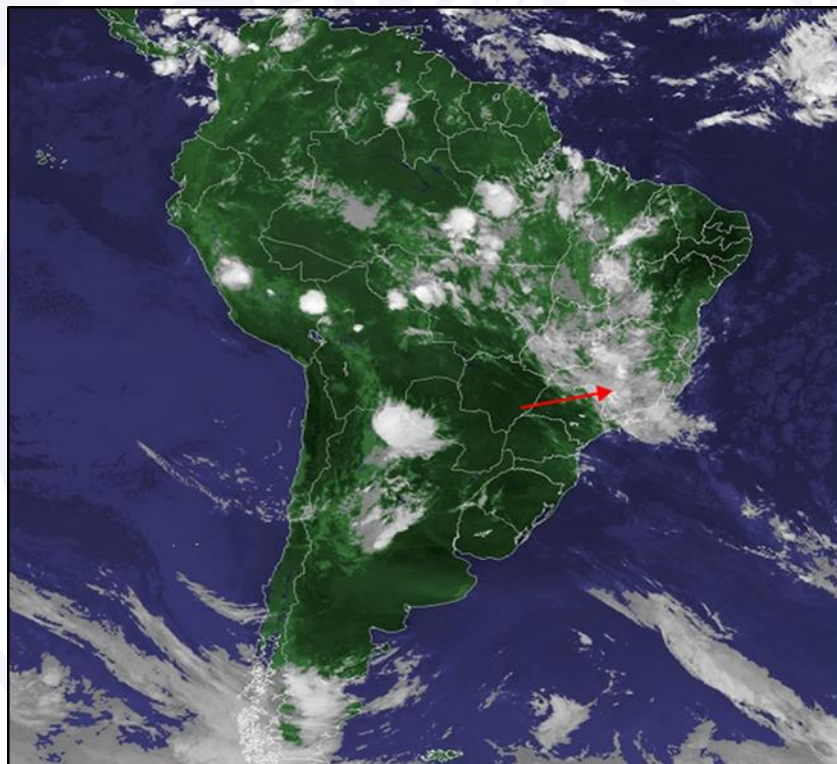
The satellite image of South America, on the day of this occurrence, presented the Minas Gerais State quite covered by clouds (Figure 3).

Figure 3 – The Minas Gerais State covered by clouds.
