COMANDO DA AERONÁUTICA
CENTRO DE INVESTIGAÇÃO E PREVENÇÃO DE
ACIDENTES AERONÁUTICOS

FINAL REPORT
A - 089/CENIPA/2017

OCCURRENCE:	ACCIDENT
AIRCRAFT:	PR-MFR
MODEL:	210M
DATE:	03JUL2017

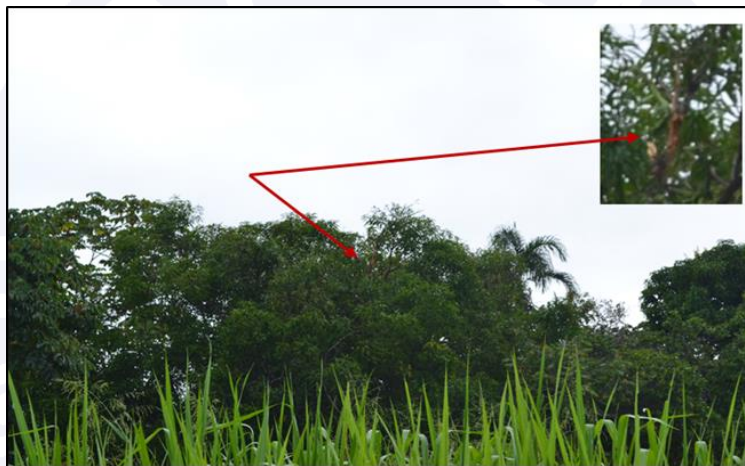
The first impact occurred in a pitch up attitude, causing the left horizontal stabilizer to collide against the top of a tree (Figure 1), which resulted in the detachment of the left elevator (Figures 2 and 3).

Figure 1 - View of the first impact point.

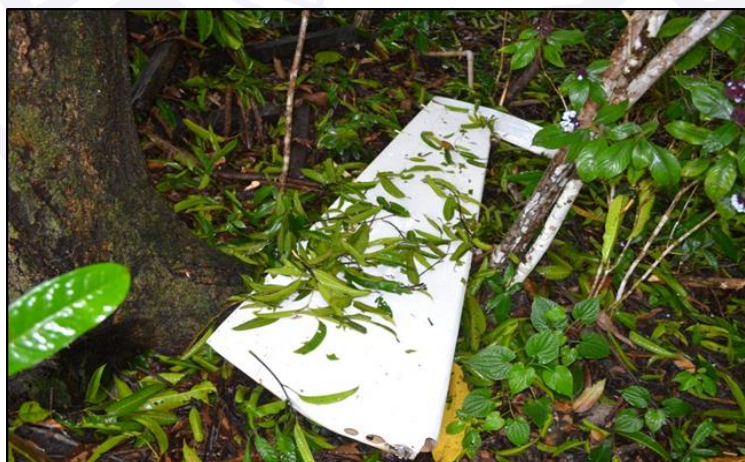
Figure 2 - Left elevator found near the first impact site.

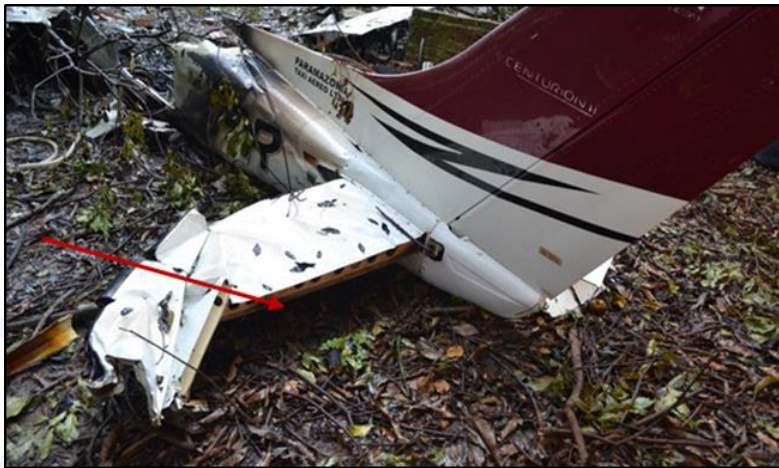
Figure 3 - Left horizontal stabilizer without elevator.

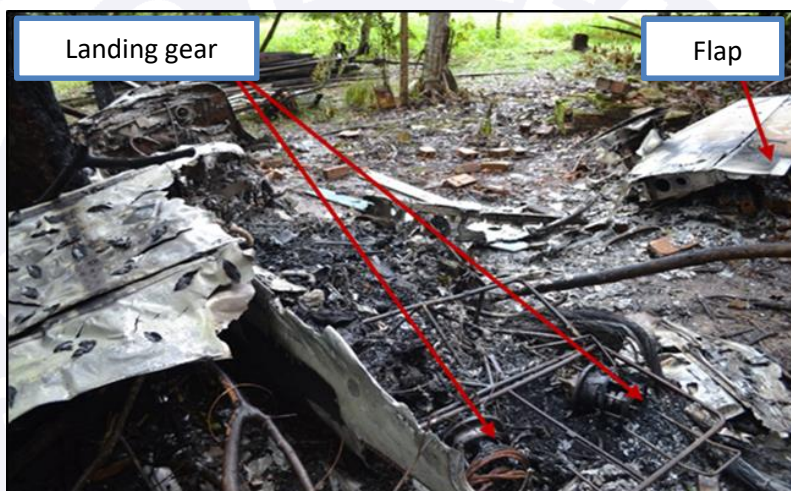
The landing gear, of the retractable type, and the flaps were retracted (Figure 4). The position of the elevators could not be determined.

Figure 4 - Aircraft destroyed by fire. Landing gear and flaps retracted.

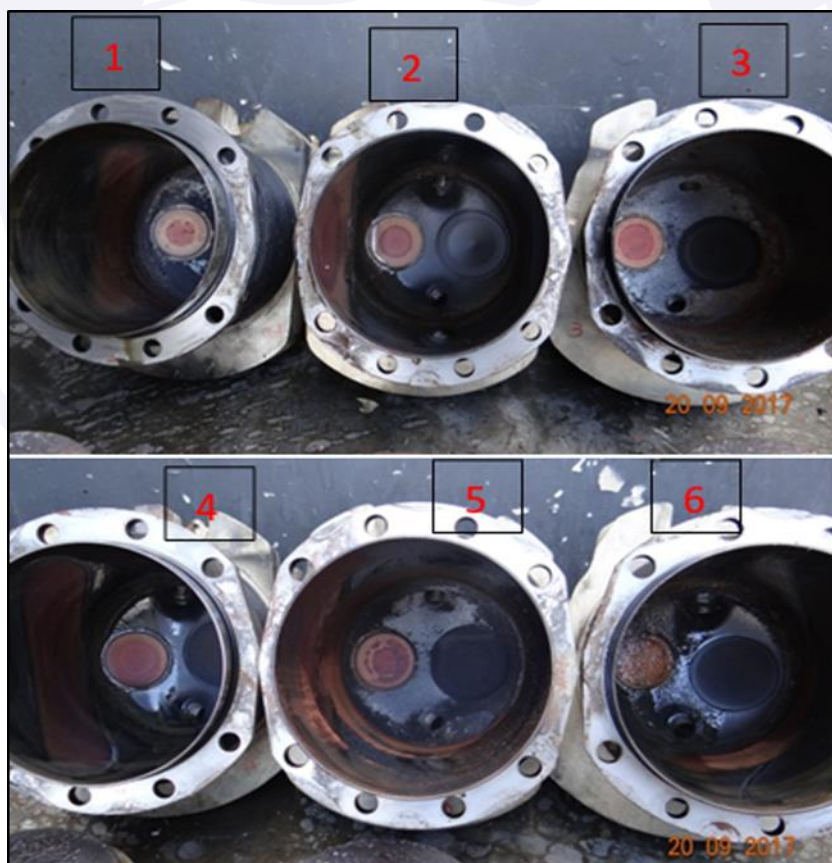
During the disassembly of the IO-520-L-12B, Serial Number (SN) 1002430, it was observed that all cylinder exhaust valves were reddish in color (Figure 5).

Figure 5 - Interior of the cylinders. Exhaust valves with reddish coloration.

Such a condition is a consequence of poor fuel mix engine operation, that is, adjusting the mix lever to a fuel and air ratio with less fuel. This procedure allows the airplane to have greater endurance.

The fuel decrease beyond the recommended in manual (very poor mix), when used routinely, causes increased engine wear.

With this, it was verified that engine problems had influence in the accident. The engine had characteristic wear of hot operation, related to the use of poor fuel mixture, that is, more air and less fuel.

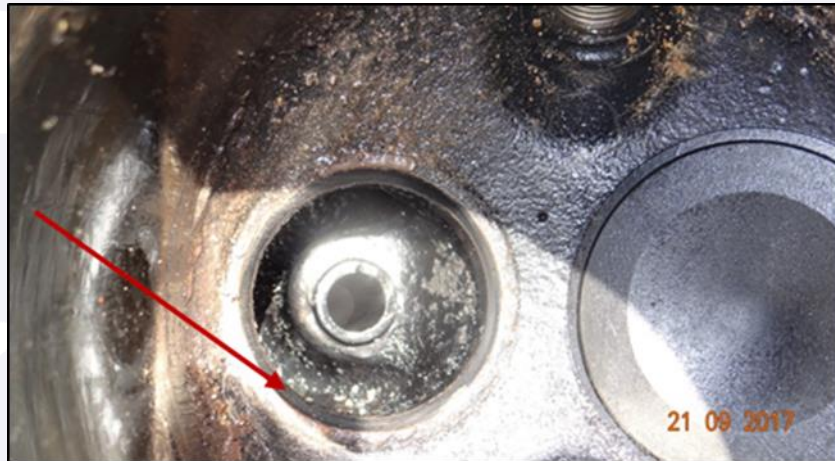
The valve seats of cylinders 1, 3, and 6 were dark in color resulting from poor seating (Figure 6).

Figure 6 - Valve seat with dark coloration.

The lack of engine power may be related to leakage in the valves of the cylinders 1, 4, 5 and 6, allowing the air / fuel mixture to escape during the compression time and causing low burning efficiency within the combustion chamber. Cylinders 1 and 4 did not pass the GO / NO GO test.

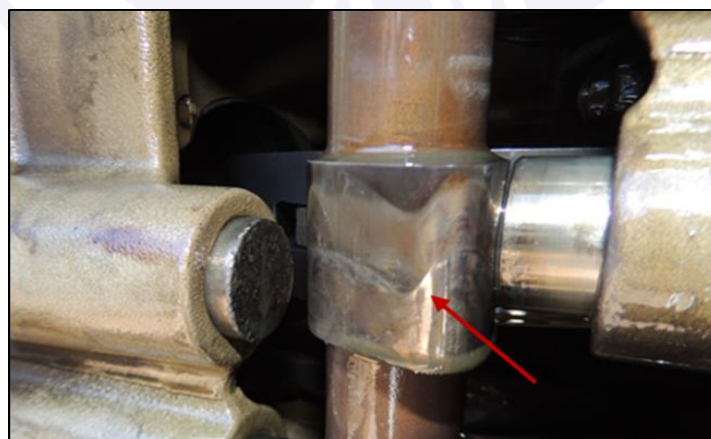
The valve control drive assembly showed wear on one cam of the valve control drive shaft (Figure 8) and three tappets (Figure 9).

Figure 8 – Wear in the Valve control camshaft.

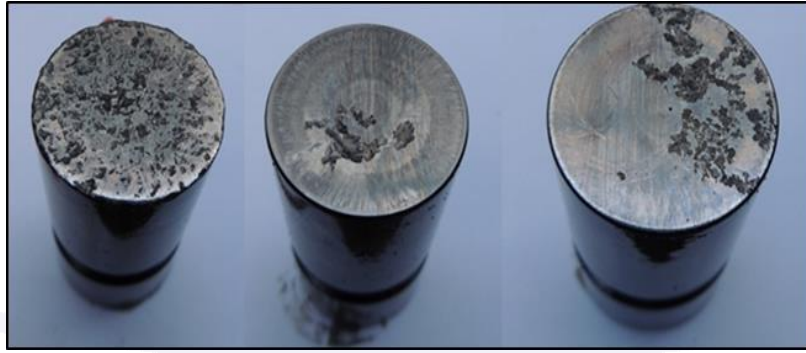
Figure 9 – Worn tappets.

The wear observed on the hydraulic tappets could generate micro particles and these would not be retained by the main and primary oil filters.

- p) the aircraft took off to transport personnel;
- q) the exhaust valves of cylinders 1, 4, 5 and 6 were leaking;
- r) three hydraulic tappets presented excessive wear;

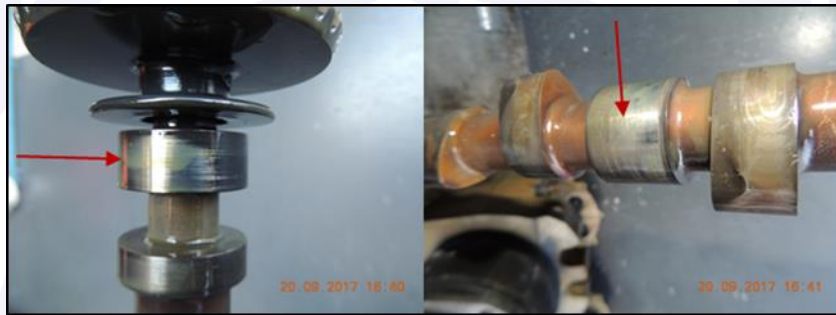
Marks compatible with such micro particles were observed. They followed the normal lubrication flow of the engine, causing scratches on the camshaft bearings (Figure 10), the crankshaft rear bearing (Figure 11), and the inside of the oil pump body. Fine filings were also observed in the residual oil in the crankcase.

Figure 10 - Supporting bearings of the valve control shaft.

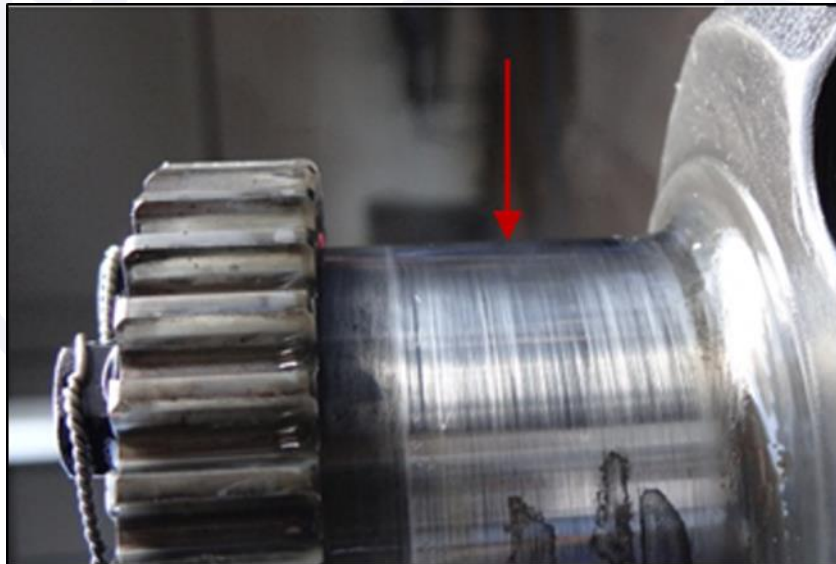
Figure 11 - Rear crankshaft bearing.

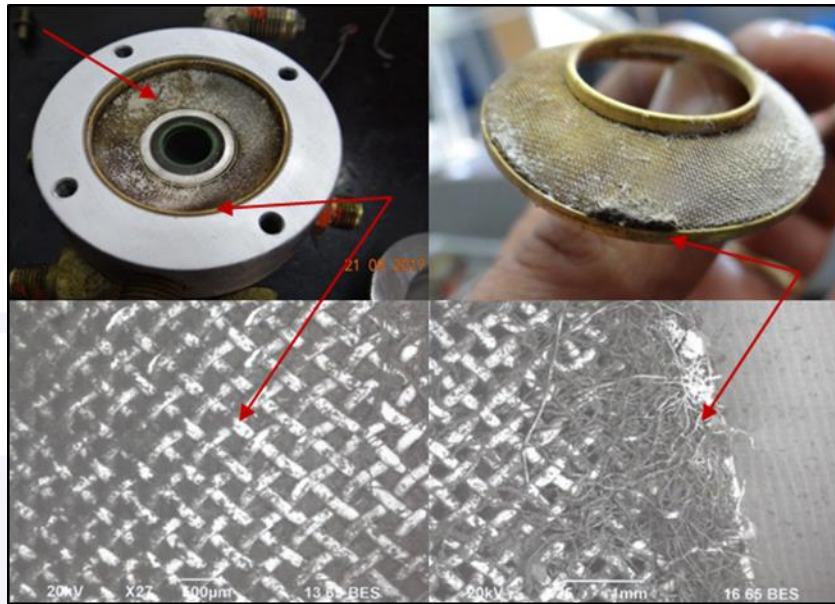
A white powder was found on the filter screen of the fuel distributor and at the bottom of the distributor diaphragm (Figure 12). After laboratory analysis, it was found that the presence of the residue was partially blocking the screen of the fuel filter.

Figure 12 - Filter of the fuel distributor with lead powder.

It was still possible to confirm the presence of lead (Pb), resulting from the degradation of the fuel. This occurs when the fuel is stored or transported in a clear container, allowing contact with sunlight. This contact promotes the precipitation, in powder form, of tetraethyl lead from the fuel.

At the last inspection performed (200 hours), there was a task of checking the fuel distributor for leaks only. There was no provision for inspection of the distributor screen.

In this case, it was recommended the system to be cleaned and that all defective units to be replaced. In view of the condition in which the screen of the fuel distributor was found, it could be inferred that the recommended cleaning was not carried out properly.

The lead found in the screen of the fuel distribution filter partially obstructed the passage of fuel to the nozzles, reducing the supply of gasoline to the cylinders.

The 200-hour inspection provided in the aircraft manual prevised the fuel distributor check only when there was a leak, that is, if there was clogging, with no leakage, there would not be on-site inspection on the screen.

Disseminate the lessons learned in this investigation, in order to alert operators and maintenance organizations about the importance of checking, during corrective maintenance procedures, the fuel system conditions of the IO-520-L-12B engines, not only for leaks, but also about the possibility of this system being contaminated by foreign material.

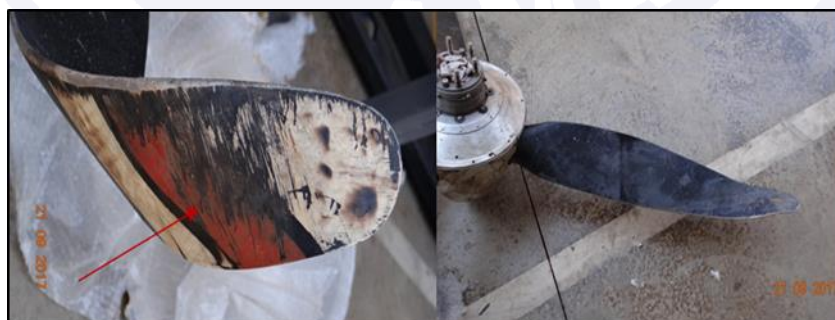
The propeller assembly had its blades kneaded back and with transverse scratches at its ends (Figure 13). This showed that at the moment of impact against the ground, the engine developed little power, but in the field investigation, it was observed that the metering valve was in the position of maximum power.

Figure 13 - Scratches and kneading of propeller blades.
