**FINAL REPORT**  
**A - 008/CENIPA/2019**

<b>OCCURRENCE:</b>	<b>ACCIDENT</b>
<b>AIRCRAFT:</b>	<b>PR-MJA</b>
<b>MODEL:</b>	<b>PA-25-235</b>
<b>DATE:</b>	<b>12JAN2019</b>

This is the Final Report of the 12JAN2019 accident with the PA-25-235 aircraft model, registration PR-MJA. The accident was classified as “[LALT] Low Altitude Operations”.

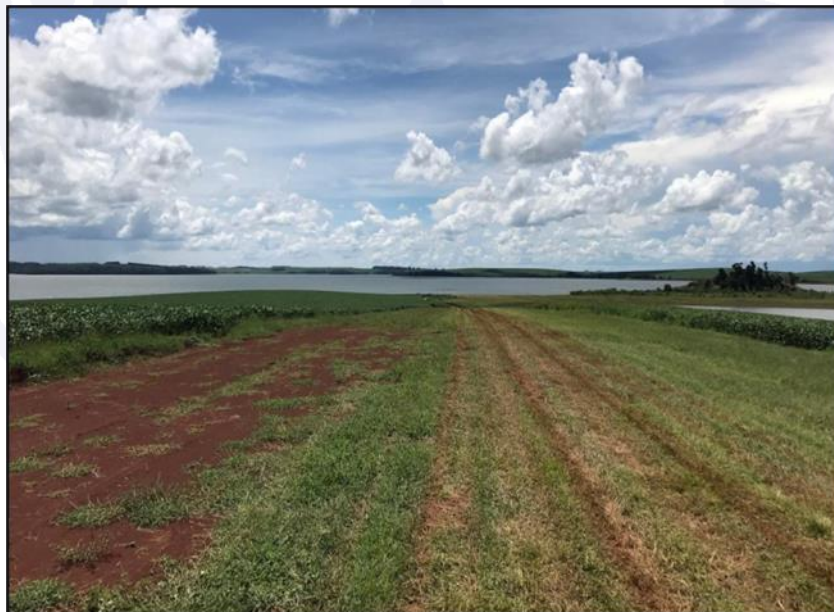
There was a dam located at the end of the runway and the plantation where the spraying was being carried out was located in the west sector, to the left of the take-off head used by the pilot on the day of the accident (Figure 3).

Figure 3 - View of the dam from the landing area for aerial agricultural use.

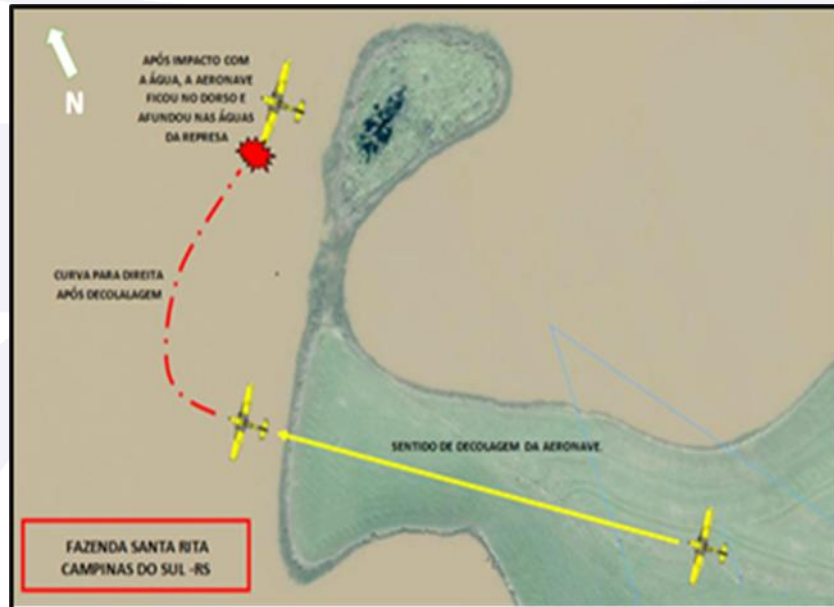
Figure 4 - Sketch of the estimated trajectory of the aircraft.

The aircraft crashed into the water in a left curve and with considerable speed. The left main landing gear wheel was torn off and the wing tip on that same side had impact marks (Figures 4 and 5).

After that, the plane tipped over and submerged on its back. The debris remained concentrated.

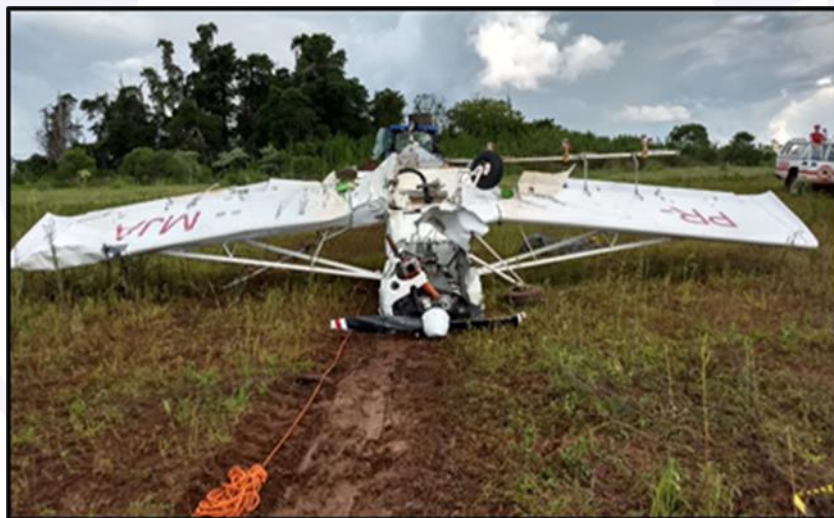
Figure 5 - View of the aircraft after being removed from the dam.

The aircraft had substantial damage. The left main landing gear came off the plane and there was damage to the fuselage and wings.

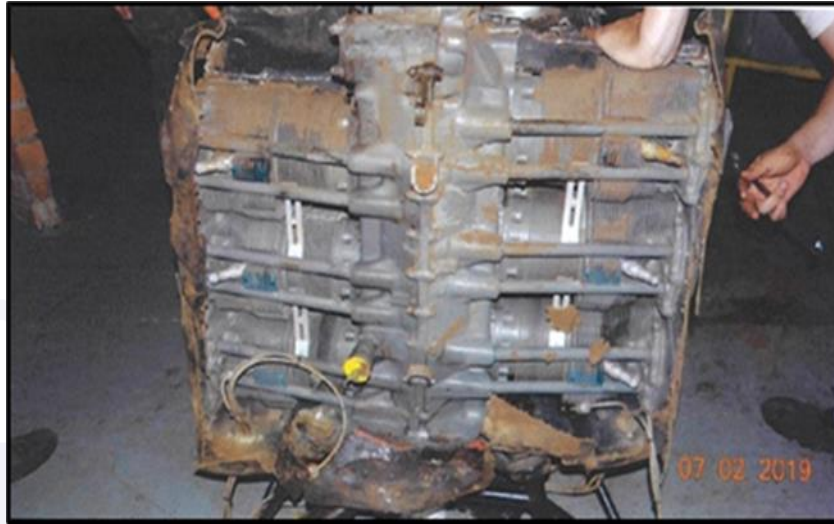
Figure 6 - View from the top of the engine.

The Lycoming O-540-B2B5 engine, serial number L-7169-40, that powered the aircraft was examined and disassembled for analysis. Externally, he did not show severe damage resulting from the accident (Figure 6).

There was water in its interior due to the fact that it remained submerged in the dam.

Examination and tests performed on the ignition system showed that both magnetos were functioning normally and that the spark plugs did not show discrepancies such as excessive wear or evidence of overtemperature and detonation.

In the same way, the carburetor disassembly did not reveal any condition that could have led to an inadequate fuel supply to the engine.

There was no sign of swarf contamination in the lubrication system and all moving internal components had lubricating oil residue, indicating proper system operation.

The cylinders and pistons also had no abnormalities, such as signs of detonation, fractures, jammed valves or overheating.

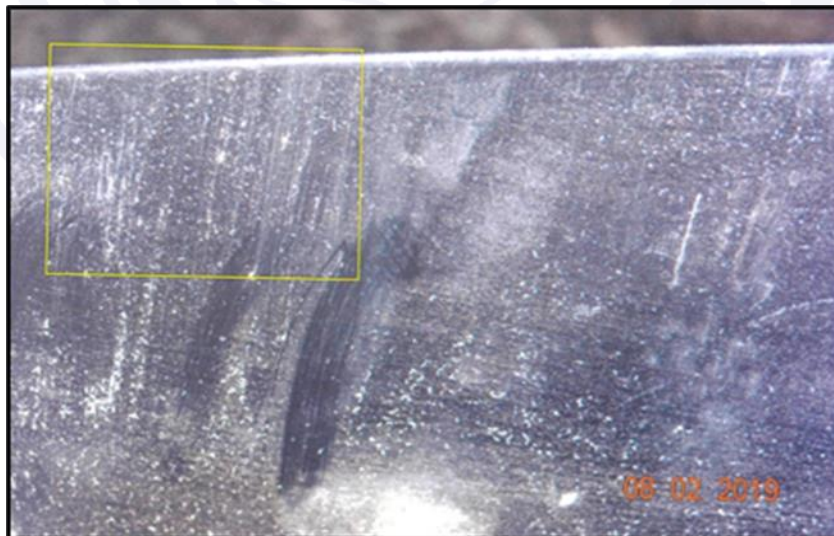
One of the propeller blades had a backward bending. Considering an impact against a liquid surface, the observed deformations did not follow a defined pattern that could indicate the power regime at the time of the accident. However, superficial transversal scratches were identified on the other blade, which indicated that the engine was running at the moment the aircraft hit the water (Figure 7).

Figure 7 - Superficial transverse scratches on the propeller blade.

This conclusion is supported by the transversal scratches found in one of the propeller blades, which were an indication that the engine was in operation at the moment the aircraft collided with the surface of the water.
