COMANDO DA AERONÁUTICA
CENTRO DE INVESTIGAÇÃO E PREVENÇÃO DE
ACIDENTES AERONÁUTICOS

FINAL REPORT
A - 131/CENIPA/2017

OCCURRENCE:	ACCIDENT
AIRCRAFT:	PR-MPE
MODEL:	208 AMPHIBIAN
DATE:	17OCT2017

This is the Final Report of the 17OCT2017 accident with the 208 Amphibian aircraft, registration PR-MPE. The accident was classified as “[ARC] Abnormal Runway Contact”.

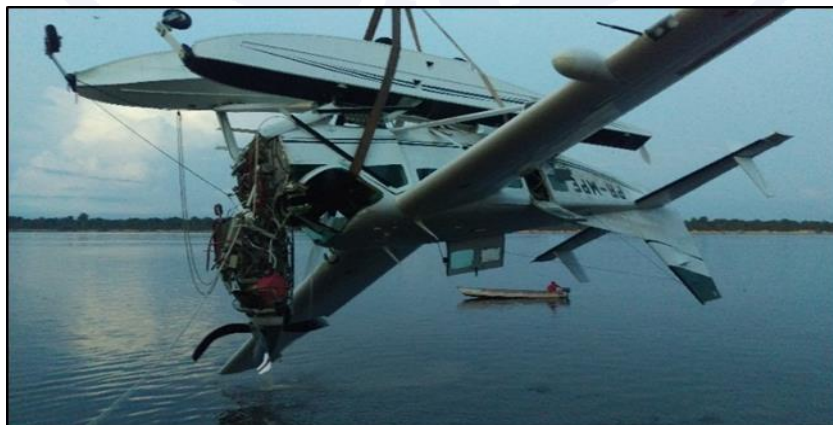
Figure 1 - View of the aircraft at the time of lifting.

The aircraft had substantial damage. Due to the force of the impact against the water, there was damage to the propeller assembly, engine and breakage of the engine mount near the firewall. The engine was attached to the aircraft by cables and pipings.

The brackets of the floats broke, being attached to the aircraft only by the tension cables, which caused the fuselage to submerge.

The fuselage was relatively preserved. There was kneading on the right front part of the cabin structure, due to the impact of the engine against that structure as well as breaking of the windshield.

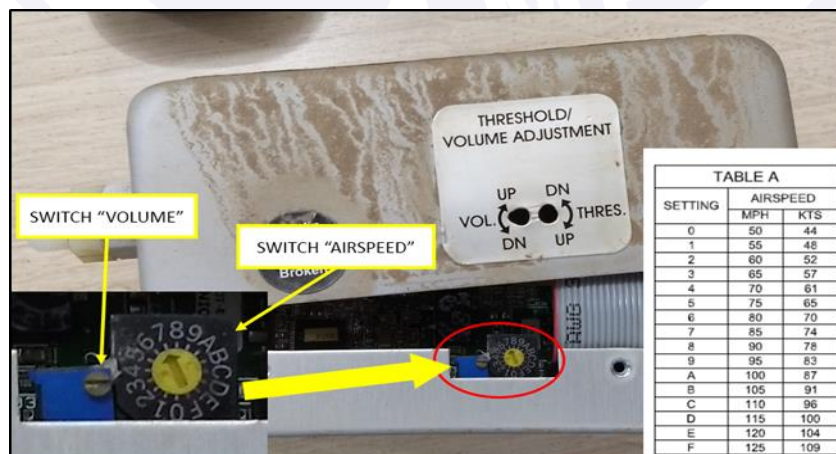
Figure 5 - Overview of the landing gear position warning system control box. In detail, the adjustment found in the control box.

The aircraft's landing gear position warning system control box was with the speed set adjusted to 85mph/74kt.

Considering that the programmed speed was set to 74 kt and the VRef prevised for flaps at 20° was 80 kt and that an adjustment between 10 and 20 mph/kt above the VRef prevised for the landing was recommended. It has been observed that the pilot performed the approach for landing on the water without the prediction of the activation of the alarm corresponding to the position of the landing gear, which in the situation of a ditching should be "GEAR IS UP FOR WATER LANDING".

The setting recorded on the AIRSPEED switch of the landing gear position warning system computer demonstrated that the scheduled speed of 74kt was not in accordance with the recommended in the 9600-1A installation manual of Wipaire Inc. in its revision G.

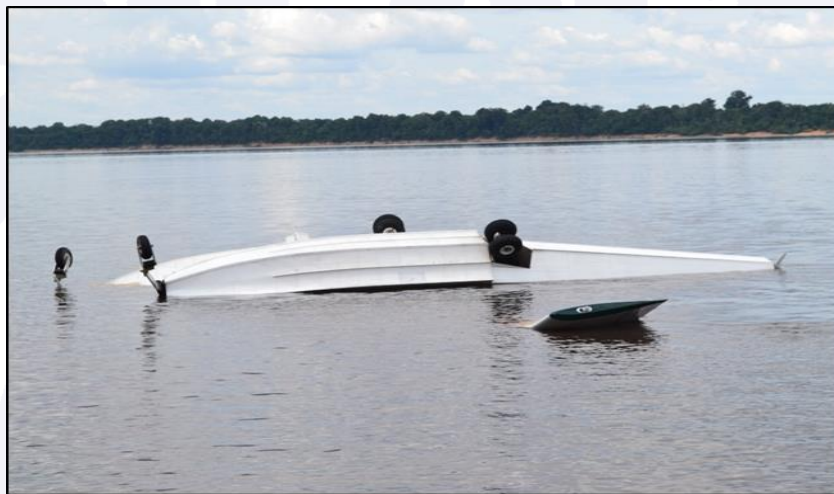
Figure 6 - View of the semi-submerged aircraft.

The floats remained on the surface and prevented the aircraft from sinking completely, being observed that the landing gear was down and locked (Figure 6).

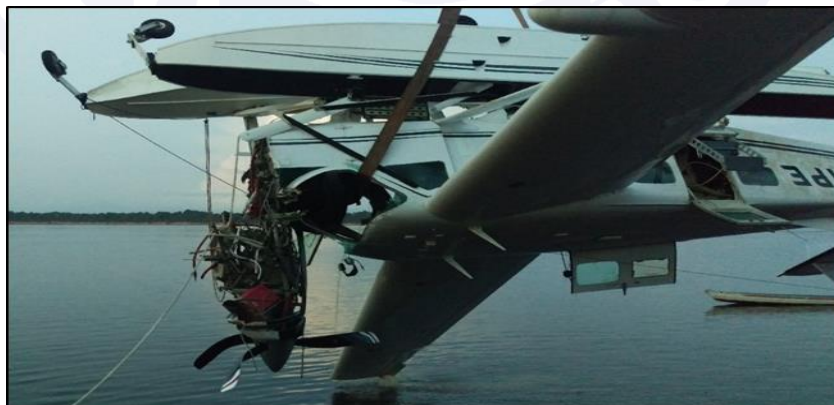
Figure 7 - Aircraft wreckage.

Most of the damage was concentrated on the front of the aircraft and fuselage, including the separation of the engine, broken windshields and impact marks from the engine hood against the fuselage, just above the right windshield (Figure 7).

The right wing presented impact damage from the float with its leading edge, while the left wing and the stabilizers were not damaged.

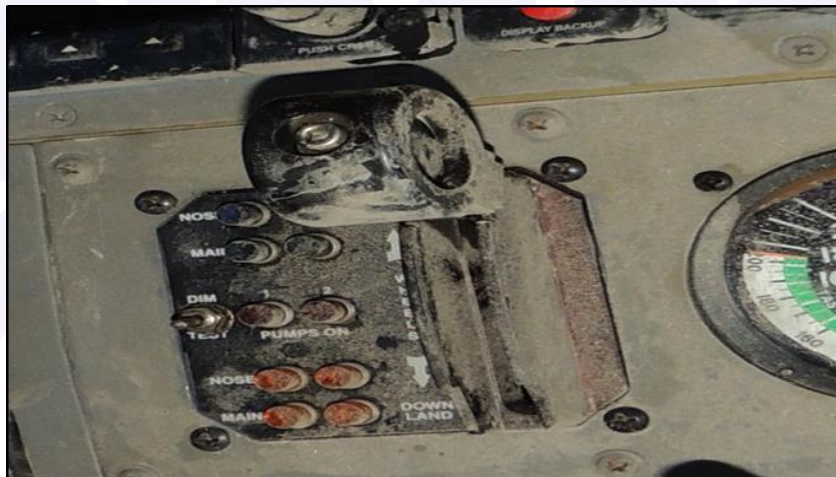
Figure 8 - Position of the landing gear control.

The amphibian steering wheel was in the UP position and locked. The landing gear control lever was in the UP position (Figure 8).

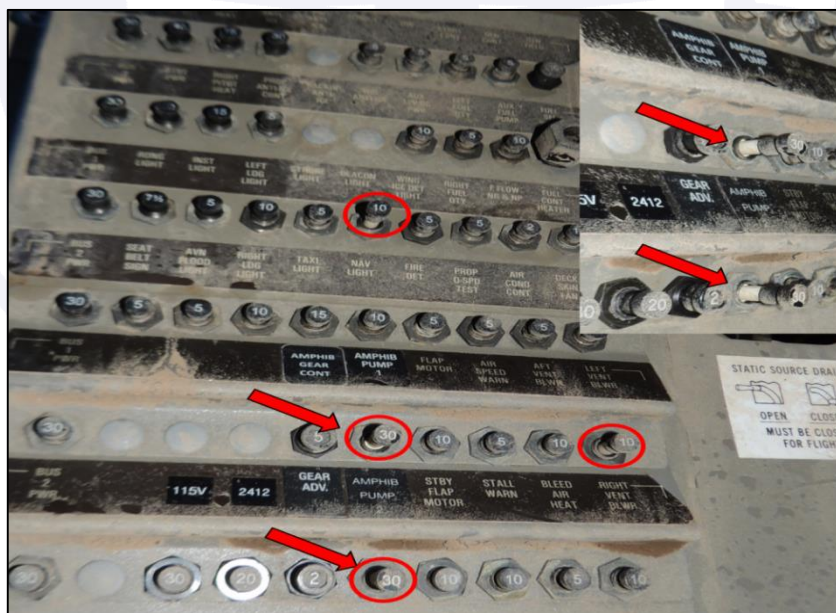
The circuit breaker panel was intact and presented four disarmed circuit breakers (Figure 9).

Figure 9 - Circuit Breaker Panel. In detail, the AMPHIB PUMP 1 and 2 circuit breakers are disarmed.

The fact that the landing gear was down and the AMPHIB PUMP 1 and 2 breakers were unarmed surprised the pilot because he had not observed this condition when doing his check before takeoff. According to his account, he had performed the pre-flight check and, at the time, he had not identified any abnormalities.

After performing the test of landing gear extension and retraction by the emergency system, the AMPHIB PUMP 1 and 2 circuit breakers were not rearmed, being the aircraft delivered to fly in this condition.

The AMPHIB PUMP 1 and 2 circuit breakers were found disarmed after the occurrence, indicating that, after the completion of the maintenance service, the executor of the tasks probably forgot to comply with the procedures for reconfiguring the aircraft.

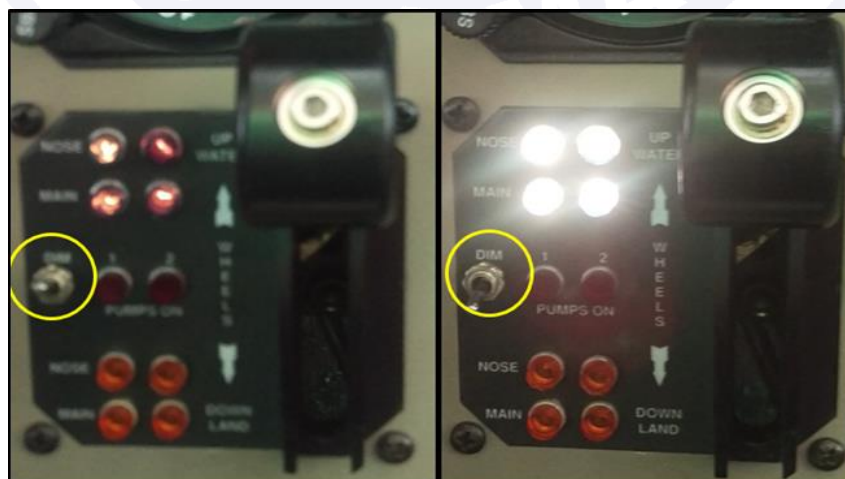
Figure 10 - Light intensity difference. DIM position to the left and NORMAL to the right.

During the field investigation, it was observed that the light switch was in the NORMAL position.
