**FINAL REPORT**  
**A - 522/CENIPA/2016**

| <b>AIRCRAFT:</b> | <b>PR-NAX</b> |
| <b>MODEL:</b> | <b>PA-28-181</b> |
| <b>DATE:</b> | <b>26DEC2012</b> |

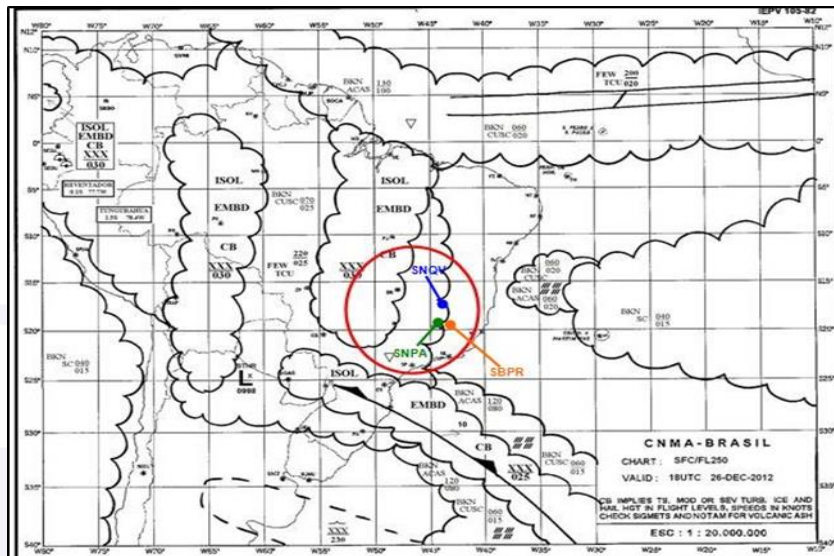
Figure 2 - SIGWX chart.

The SIGWX chart of 1800 (UTC) in South America, showed the proximity of cumulonimbus (CB) cloud formations from the locations of SNQV, SNPA and SBPR, as highlighted in Figure 2.

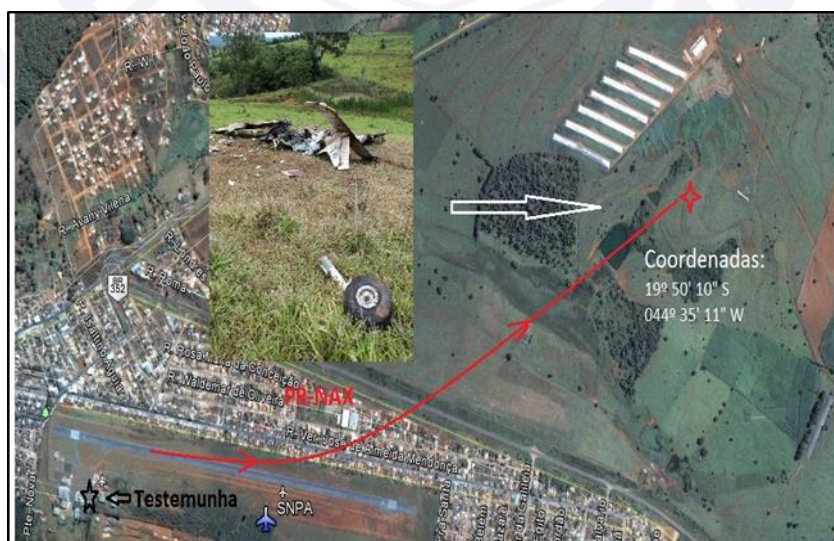
Figure 3 - Diagram of the trajectory of the aircraft and coordinates of the place of the occurrence.

According to a witness who was in SNPA, the aircraft started to turn left after the go-around procedure, losing altitude and colliding with the ground, in the vicinity of the Aerodrome.

The first impact heading of the aircraft on the ground occurred at the 025° head. The left wing collided against the ground, causing the aircraft to roll to the left, up to it was upside down, while moving ahead.

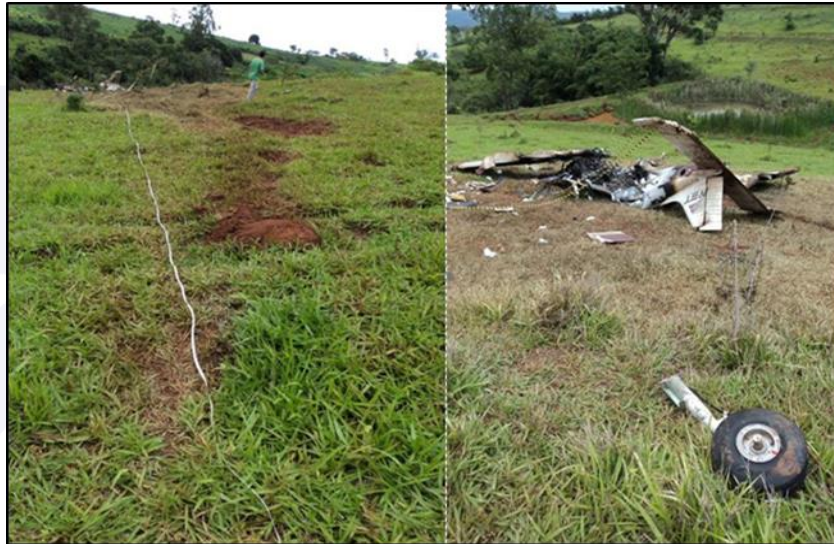
Figure 4 - Trajectory of the aircraft after the collision against the ground, leg of the landing gear that detached from the aircraft after the impact (foreground) and concentration of the wreckage (background).

After the total stop, approximately 45 meters from the first impact, the wreckage got concentrated, upside down and the aircraft caught fire. One leg of the landing gear detached from the aircraft, stopping about 3 meters from the wreckage (Figure 4).

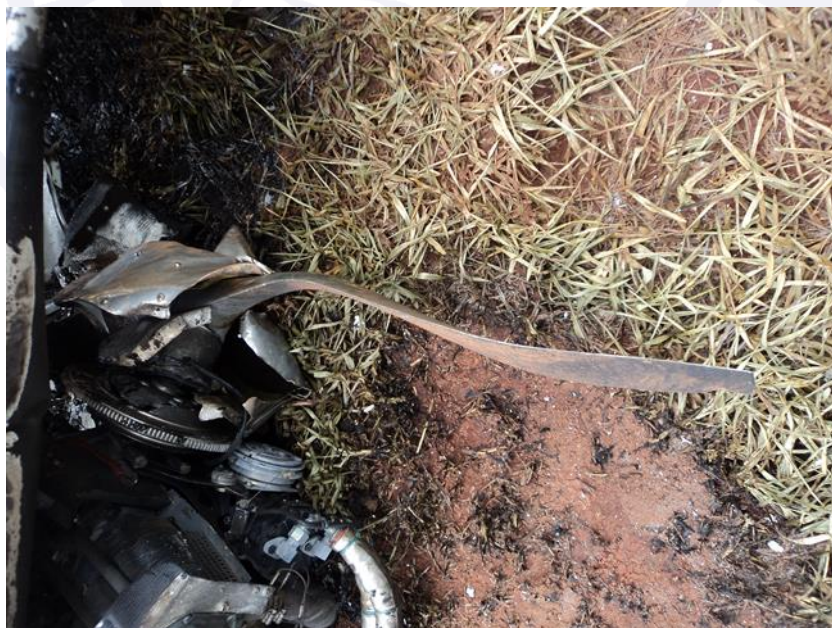
Figure 5 - Deformation in one of the aircraft propeller blades with evidence of wide angle impact and against soft ground.

One of the propeller blades had typical deformations of a low speed, wide angle and soft ground impact (Figure 5).

The torsional fractures found on the engine shaft and the deformations produced in one of the blades indicated that the engine developed power at the moment of the impact against the ground.
