COMANDO DA AERONÁUTICA
CENTRO DE INVESTIGAÇÃO E PREVENÇÃO DE
ACIDENTES AERONÁUTICOS

FINAL REPORT
A - 143/CENIPA/2014

OCCURRENCE:	ACCIDENT
AIRCRAFT:	PR-NEO
MODEL:	EC-130B4
DATE:	23AUG2014

This is the Final Report of the 23AUG2014 accident with the EC-130B4 aircraft, registration PR-NEO. The accident was classified as “[CTOL] Collision with Obstacle during Take-Off and Landing”.

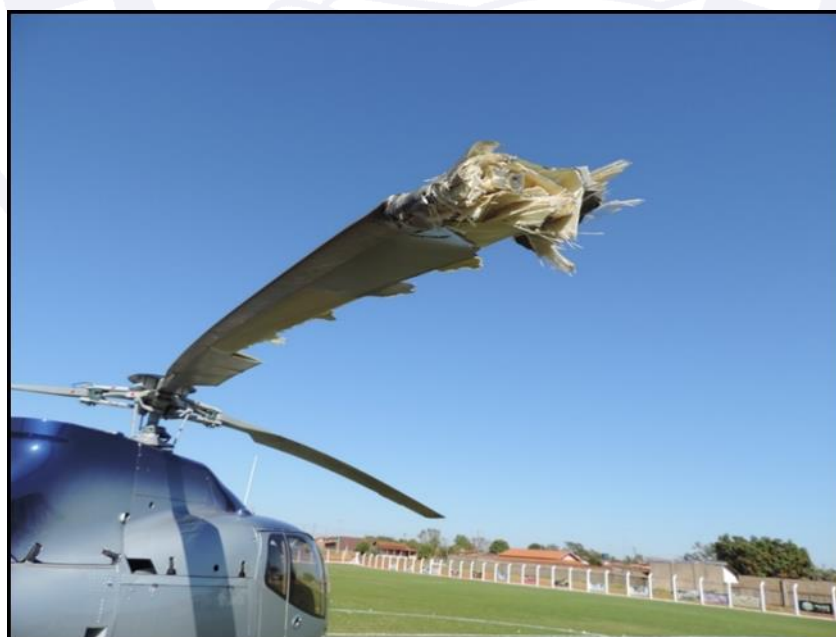
The aircraft had substantial damage to its main rotor blades and perforations in the tail cone structure and vertical stabilizer.

Figure 1 - Damage to the main rotor blades.

The main rotor blade struck the top of the goal, resulting in damage to both of them. The fragments of the blade caused perforations in the structure of the tail cone.

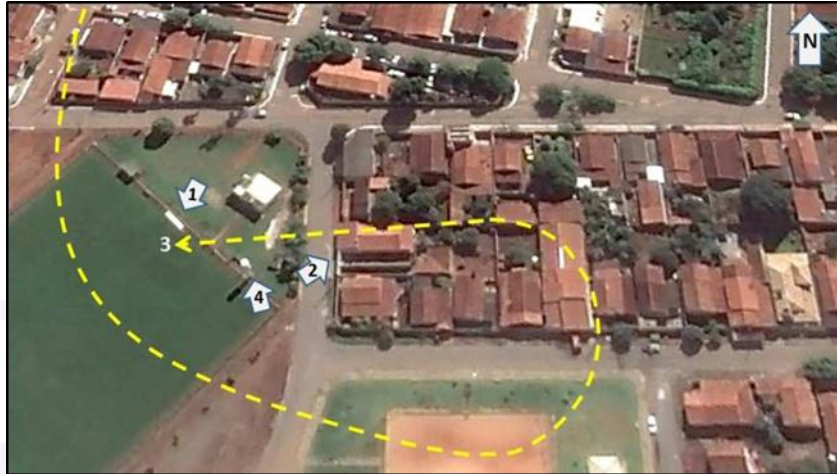
Figure 2 - Sketch of the route until the impact.

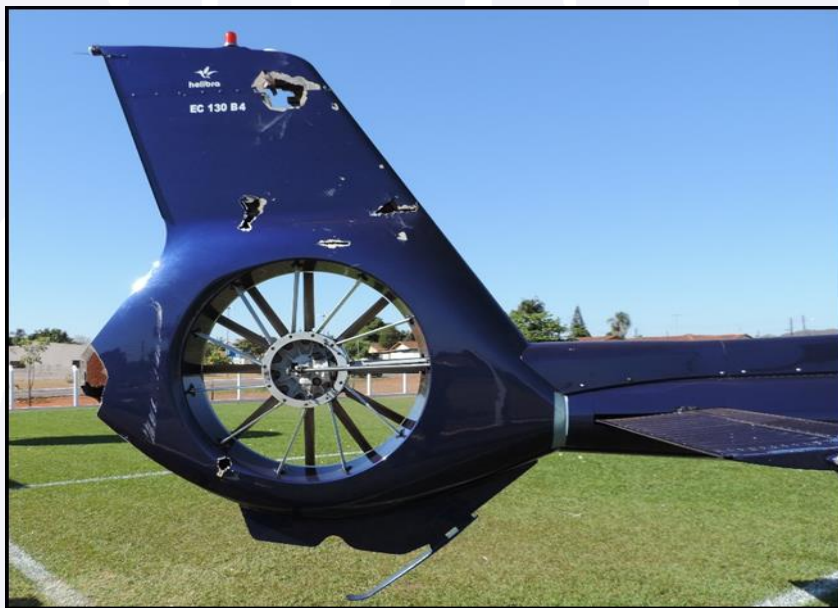
Figure 3 - Perforations on the vertical stabilizer.

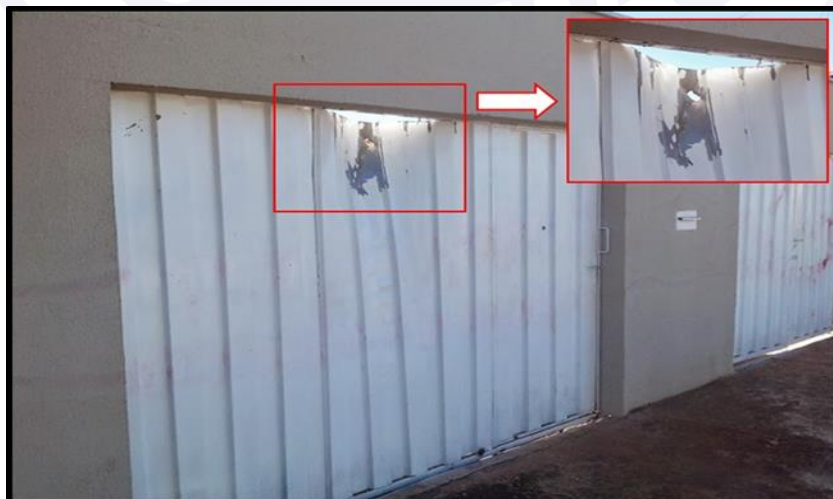
The metal shards from the goal crossbar hit the gate of a residence 43 meters away, causing damage.

Figure 4 - Damage to the gate of a residence.

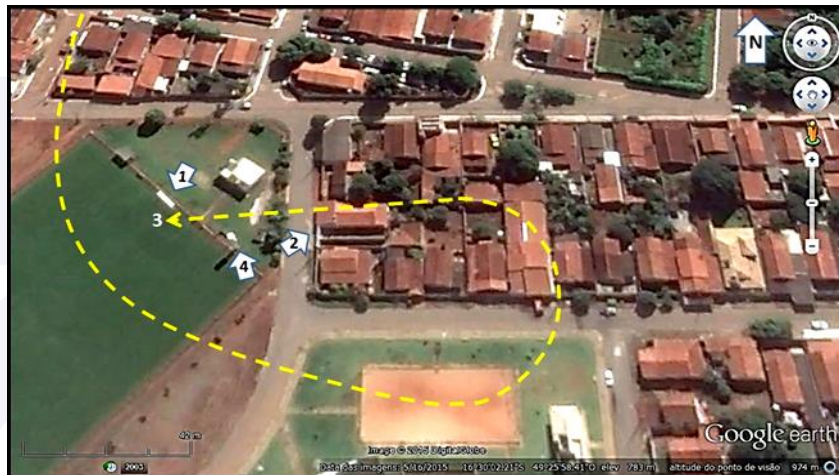
The final flight trajectory occurred on head 280° above a residential neighborhood (Figure 5).

Figure 5 - The dashed line in yellow indicates the approximate trajectory described by the pilot. "1" - indicates the goal; "2" - indicates the gate hit by fragments of the goal; "3" - indicates the final stop position of the aircraft; and "4" - indicates a water tank by the side of the field.

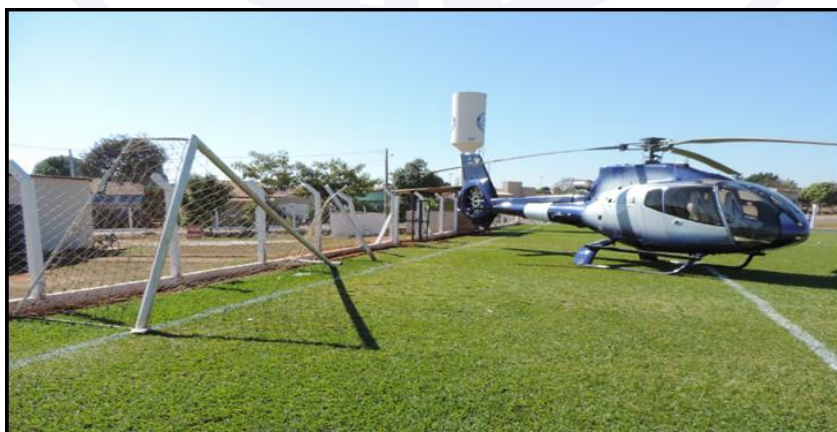
The approximation was made to the initial limit of the field. The helicopter stopped with its tail near the fence of the football field. The distance between the mast of the helicopter and the goal was of 5.23m.

The height of the goal was of 2.55m and the measured height from the tip of the main rotor blade to the ground was 2.47m (measured with the static blade).

Figure 6 - Position of the final stop of the helicopter.

The approximation was made to the initial boundary of the field. At landing, the helicopter was positioned at a distance lower than that recommended in RBHA 91.327 (7) (ii), presented in item 1.19 of this Report.

In this way, it can be said that the collision resulted from an inadequate judgment of the separation distances of obstacles in the landing, both lateral and vertical distance.

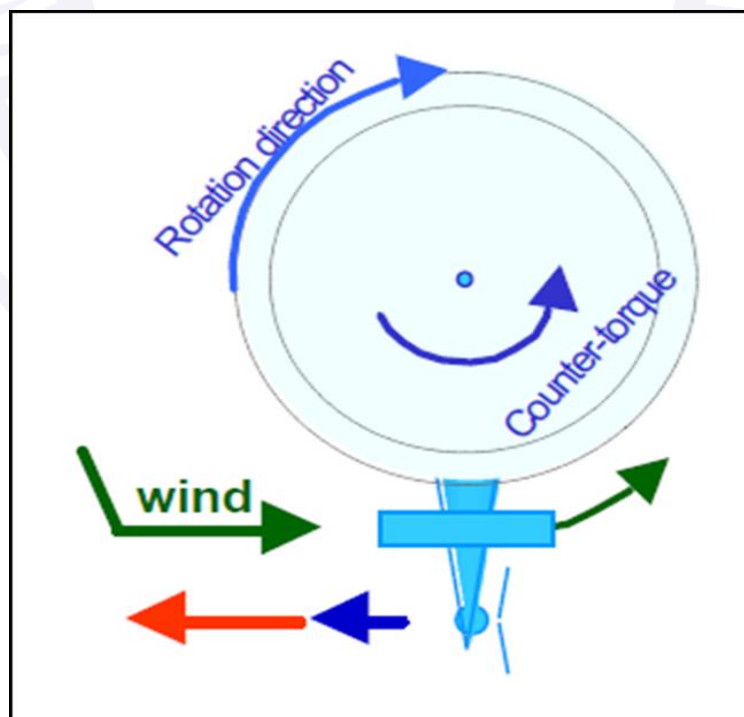
Then, it was estimated that at 400ft the aircraft received a left wind component with gusts. This wind condition may have favored the creation of a left yaw moment on the aircraft when in hovering or at very low speed.

Figure 16 - Representation of the aircraft from above, added a component of left crosswind.

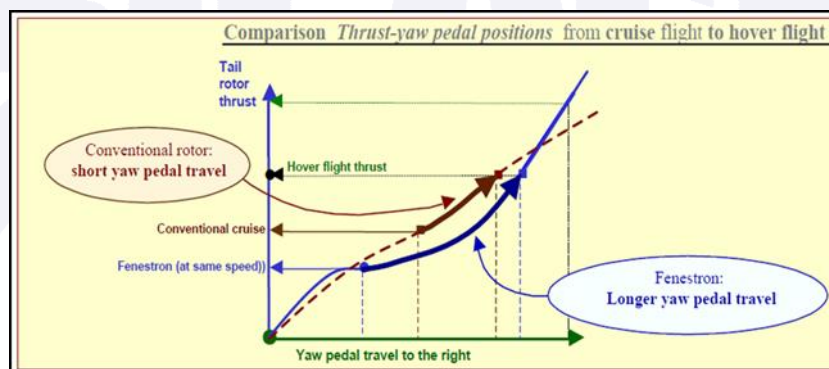
The first refers to the transition from the cruise to the hover flight. This document mentions that with the Fenestron, when there is a change from the cruise to the hover flight, the pilot must be prepared for a significant movement of the foot to the right (Figure 17). Insufficient application of the right pedal may result in a rotation of the aircraft to the left during the transition to hovering.

Figure 17 - Comparison between thrust and position of the yaw pedal, in the transition from the cruise flight to the hover flight.
