FINAL REPORT
A-560/CENIPA/2016

OCCURRENCE:	ACCIDENT
AIRCRAFT:	PR-OMV
MODEL:	EC 225 LP
DATE:	06JUN2012

This is the Final Report of the 06JUN2012 accident with the EC 225 LP aircraft, registration PR-OMV. It was classified as “[LOC-G] Loss of Control - Ground”.

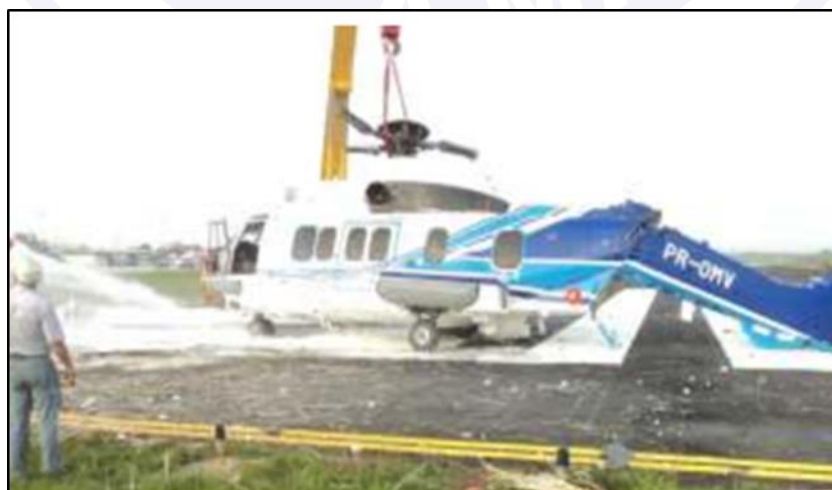
The aircraft had substantial damage to the main rotor, tail rotor, tail cone, fuselage, main and rear transmission (sudden stop) and landing gear.

Figure 1 - View of damage to the aircraft.

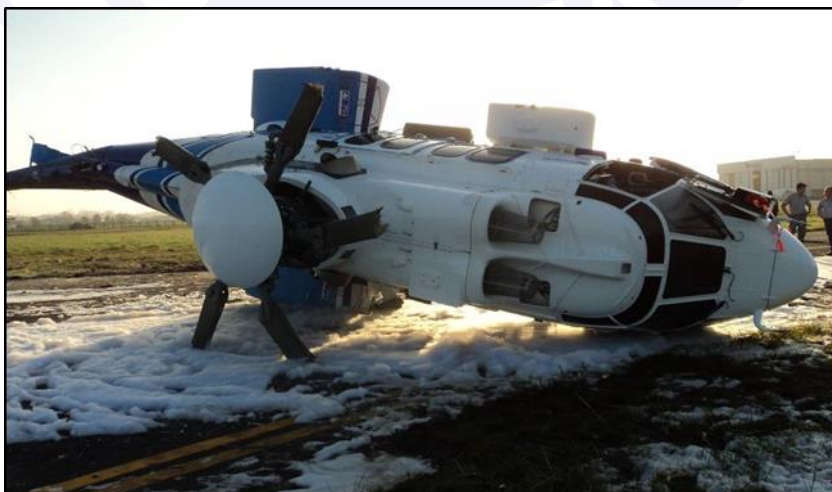
During the turning of the nose to the left, in relation to the vertical axis of the aircraft, it tilted to the right, with the main rotor touching the taxiway asphalt pavement. This was the first impact.

Figure 2 - Aircraft tilted to the right and impact of the main rotor against the ground.

An aircraft from another company was hit by the pieces of the main rotor blades that were thrown after the impact on the ground.

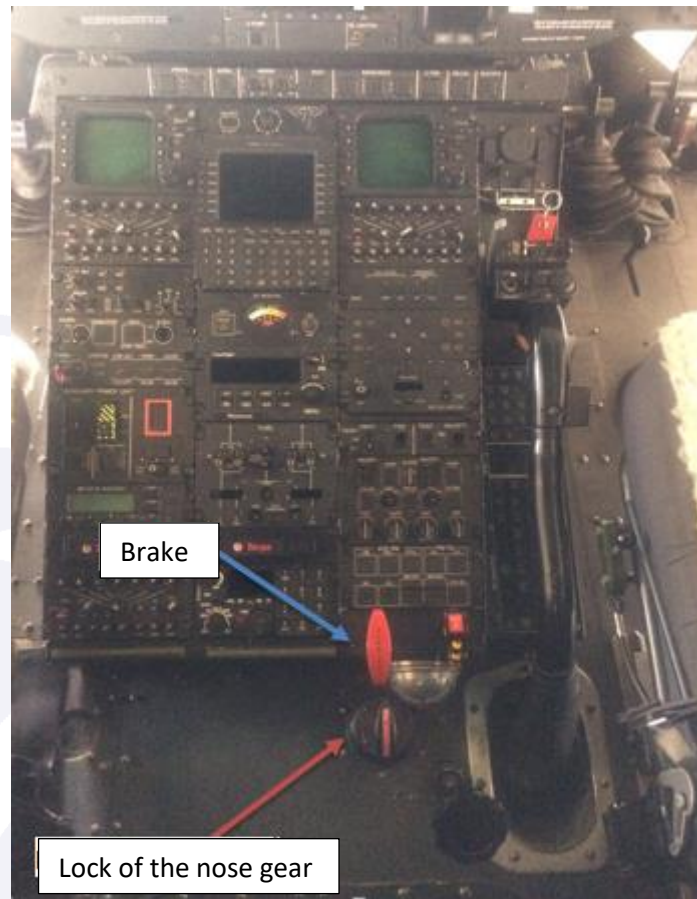
It was found that the nose wheel locking system was not unlocked after landing, as provided on the check, after landing, in the checklist.

Figure 3 - View of the two levers (brake and lock of the nose gear).

At that moment, the PM lowered his head to check the position of the nose landing gear's directional control lock located between the pilot's seats because, at nighttime, the parking brake and nose landing gear lock levers were difficult to see. Although they had distinct colors, the proximity between them and similar formats made it difficult to distinguish them during the night period.

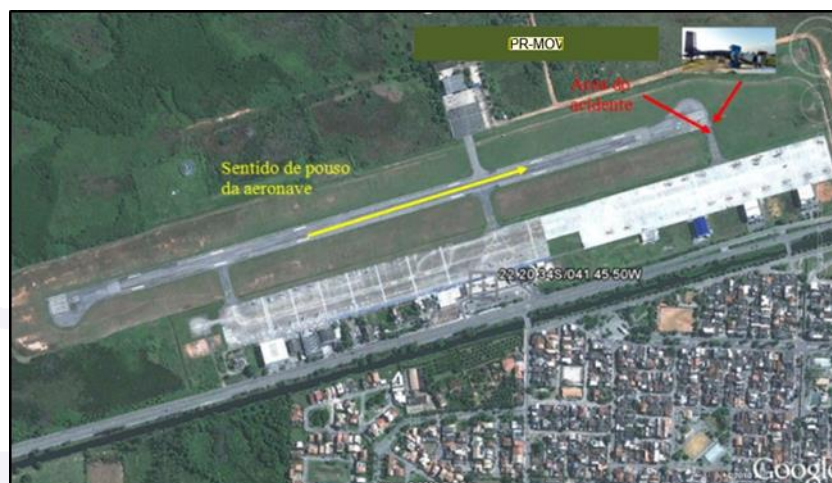
The aircraft went out of control, turned about 360 ° to the left, around its vertical axis, and fell to the right, colliding against the ground. With the overturning, there was the touch of the main rotor with the ground, followed by the shock of the blades of the tail rotor and the right fuselage. The aircraft continued in a left turn, with the right fuselage on the ground, completing a further 270 °, and ended the turn at about 90 ° with the taxiway "D".

Figure 4 - View of the occurrence site.
