**COMANDO DA AERONÁUTICA**  
**CENTRO DE INVESTIGAÇÃO E PREVENÇÃO DE**  
**ACIDENTES AERONÁUTICOS**

**FINAL REPORT**  
**A - 095/CENIPA/2017**

| <b>AIRCRAFT:</b> | <b>PR-PRF</b> |
| <b>MODEL:</b> | <b>SR20</b> |

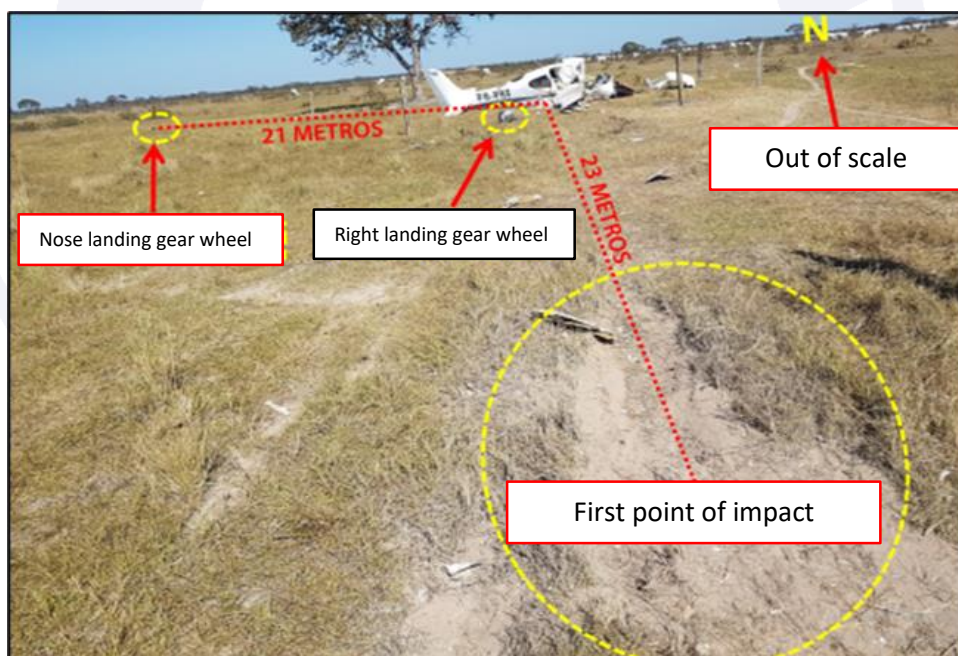
The first point of impact of the aircraft against the ground was twenty-three meters away from the place where the wreckage was concentrated. The right main landing gear opened a small hole in the ground, then detached and projected forward, in the direction of displacement (Figure 2). There was also the detachment of the nose gear wheel, which remained close to the wreckage. The final stopping position of the aircraft was with the nose pointing to the 353° magnetic heading.

Figure 2 - First point of impact and distribution of the wreckage.

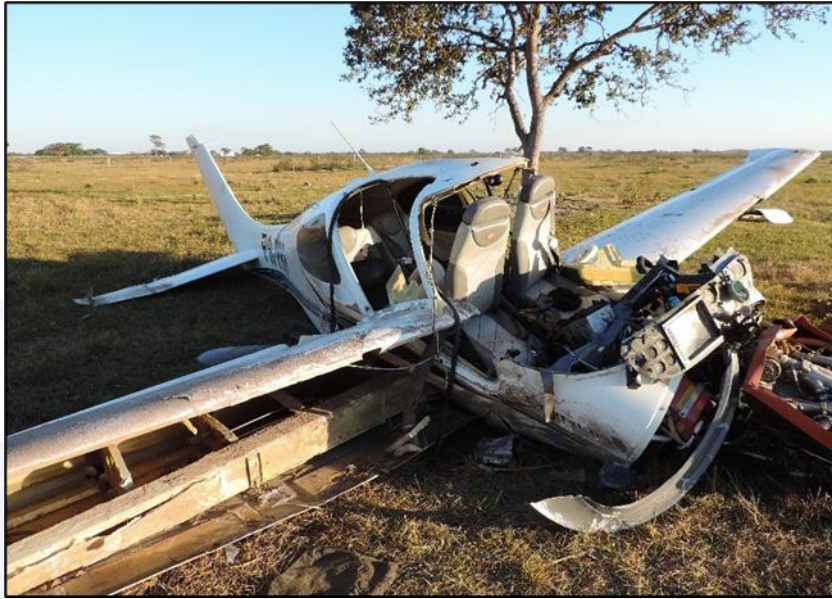
The right wing was destroyed, as was the central coffin that held the fuel tank (Figure 3). The left wing was damaged, and the flaps corresponded to the 100% lowered position (Figure 4).

Figure 3 - General view of the wreckage. Cabin and right wing destroyed.

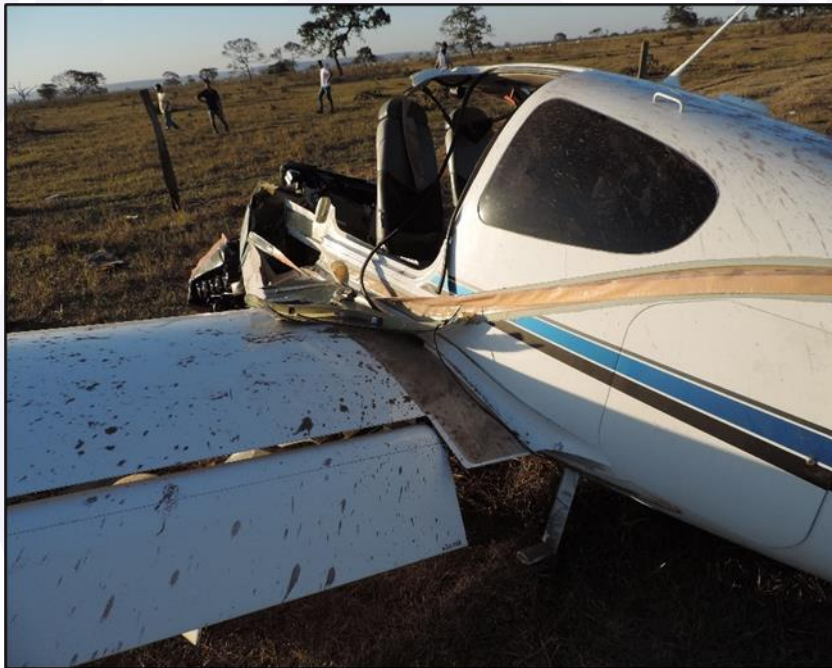
Figure 4 - Left wing flaps fully deflected.

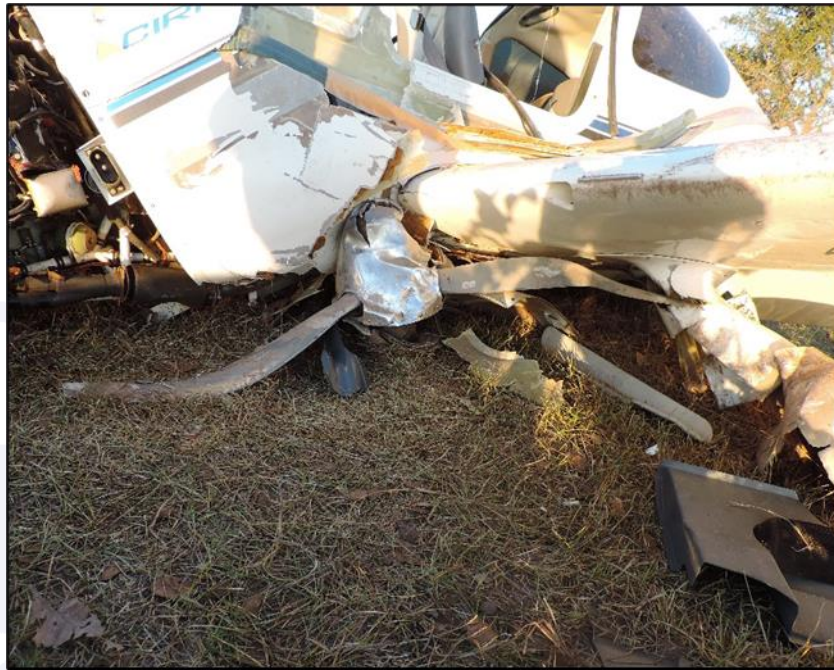
The coupling flange between the engine and the propeller was broken. Two of the three propeller blades were slightly bent backwards, and the other was bent forward, halfway along its length. The propeller assembly was found under the aircraft cabin (Figure 5).

Figure 5 - Propeller set detached and found under the fuselage, with folding blades.

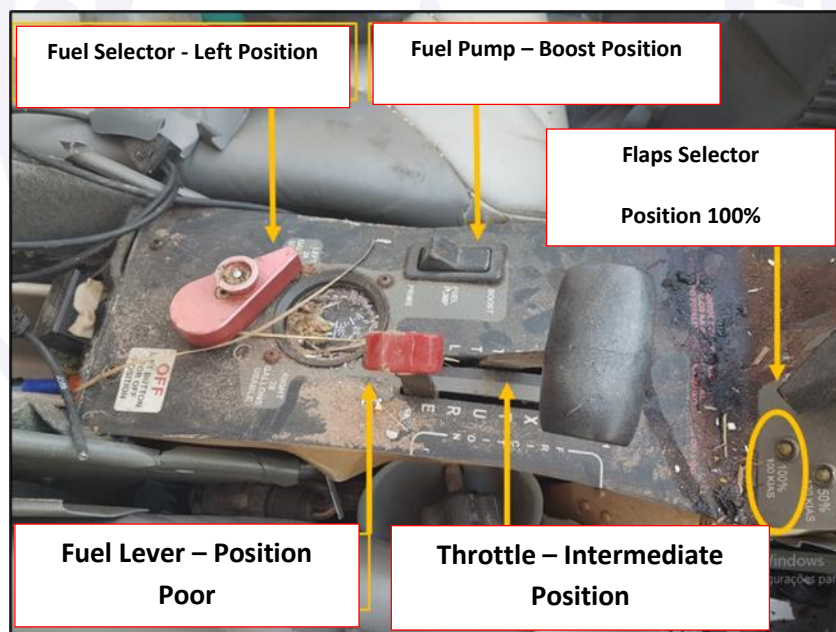
In the central console, the following was observed: flap selector commanded to the “100%” position; throttle at half stroke; fuel lever (mixture) in poor position, fuel pump in boost position; and fuel selector valve commanded for the left tank (left), as shown in Figure 6.

Figure 6 - Central console and lever pedestal in the cockpit.

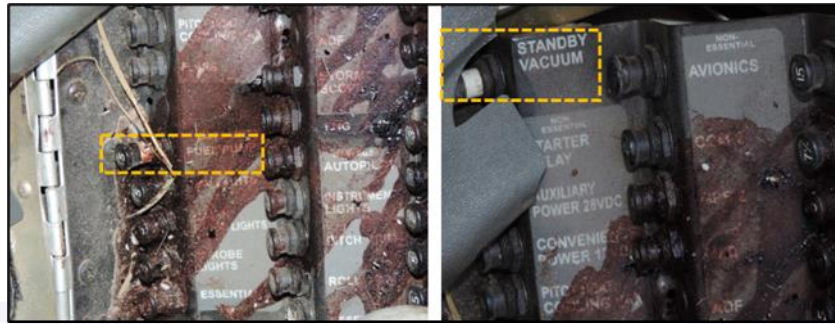
The Fuel Pump and Standby Vacuum circuit breakers were tripped in the circuit breaker panel, as shown in Figure 7.

Figure 7 - Circuit breaker panel. The Fuel Pump (left side) and Standby Vacuum (right side) circuit breakers are highlighted.

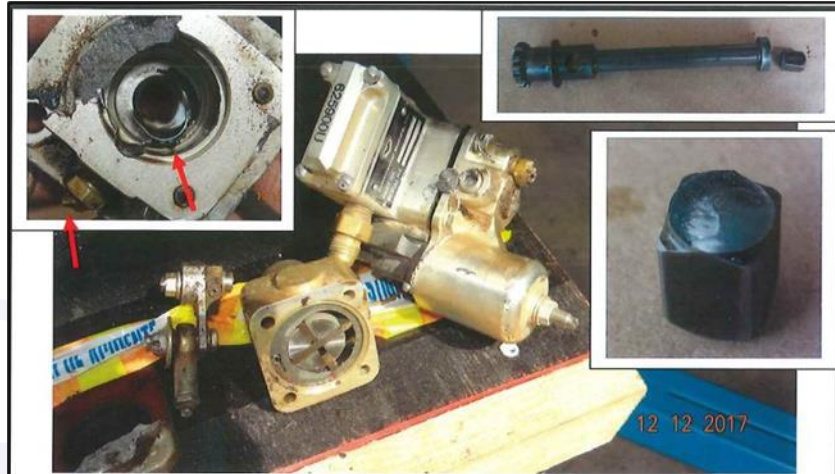
- the fuel pump drive shaft was found with a fracture at its end, as seen in Figure 8.

Figure 8 - General view of the fuel pump. Highlighted on the right are photos of the drive shaft and the fracture surface at its end. Left highlight shows observed damage to pump retainer and connection.

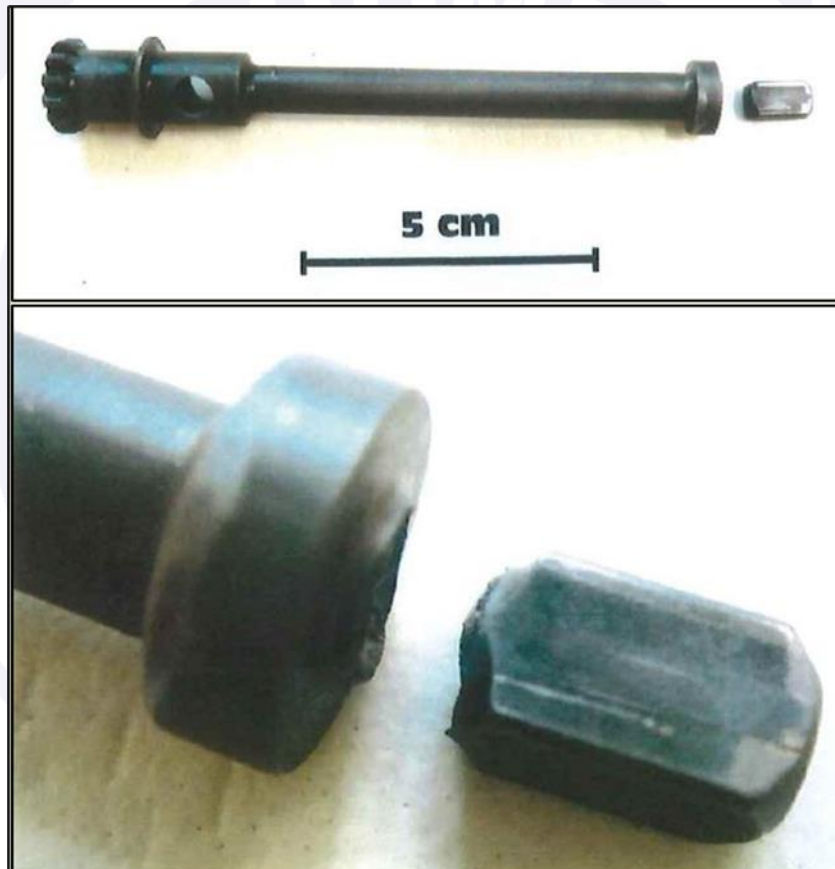
A fracture was found at the end of the shaft (Figure 9). The fracture surfaces indicated the presence of a pre-crack region followed by a torsional overload failure region.

Figure 9 - Engine fuel pump drive shaft with fracture at its end.

Based on the results obtained, it was possible to conclude that the fracture of the fuel pump shaft initially occurred in a fragile way, with the formation of a pre-crack of approximately 0.5 mm, followed by a ductile fracture by torsion.

Comparing the material of the fractured shaft with the other removed from use and not fractured, it was found that, despite the material being the same for both shafts, that is, steel AISI 8640, differences were observed in relation to hardness and microstructure of the axes. These differences seem to indicate that the broken shaft underwent an abnormal heat treatment that facilitated its fracture in service.

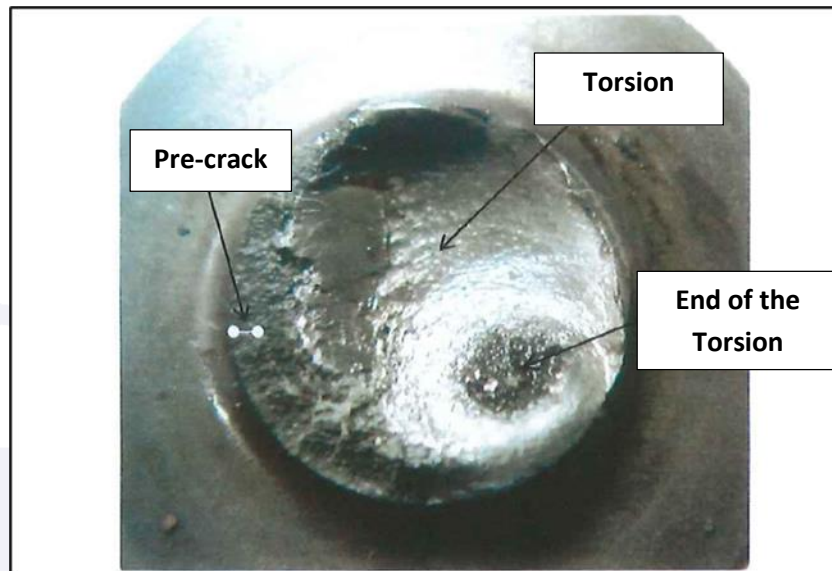
The MEV examinations confirmed the presence of pre-crack, as seen in Figures 10 and 11, and revealed a fragile fracture aspect in this region, due to the cleavage and intergranular fracture mechanisms.

Figure 10 – Stereography showing the fracture surface of the fuel pump shaft, with the presence of pre-crack and rupture by torsion.

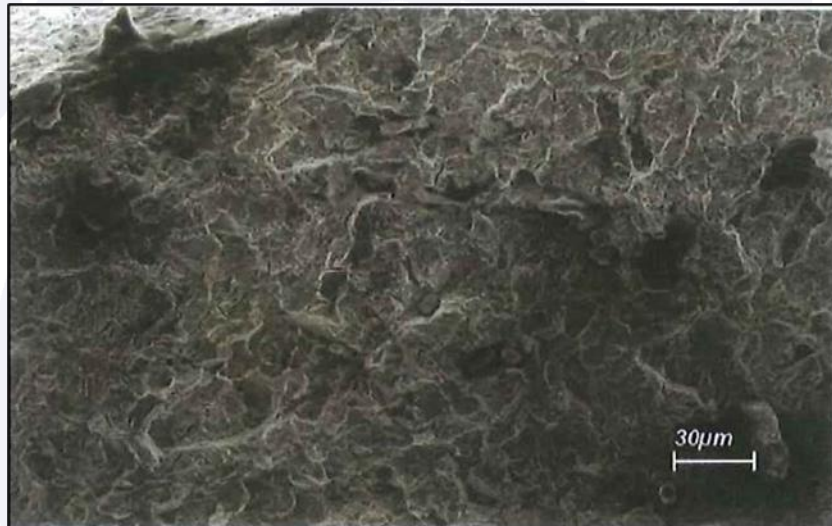
Figure 11 – Electro micrograph showing the fragile aspect of the fracture, with cleavage and intergranular mechanisms.
