COMANDO DA AERONÁUTICA
CENTRO DE INVESTIGAÇÃO E PREVENÇÃO DE
ACIDENTES AERONÁUTICOS

FINAL REPORT
A - 088/CENIPA/2018

OCCURRENCE:	ACCIDENT
AIRCRAFT:	PR-RCJ
MODEL:	210N
DATE:	16MAY2018

This is the Final Report of the 16MAY2018 accident with the 210N aircraft, registration PR-RCJ. The accident was classified as “[LOC-I] Loss of Control in Flight”.

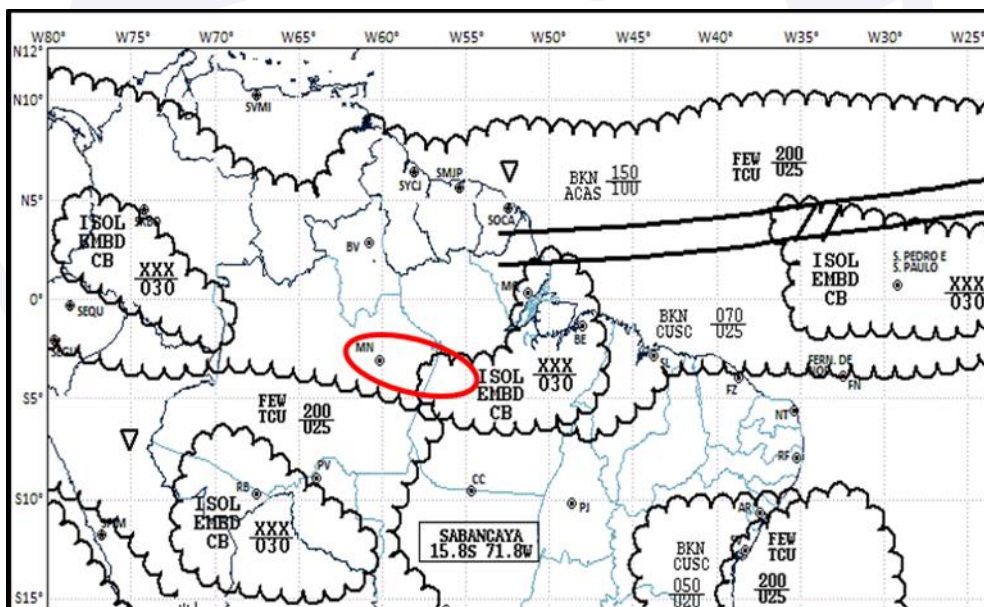
The Significant Weather Chart (SIGWX), made at 2304 (UTC), valid until 1200 (UTC) on 16MAY2018, obtained by the REDEMET site, illustrated the presence of few clouds ToweringCumulus (TCU) at 2,500ft and top at FL200, cloudy sky and presence of clouds Autocumulus (AC) and Autostratus (AS) based on 10.000ft and top at 15.000ft and Cumulus (CU) and Stratocumulus (SC) clouds based on 2500ft and top at 7,000ft (Figure 1).

Figure 1 - SIGWX chart of 16MAY2018, 12h00min (UTC), highlighting the clouds present in the region of Itacoatiara - AM. The ellipse shows the region of the proposed route.

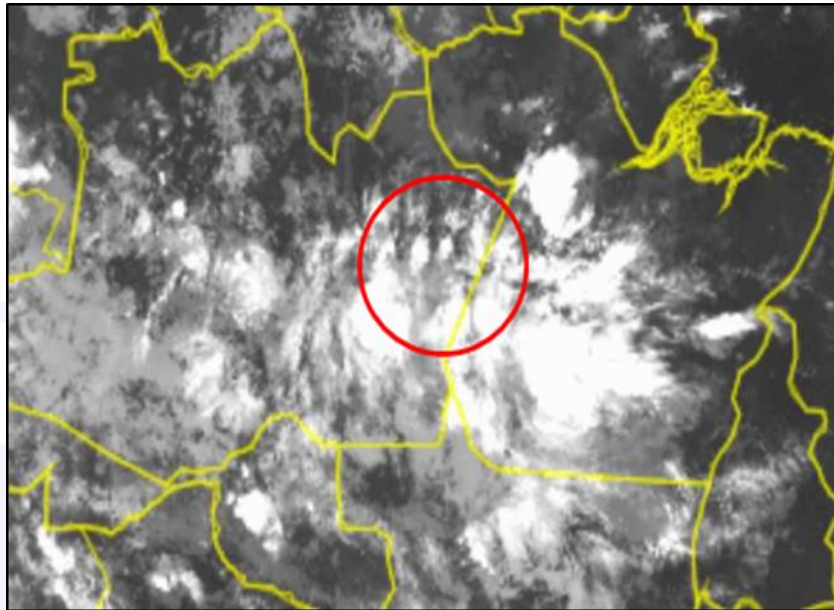
The infrared satellite image of 10h30min (UTC), obtained at the REDEMET site, indicated large cloudiness in most of the route to be flown (Figure 2).

Figure 2 - Infrared satellite image of 16MAY2018, at 1030 (UTC). The detail shows approximately the region of the route flown by the aircraft.

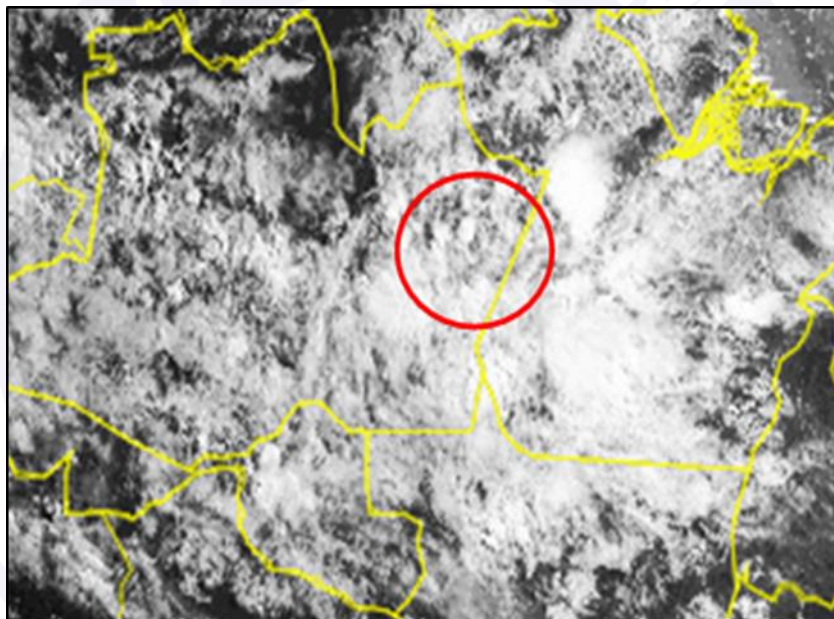
The visible satellite image, 1230 (UTC), also provided by the site, indicated a large cloud cover throughout the route (Figure 3).

Figure 3 - Visible satellite image of 16MAY2018, at 1230 (UTC). The detail shows approximately the region of the route flown by the aircraft.

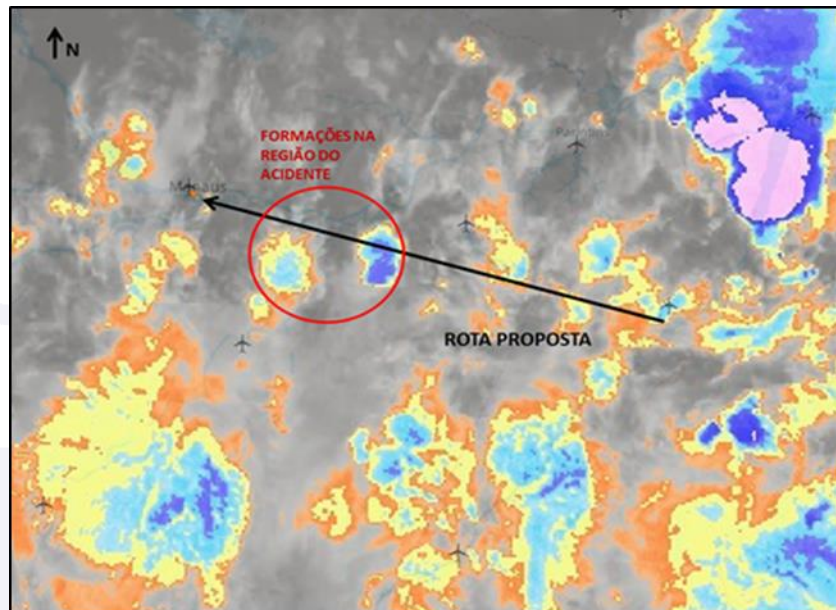
In the highlighted image obtained through the CPTEC, at 1100 (UTC), it was possible to observe a great meteorological formation at the scene of the accident, with an estimated coverage of 65km in diameter. This type of cloudiness (TCU) has very strong ascending and descending currents (Figure 4).

Figure 4 - Enhanced satellite image of 16MAY2018 at 1100 (UTC). The detail in red shows the formations in the region of the accident and, in black, the flight route proposed by the aircraft.

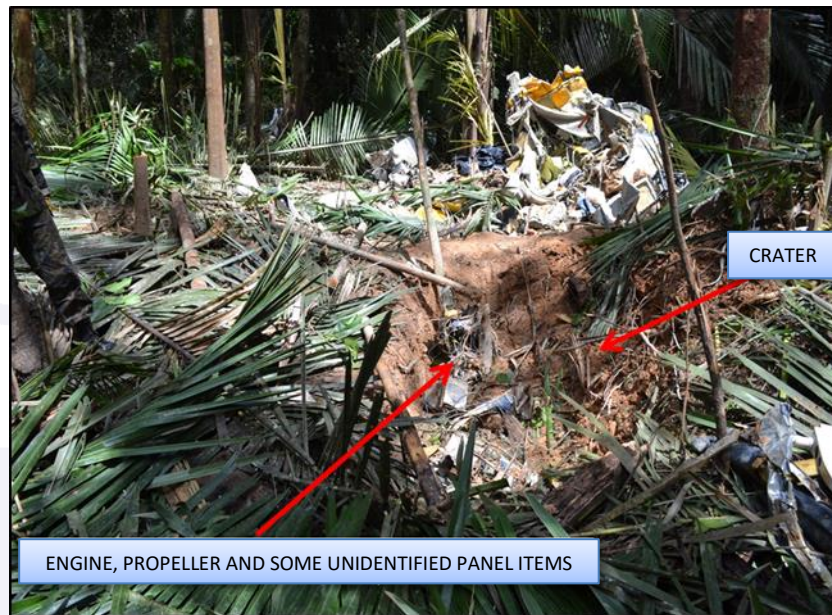
The last impact occurred against the ground opening a 3m horizontal crater, 1m deep.

In the crater, the engine, a propeller blade and some components of the instrument panel were found buried, which were not identified, due to the damage caused by the impact (Figure 5).

Figure 5 - Crater and place where the engine and the propeller were buried, plus some unidentified panel items.

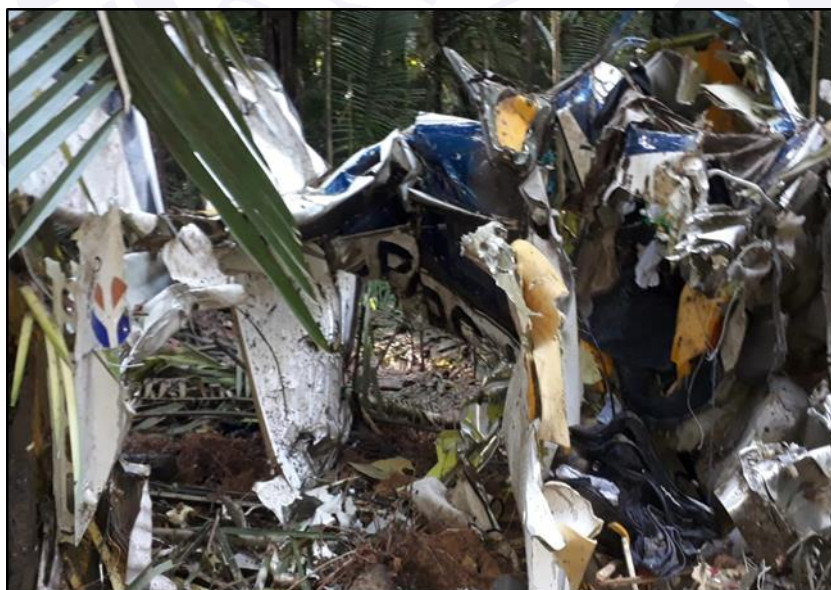
After the last impact, the aircraft stopped at 180° from the axis of displacement, 2m away from the crater, tilted to the left, without the wings and the elevators. The vertical stabilizer was sectioned in half and the steering rudder was attached to the aircraft by the control cables, but out of its original position.

Figure 6 - Position of the aircraft after the total stop. Without wings and with the cabin destroyed.

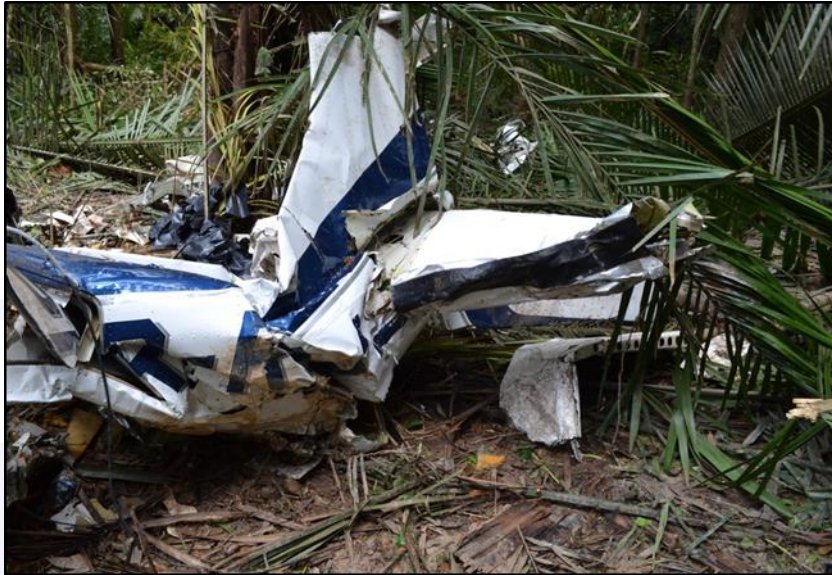
Figure 7 - Tail of the aircraft without rudder and elevator. The violence of the impact against the ground can be identified by the kneading and twisting of part of the fuselage observed in the photo.

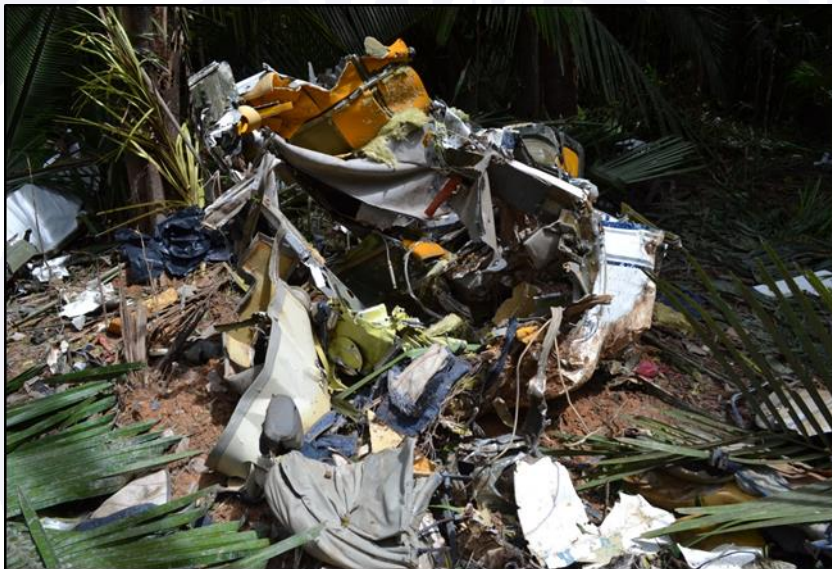
The aircraft's cabin destruction degree prevented the verification of equipment and instruments. In addition, a few people moved the aircraft and some components of its structure disappeared.

Figure 8 - Wreckage of the front part and cabin of the aircraft.
