**COMANDO DA AERONÁUTICA**  
**CENTRO DE INVESTIGAÇÃO E PREVENÇÃO DE**  
**ACIDENTES AERONÁUTICOS**

**FINAL REPORT**  
**A-157/CENIPA/2016**

<b>OCCURRENCE:</b>	<b>ACCIDENT</b>
<b>AIRCRAFT:</b>	<b>PR-TUN</b>
<b>MODEL:</b>	<b>R44 II</b>
<b>DATE:</b>	<b>04DEC2016</b>

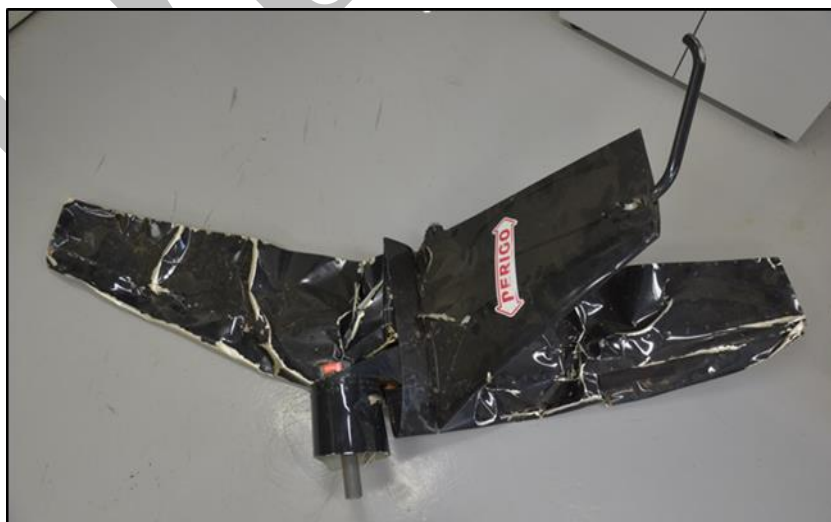
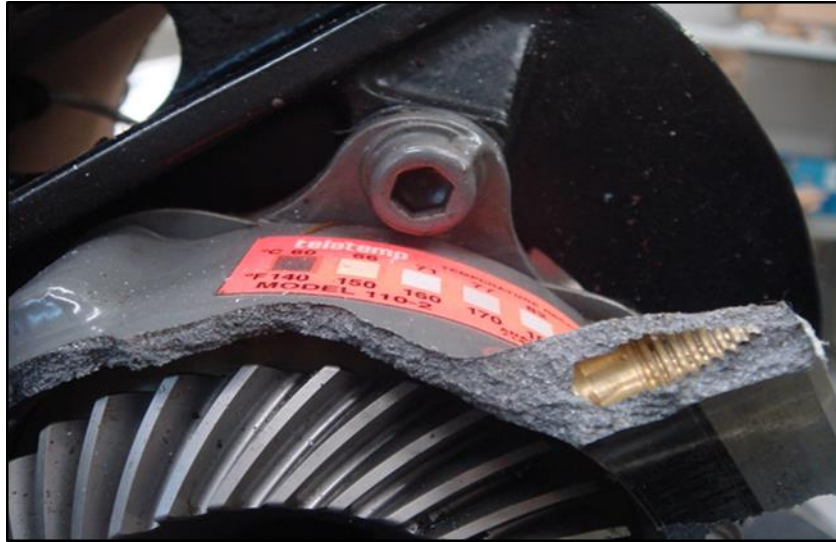
26 Overload damage was observed in the region where the tail rotor was separated from  
27 its fixation in the aircraft's tail cone (Figures 7 and 8). There was no evidence of fatigue or  
28 impact at the fracture place.

29 Figure 7 - Part of the tail of the aircraft.  
30

Figure 8 - Surface of fracture with aspect of overload.

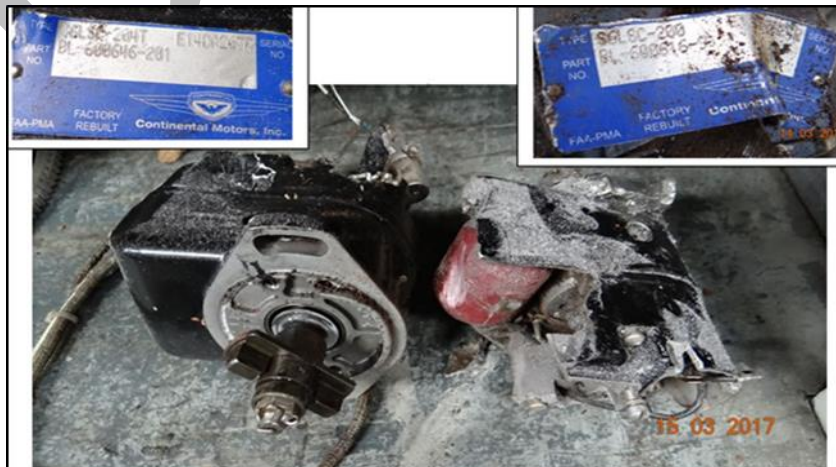
Figure 10 shows the engine magnetos. It was observed that they were damaged, which prevented bench tests.

Figure 10 - View of the engine magnetos with their respective identifications.

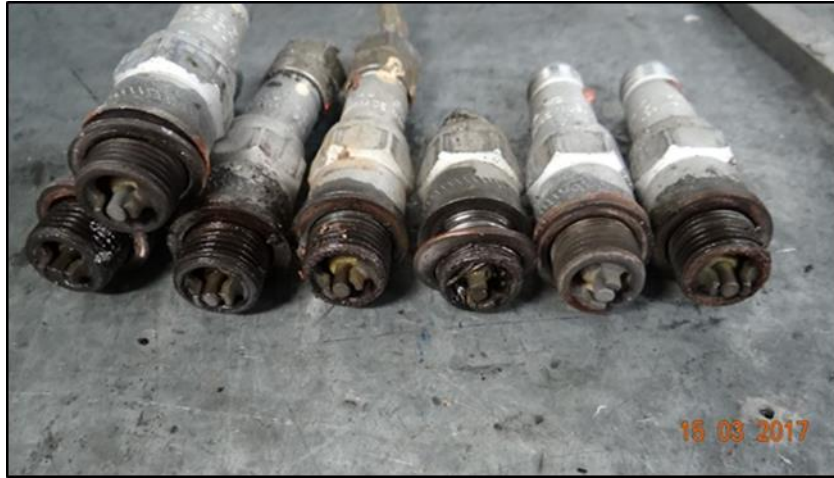
1 Control valves, hydraulic tappets, lubrication system and other internal engine  
2 components were inspected. It was found that the spark plugs presented evidence of normal  
3 operation (Figure 11).

4  
5 Figure 11 - Spark plugs with normal operating color.

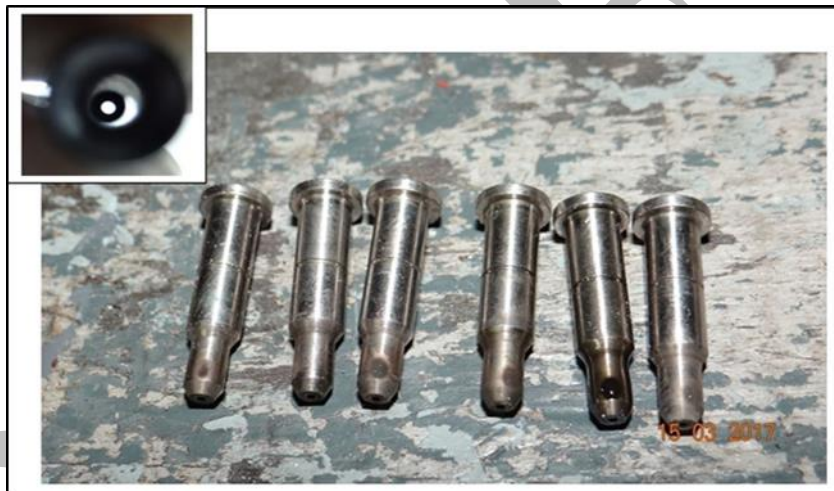
6 The injector nozzles were unobstructed (Figure 12).

7  
8 Figure 12 - View of the nozzles. Highlights the clearing.

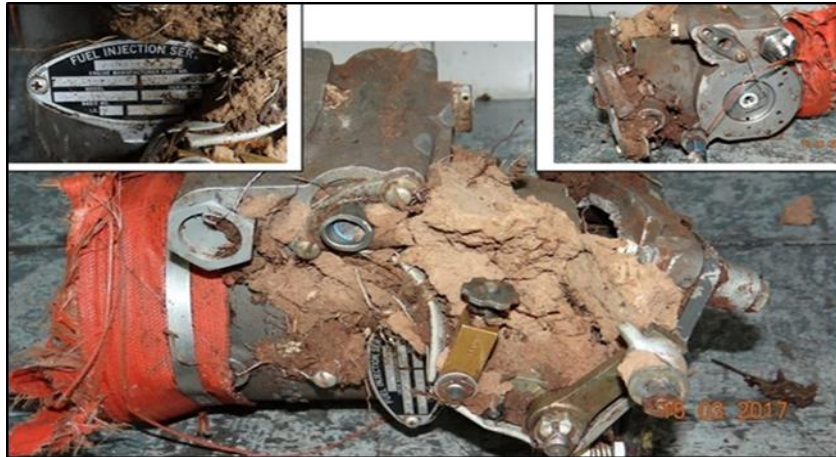
1 Figure 14 shows the servo fuel injector. This unit had serious faults as a result of the  
2 accident and was with dirt.

3  
4 Figure 14 - Overview of the servo fuel injector. The highlights show their identification and  
5 the damages resulting from the accident.

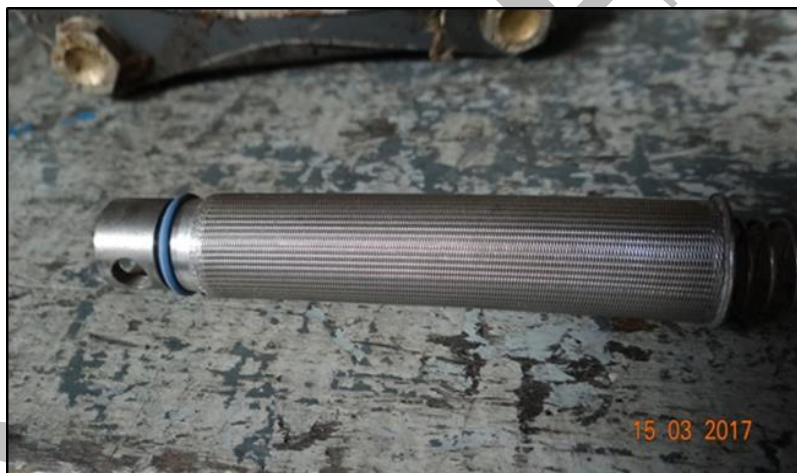
6 The fuel inlet filter was inspected (Figure 15). It was clean and uncontaminated, as it  
7 could be observed.

8  
9 Figure 15 - View of the fuel filter at the inlet of the servo injector, with no contaminants.

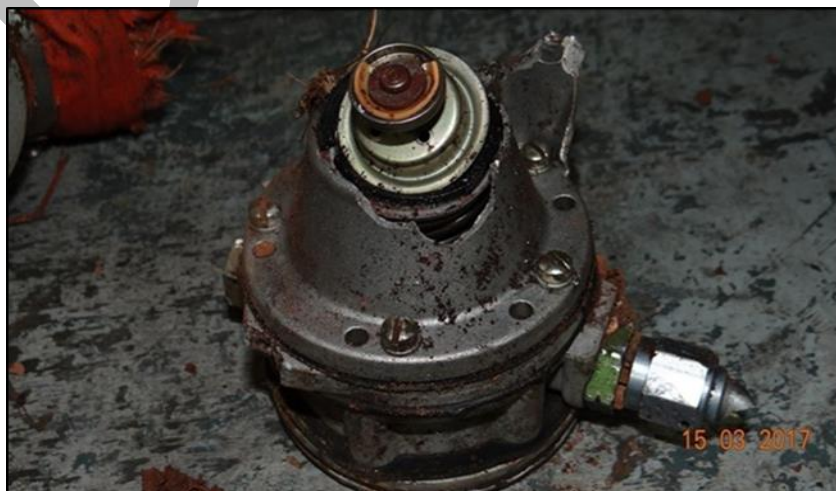
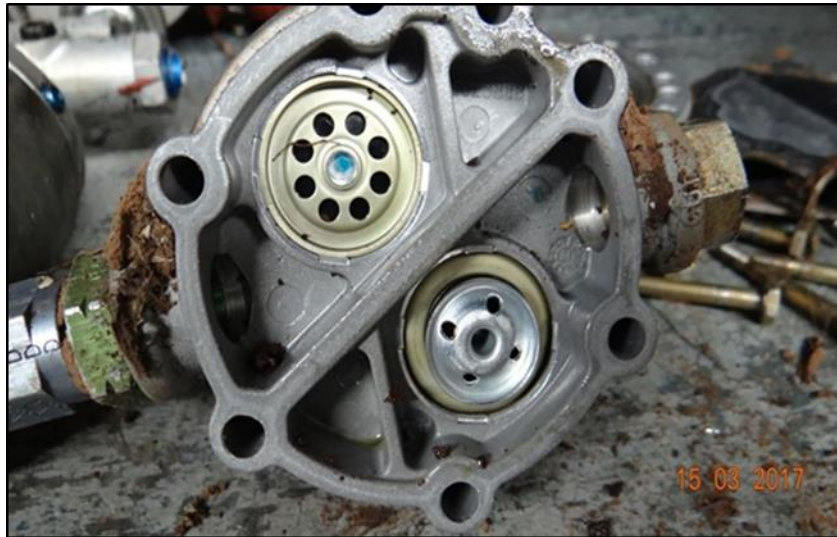
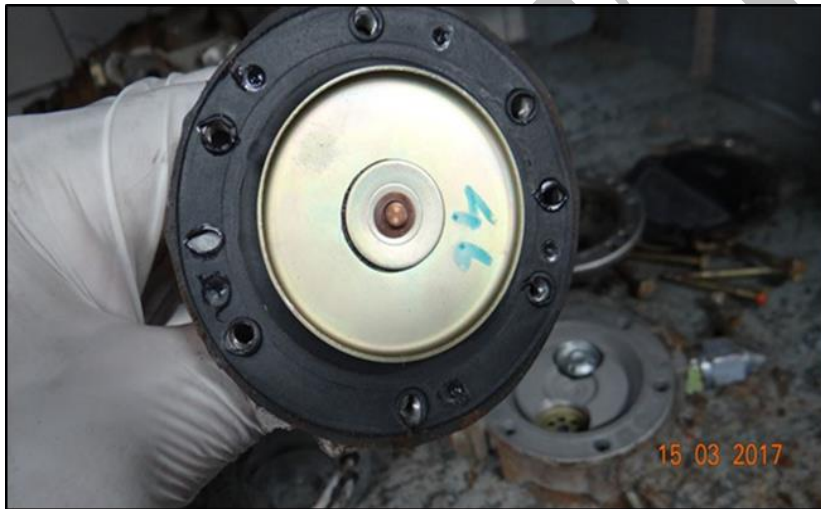
10 Figures 16 to 18 show the fuel pump. It was found fractured due to impact. In its internal  
11 components, no anomalies that showed a malfunction were found.

12  
13 Figure 16 - Fuel pump view.

1  
2 Figure 17 - View of the interior of the fuel pump, showing its valves.

3  
4 Figure 18 - Clean fuel pump diaphragm view.

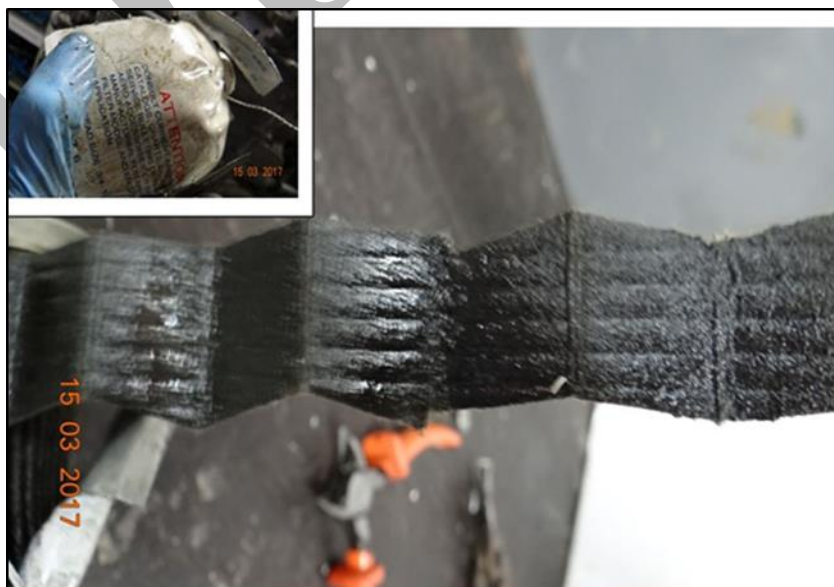
5 Figure 19 shows the filter element of the oil filter, without the presence of filings. The  
6 filter before its opening is shown in the highlight of the same figure.

7  
8 Figure 19 – Oil Filtering element with no filings. Highlighted the oil filter before opening.

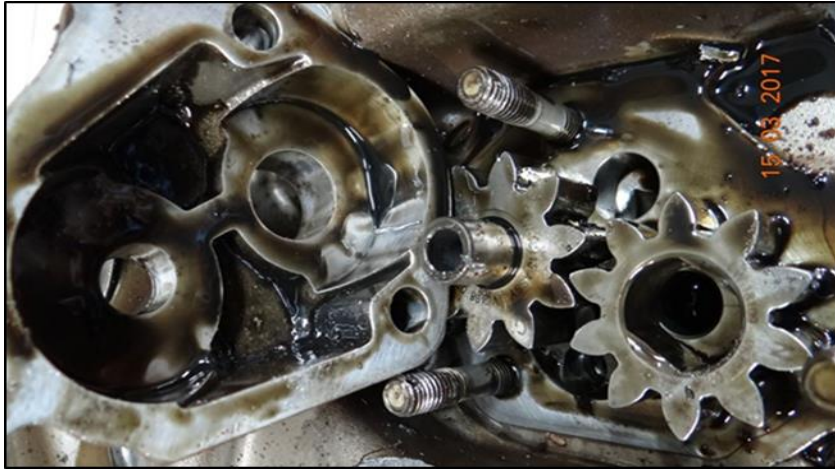
1 Figure 20 shows the oil pump as well as its gears, without operational damage. At the  
 2 time of the accident, the engine of the aircraft had its crankcase and its primary oil filter  
 3 ripped off. They were not located for analysis.

4  
 5 Figure 20 - Gears and housing of the engine oil pump without scratches.

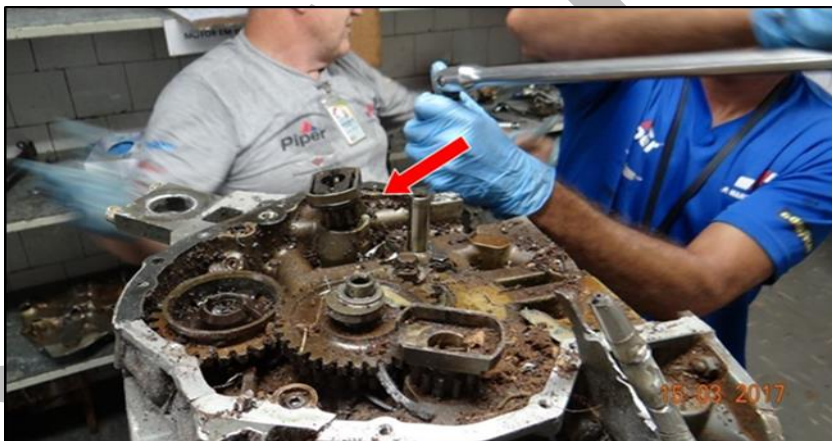
6 Figure 21 shows a view of the engine synchronizing gears. It is observed that the drive  
 7 gear bearing of the right magneto was misaligned. The impact that the magneto suffered at  
 8 the moment of the collision against the ground caused this misalignment.

9  
 10 Figure 21 – Gears of the accessory box. The arrow indicates misalignment of the drive  
 11 gear of the right magneto.

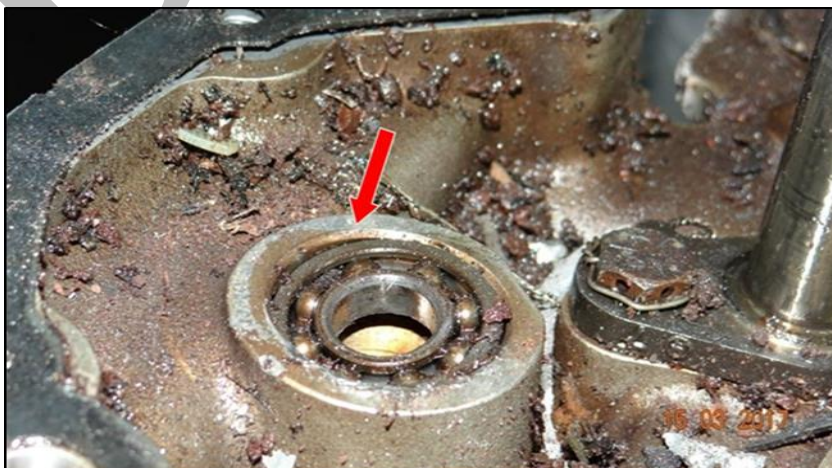
12 Figure 22 shows the detail of the misalignment with the bearing still assembled.

13  
 14 Figure 22 - Misalignment in the drive gear bearing of the right magneto.

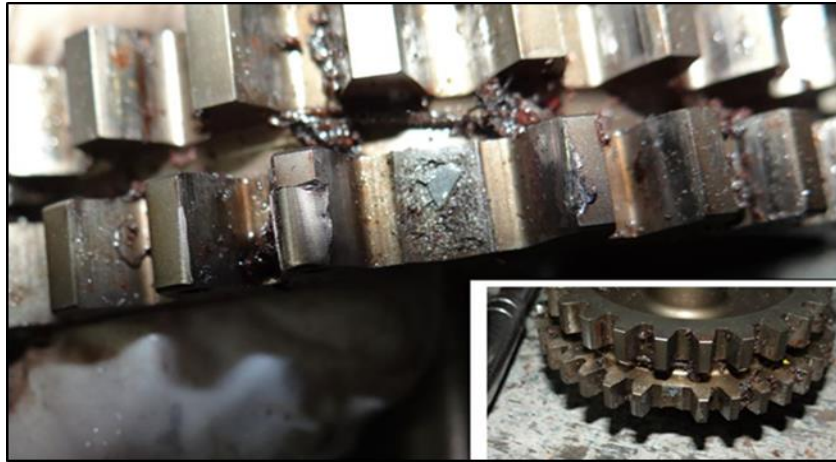
1 The intermediate gear, which drives the left magneto and the valve control, had a  
2 fractured tooth. The misalignment caused by the impact promoted the decoupling of the  
3 "teeth" and allowed the incorrect contact between them.

4 This caused the "tooth" fracture of this intermediate gear by overload and the contact  
5 marks observed in the ridges of the neighboring teeth (Figure 23). Such evidence  
6 corroborates that, at the moment of impact, the magneto was spinning, because more than  
7 one "tooth" of the gear was affected.

8  
9 Figure 23 - View of the tooth fracture of the left magneto drive synchronizing gear and the  
10 valve control.

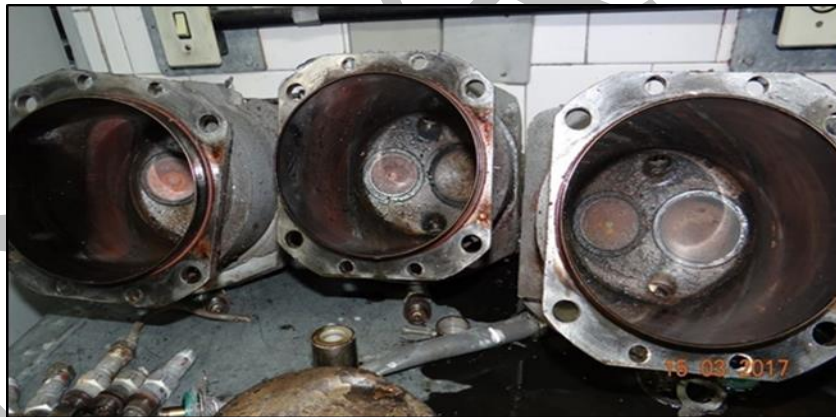
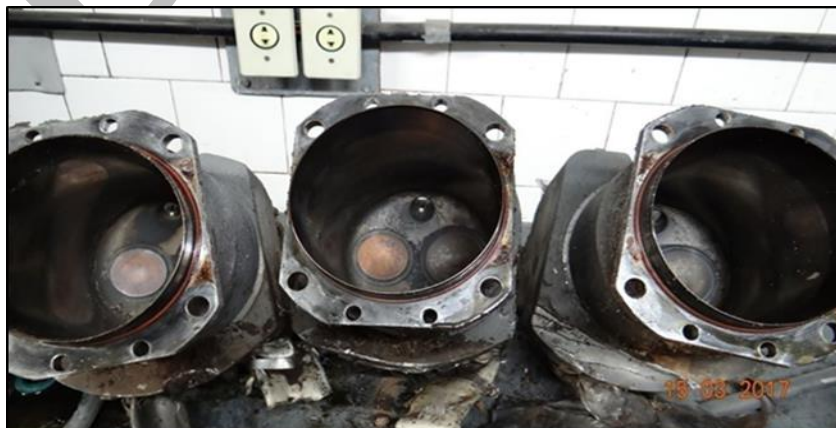
11 Figures 24 and 25 show the interior of the engine cylinders. There were no scratches,  
12 no evidence of detonation or signs of overheating that could indicate engine malfunction.

13  
14 Figure 24 - View of cylinders 1, 2 and 3, with no operational damage.

15  
16 Figure 25 - View of cylinders 4, 5 and 6, without operational damage.  
17

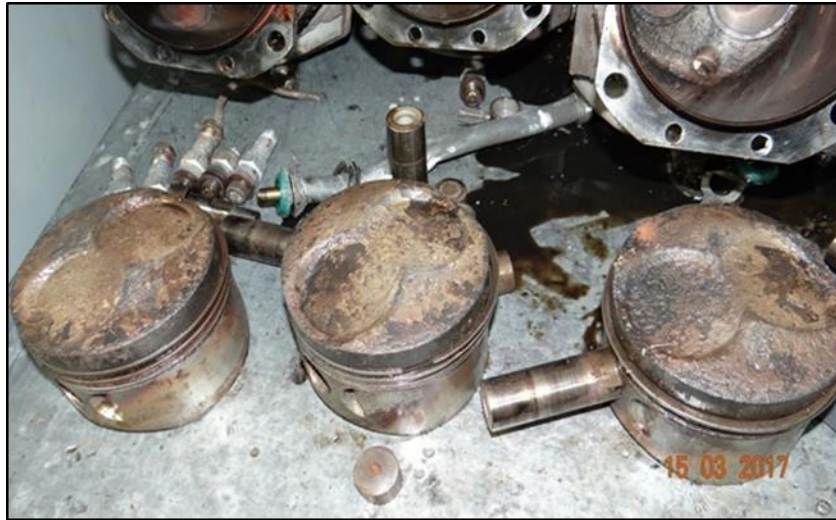
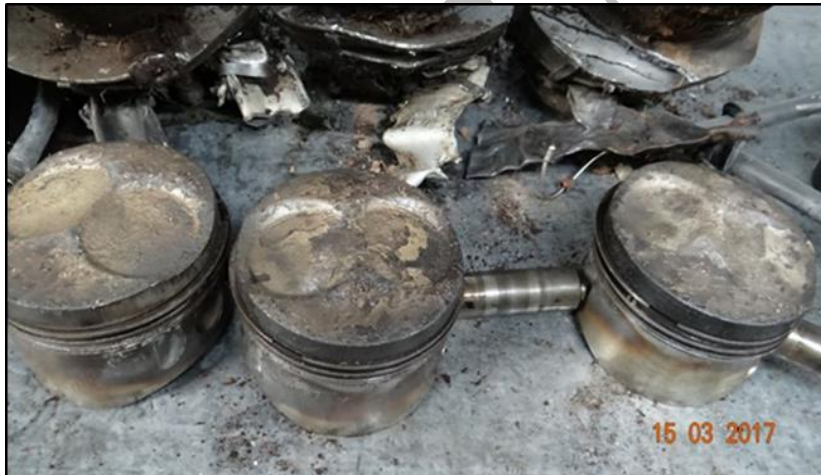
- 1 The same analysis procedure was adopted to inspect the pistons (Figures 26 and 27).  
2 No anomaly was found.

3  
4 Figure 26 - View of the pistons 1, 2 and 3, with normal working color.

5  
6 Figure 27 - View of the pistons 4, 5 and 6, with normal working color.

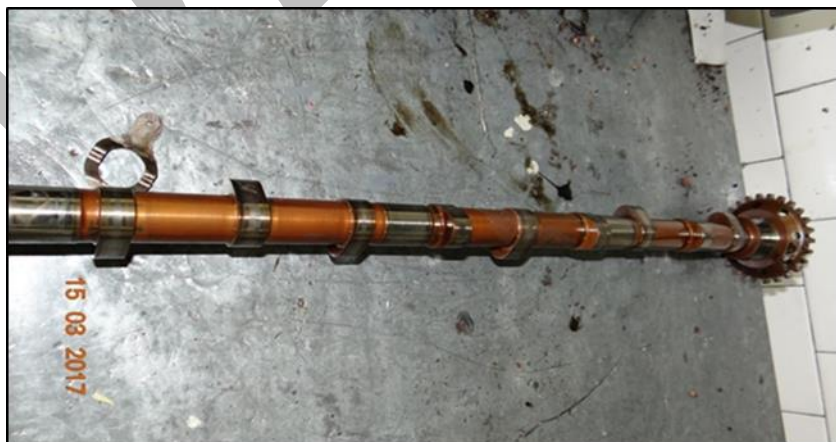
7 Figure 28 shows a view of the valve control shaft of the engine, which was also intact.

8  
9 Figure 28 - Overview of the engine valve control shaft.

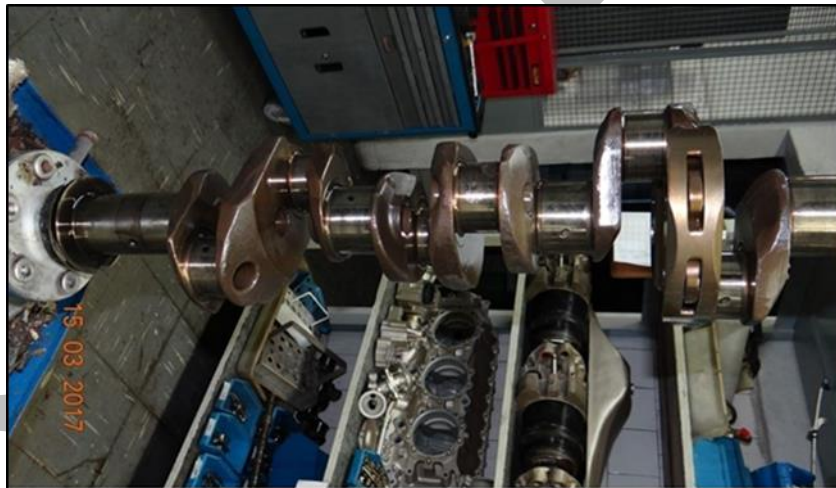
3 The crankshaft of the engine is shown in Figure 30. All connecting rods (Figure 31)  
4 were moved before disassembly and no jamming or signs of lack of lubrication were  
5 observed, which could compromise the operation of the engine.

Figure 30 - Engine crankshaft in good condition.

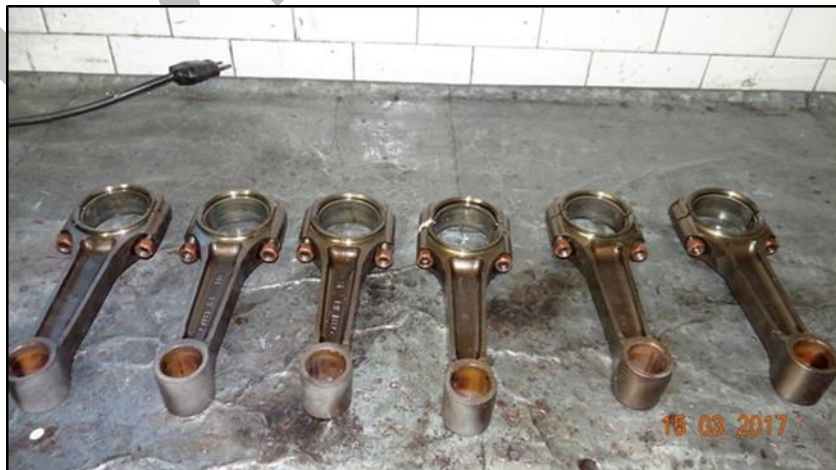
Figure 31 - View of the connecting rods in good condition.

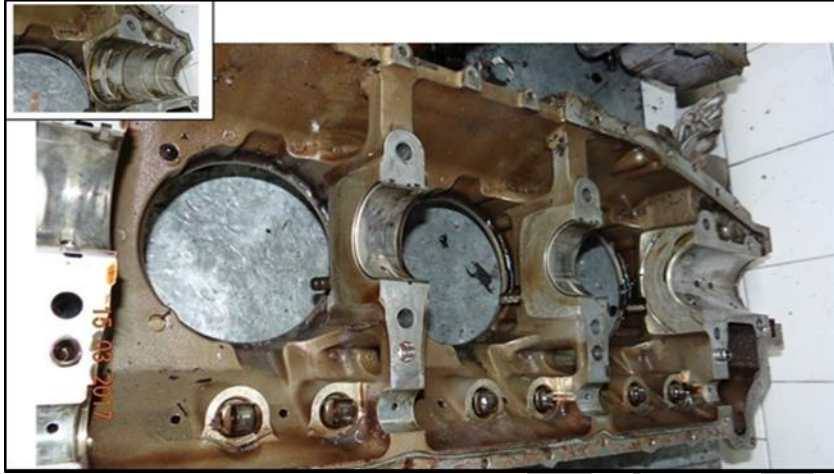
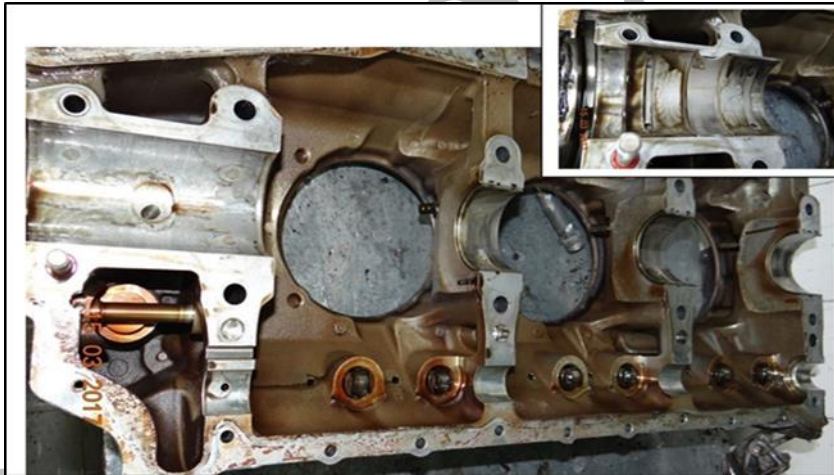
- 1 The semi-engine housings (Figures 32 and 33) were normal. No evidence of impact  
 2 damage or bearing problems was found. The front connecting rod of the engine were normal  
 3 and showed no evidence of abnormal wear or lack of lubrication.

4  
5  
6 Figure 32 - View of the right semi-engine housing and of the connecting rod in good condition.

7  
8  
9 Figure 33 - View of the left semi-engine housing and the connecting rod in good condition.

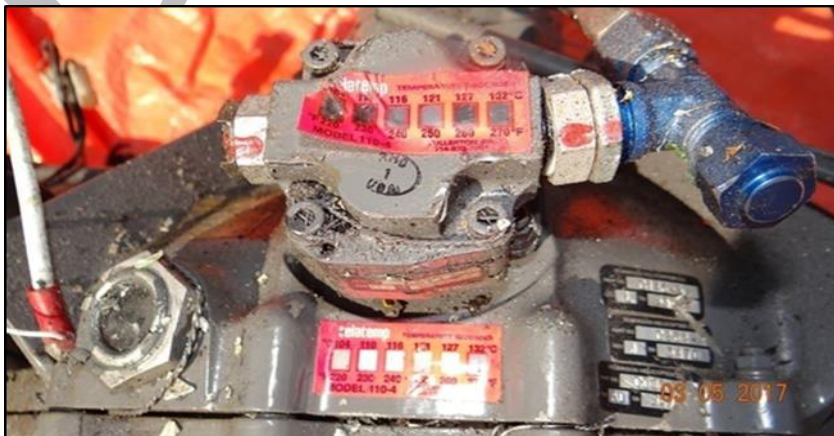
- 10 In Figure 34 we observe the local temperature indicator (Telatemp heat indicator) that  
 11 indicated high temperature in the hydraulic pump. This is why the gearbox was  
 12 disassembled.

13  
14  
15 Figure 34 - Temperature indicator (Telatemp) showing temperature increase in the hydraulic pump.

No abnormality was observed. Thus, it has been observed that the temperature excess observed in Telatemp was probably the result of heat irradiated by the engine after the accident.

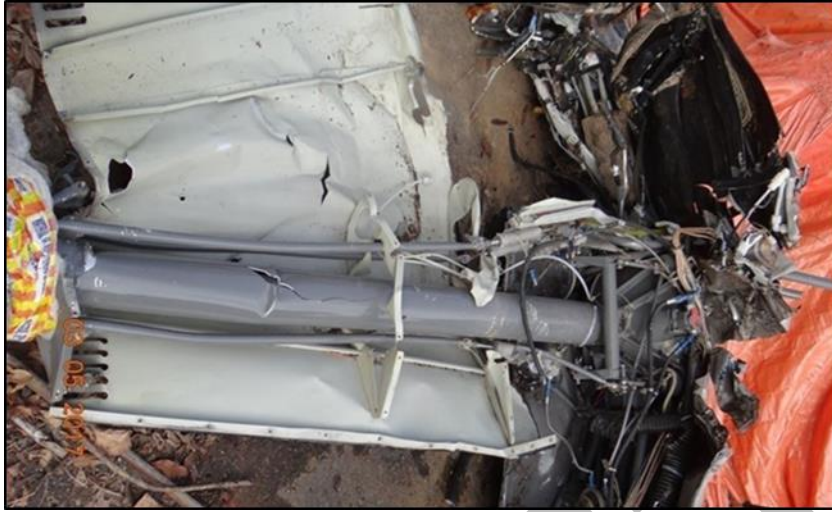
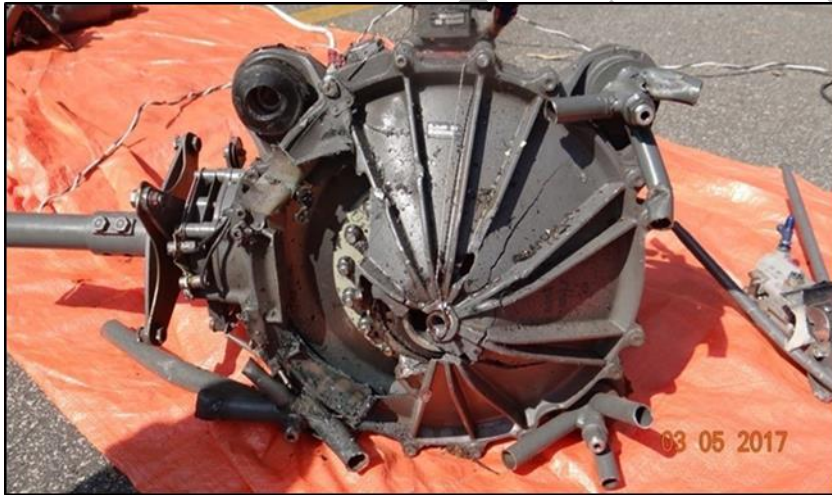
- 1 Figures 35 and 36 show the main rotor drive assembly after opening the fairing. A  
2 gearbox casing fracture was observed, due to the collision against the ground.

3  
4 Figure 35 - Overview of the transmission assembly after opening the fairing.

5  
6 Figure 36 - View of the transmission case crankcase fracture.

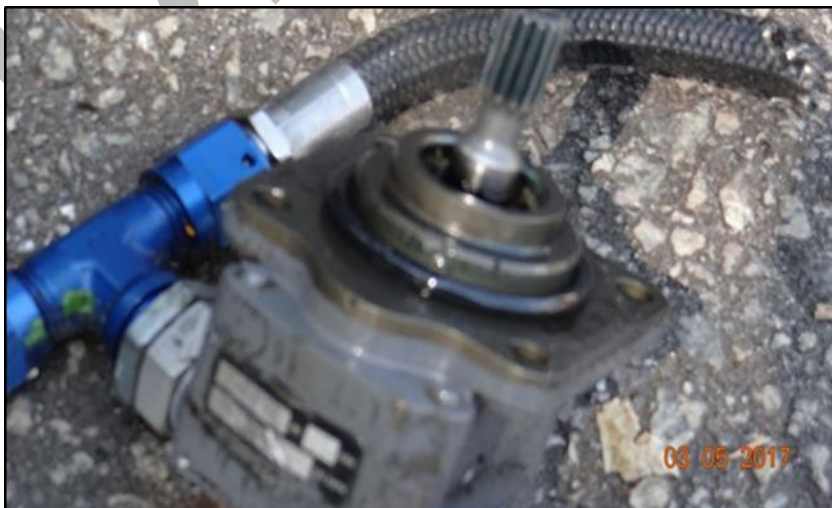
- 7 Figure 37 shows a view of the hydraulic pump, component that showed temperature  
8 increase indication (Telatemp tape).

9  
10 Figure 37 - Main gearbox hydraulic pump.

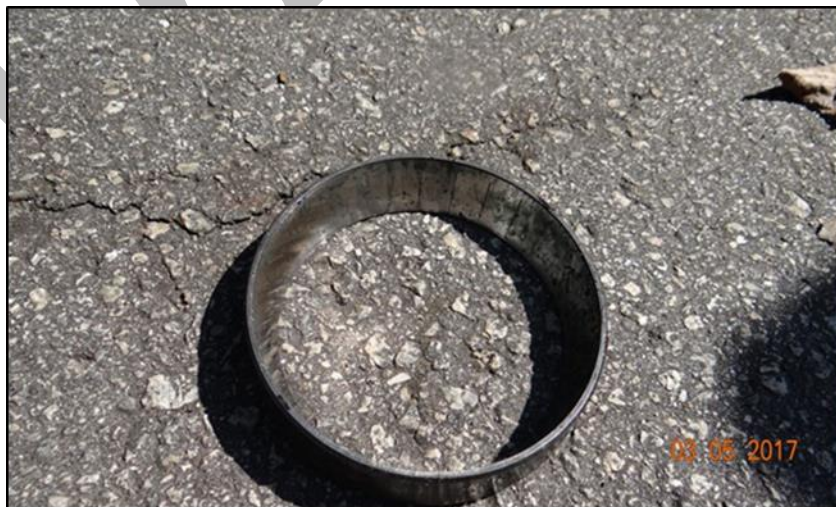
9  
10 Figure 40 - Transmission case lower bearing outer race, undamaged.
