# **COMANDO DA AERONÁUTICA**

## **CENTRO DE INVESTIGAÇÃO E PREVENÇÃO DE ACIDENTES AERONÁUTICOS**

## **FINAL REPORT A - 128/CENIPA/2017**

| <b>AIRCRAFT:</b> | <b>PR-XLX</b> |

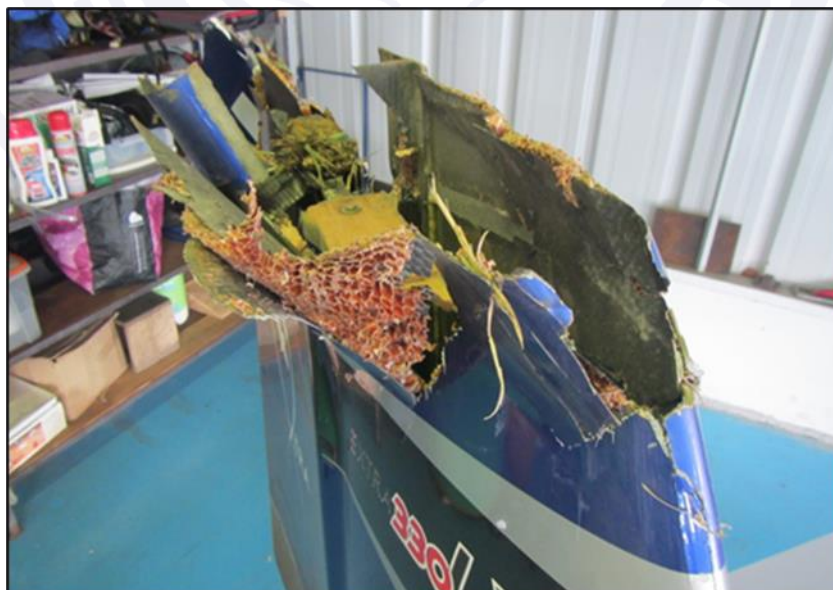
The aircraft had substantial damage to the vertical stabilizer, rudder, engine, propeller, right wing, canopy, engine hood and spinner.

Figure 1 - Damage to the vertical stabilizer and rudder.

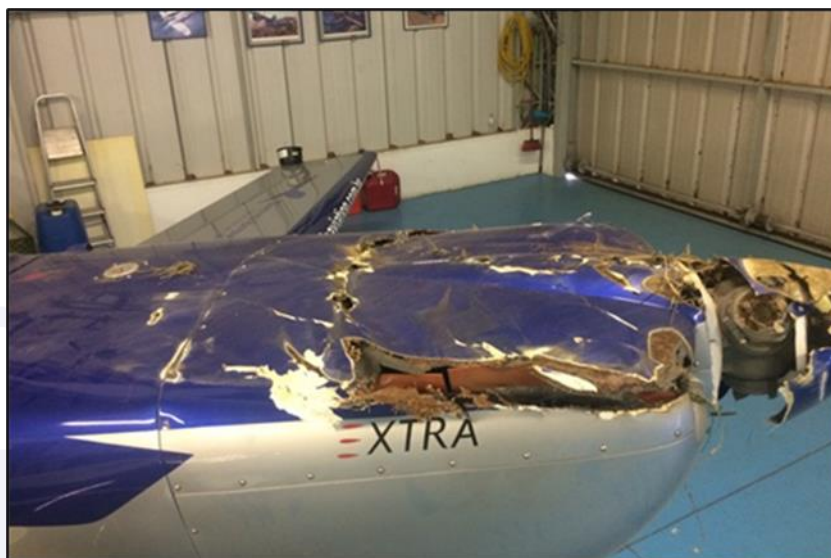
Figure 2 - Engine hood, spinner and propeller damage.

During this displacement, contact with the pavement caused damage to the propeller, which broke at the root; to the canopy; to the top of the engine hood; to the spinner and the tip of the right wing.

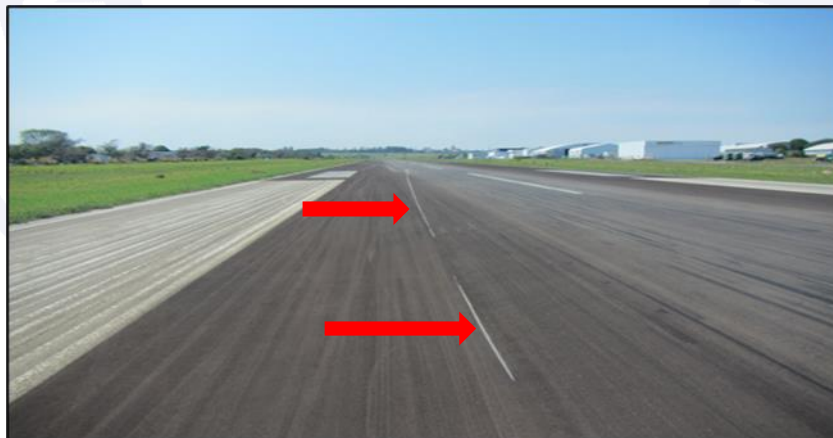
During the inverted flight, the aircraft's vertical stabilizer/rudder touched the runway asphalt.

Figure 5 - Marks left by the vertical stabilizer/rudder contact with the runway.

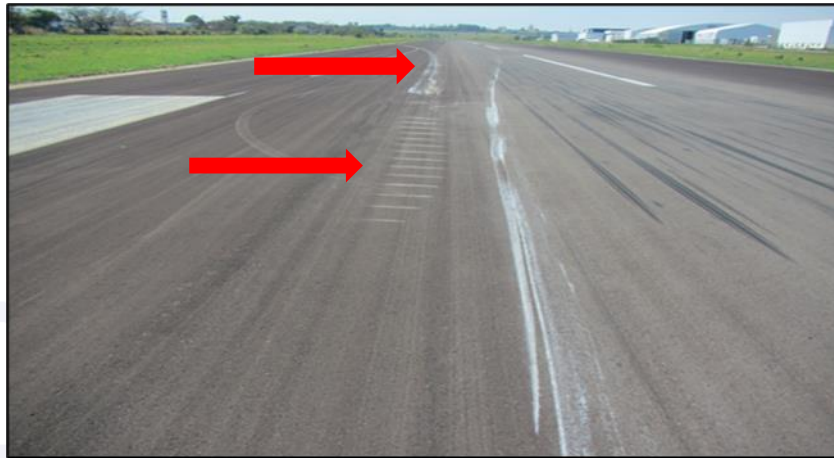
After this first contact, the propeller collided with the ground.

Figure 6 - Marks left by the contact of the rudder, propeller, engine hood, spinner and right wing with the runway.

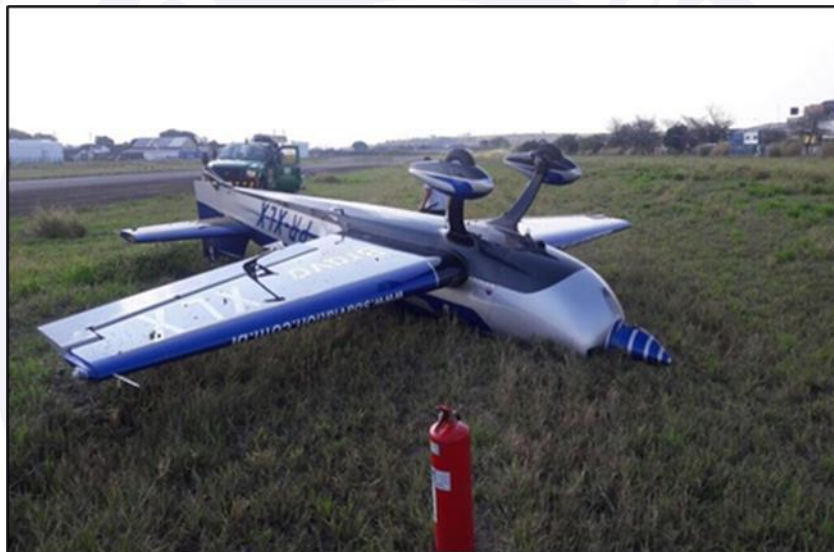
The plane dragged along the pavement, made a yaw left, overtook the runway's side limit, and stopped in the adjacent grassy area, still in the inverted position.

Figure 7 - Aircraft after a total stop.

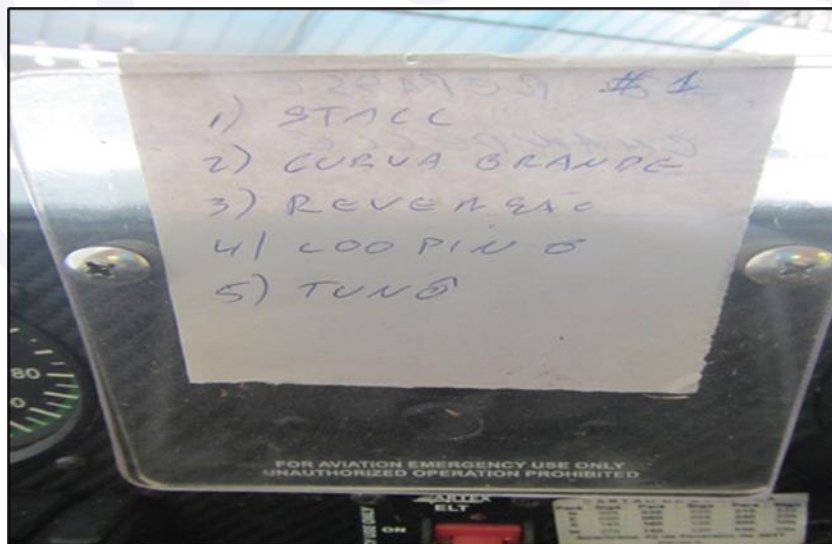
It was the first flight of the day, in which a sequence of maneuvers and acrobatics would be trained, as shown in the list in Figure 8.

Figure 8 - Flight sequence fixed on the aircraft panel.
