**COMANDO DA AERONÁUTICA**  
**CENTRO DE INVESTIGAÇÃO E PREVENÇÃO DE**  
**ACIDENTES AERONÁUTICOS**

**FINAL REPORT**  
**A-078/CENIPA/2016**

| <b>AIRCRAFT:</b> | <b>PR-YCB</b> |
| <b>MODEL:</b> | <b>AS 350 B2</b> |

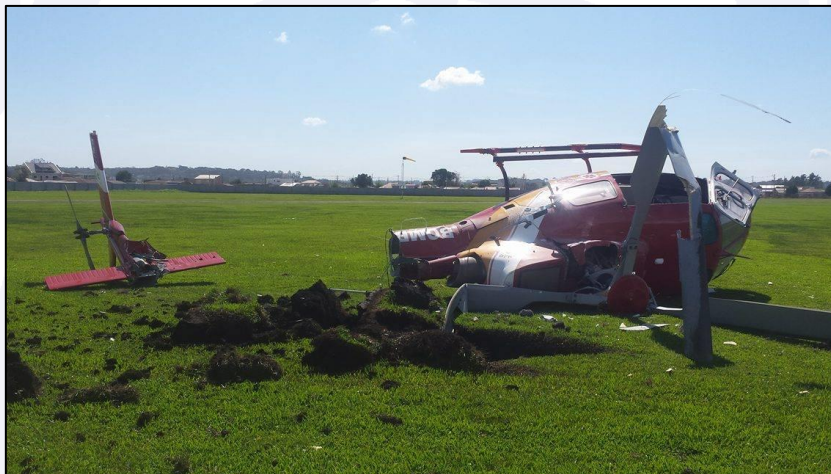
Figure 1 - Overview of the aircraft after the accident.

Sectioning of the tail cone and its transmission, breaking of the main rotor blades and breaking of the right windshield.

The wreckage (sectioned tail cone, bent main rotor blades and broken right windshield) were distributed radially in a fan position.

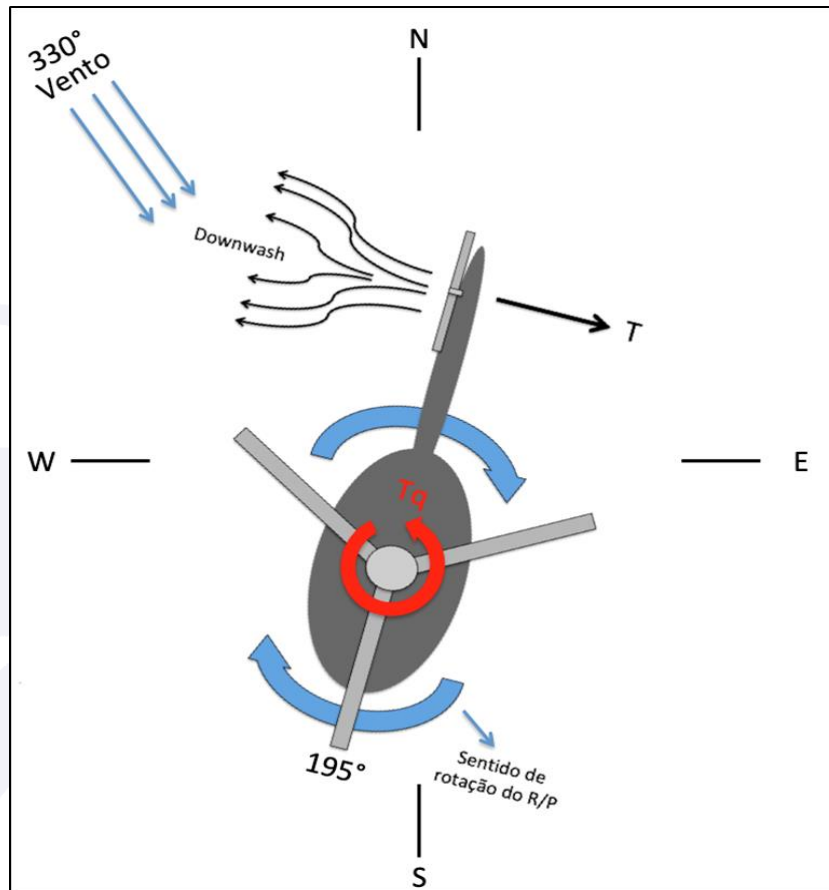
Figure 2 - Diagram of the positioning of the helicopter at take-off.

The estimated wind in the Aerodrome came predominantly from the direction 330° (NO). However, the aircraft was positioned with the nose steered in the 195° (SO) magnetic direction. In this condition, the helicopter was subjected to a tail wind component, as shown in Figure 2.

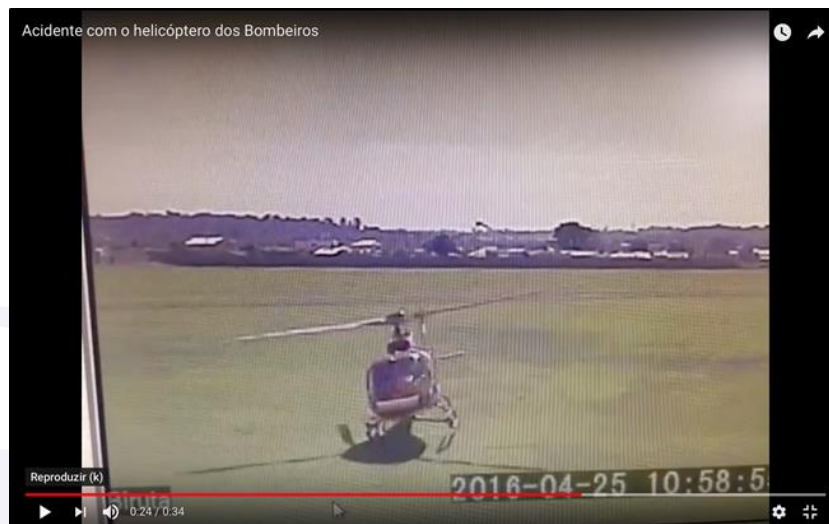
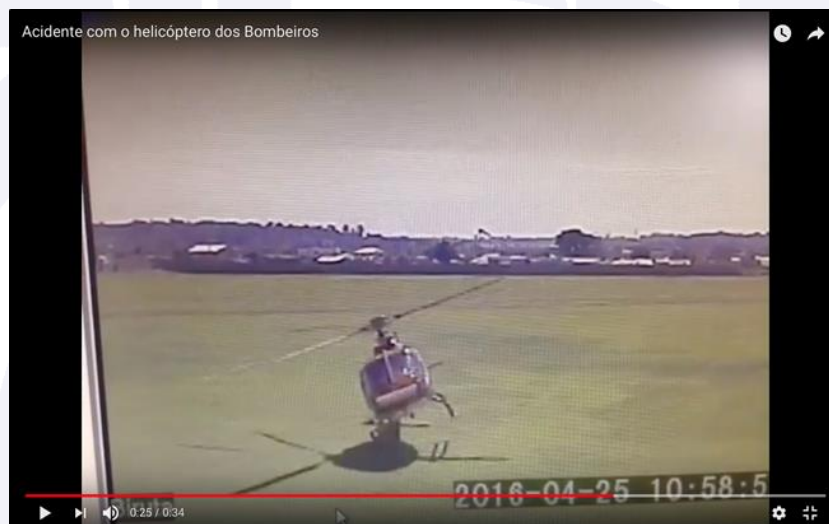
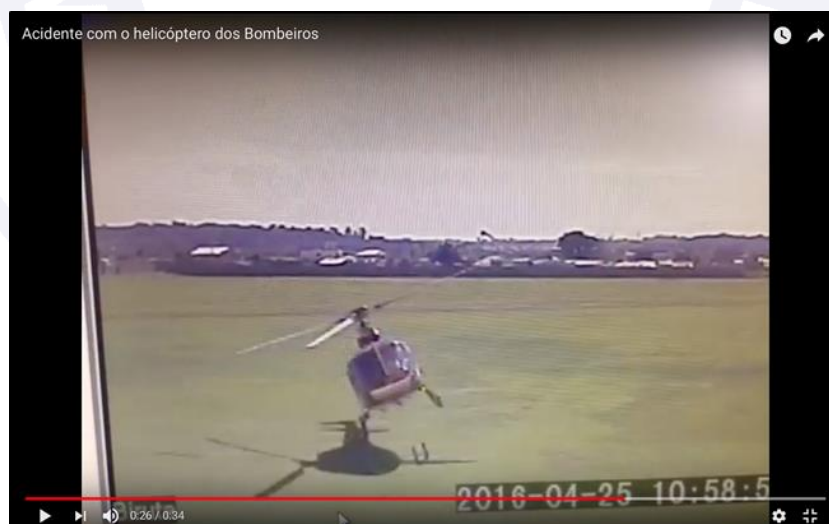
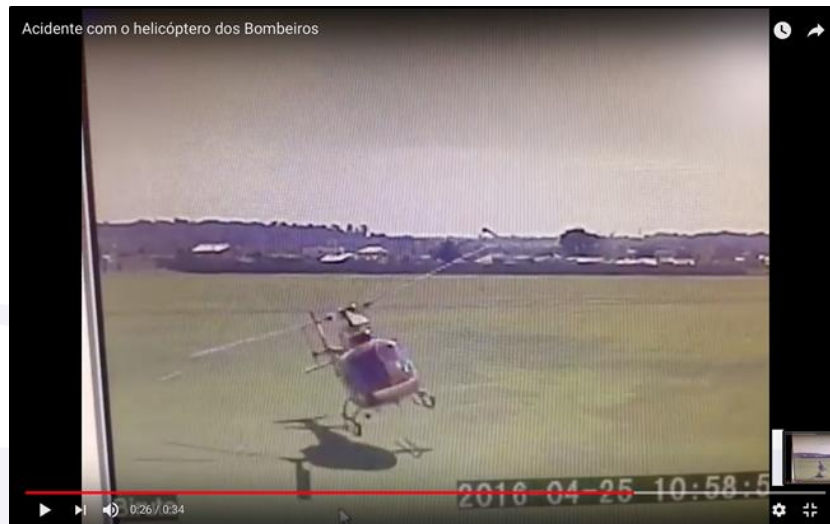
The recorded images showed that the left ski of the aircraft left the ground before the right ski, generating a slope to the right. In addition, the images showed that the nose of the helicopter started a left turn (right tail), as shown in Figures 3, 4, 5 and 6.

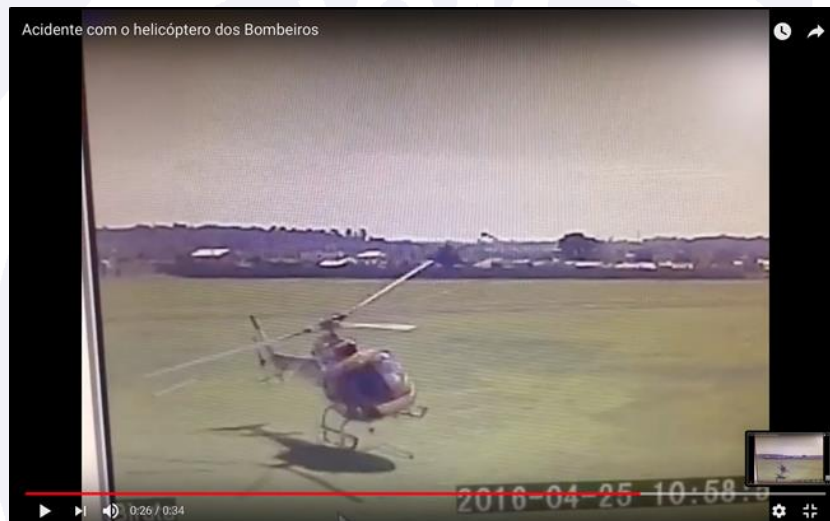
Figure 7 - Sequence of vertical take-off events.

Figure 7 shows the instant when the right ski left the ground. At that time, the aircraft was tilted to the right and turned nose to the left (right tail).

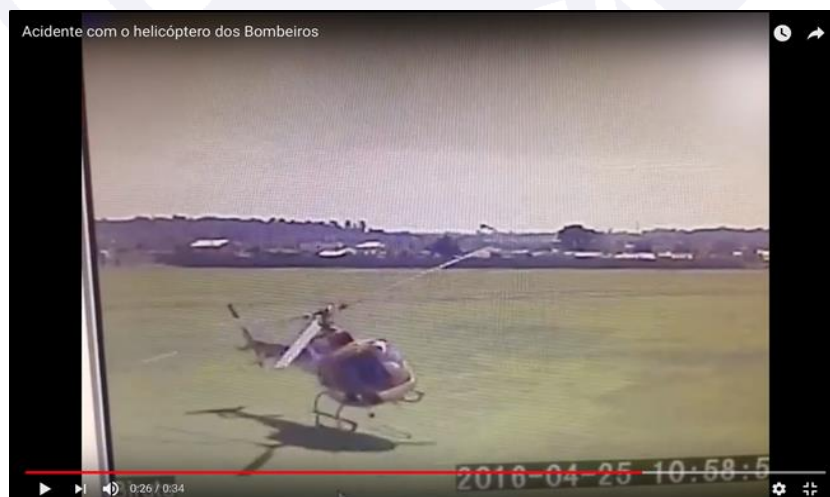
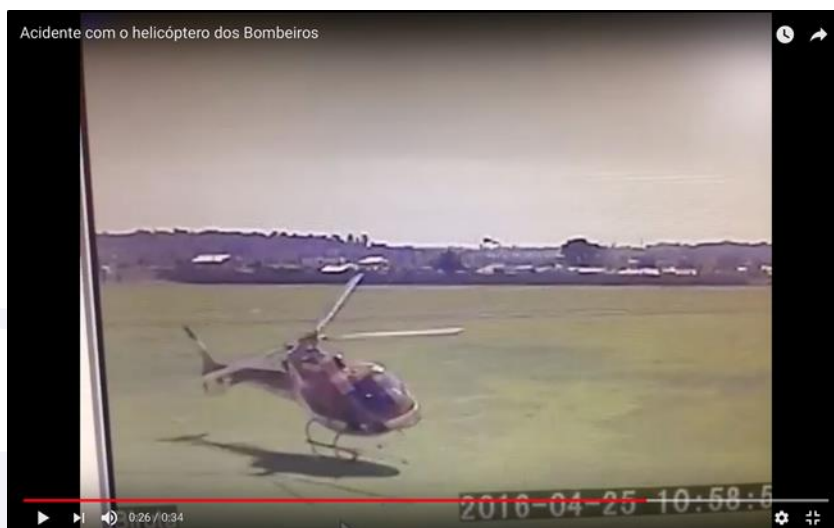
From that moment on, the right tilt and the nose turn to the left intensified, as shown in Figures 8 and 9.

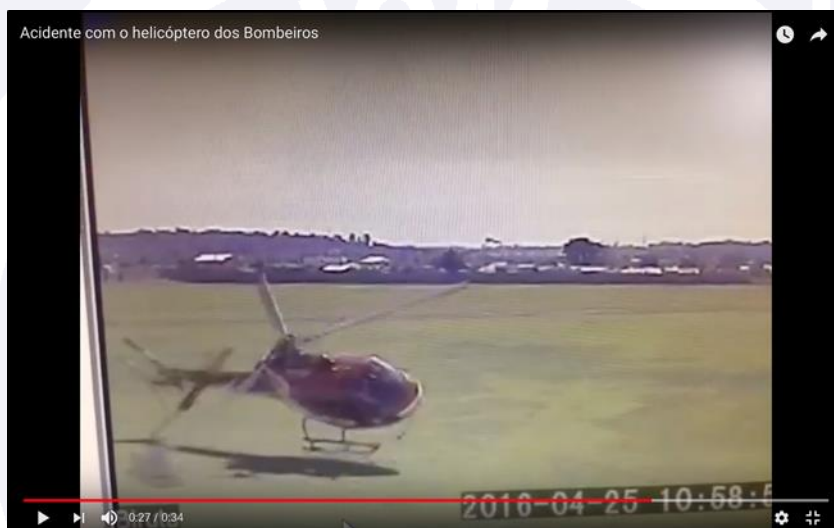
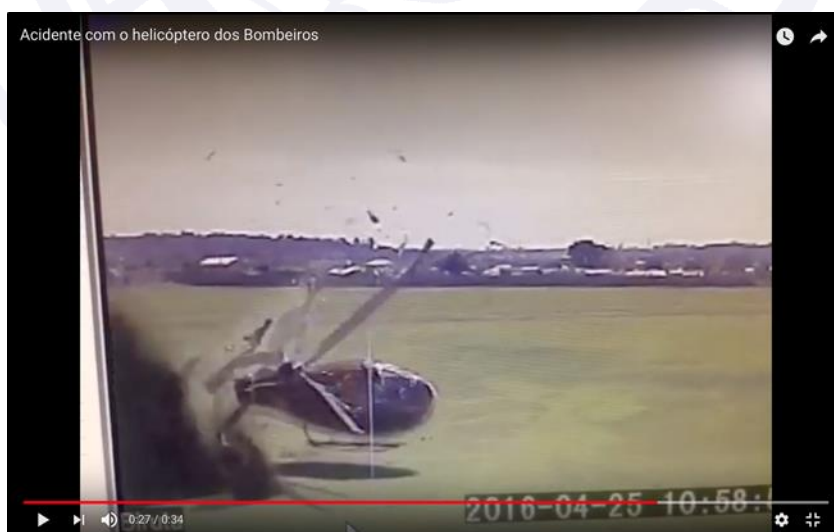
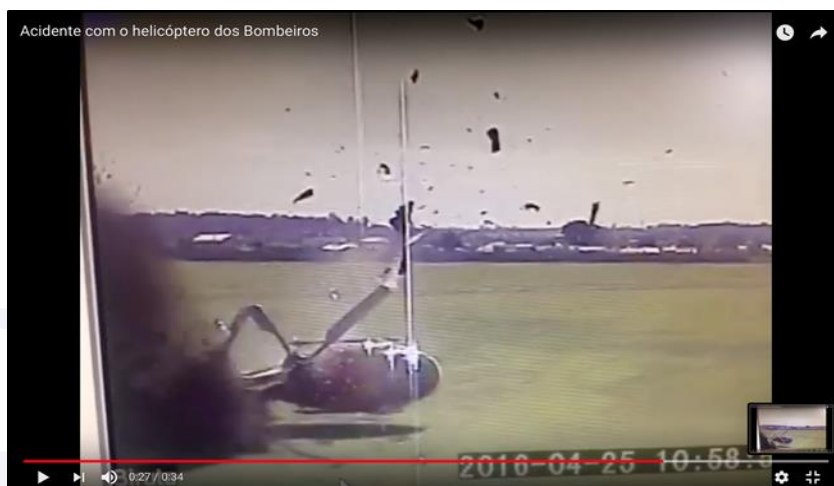
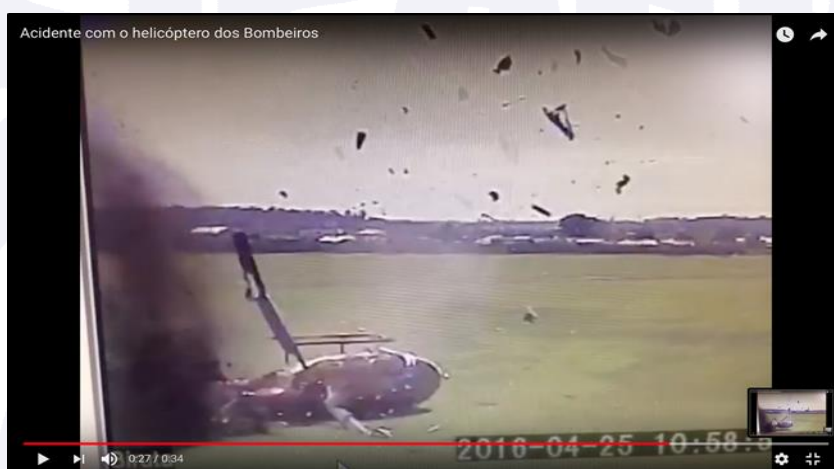
In Figures 10, 11, 12 and 13 it is observed that the blades of the main rotor collided against the lawned ground.

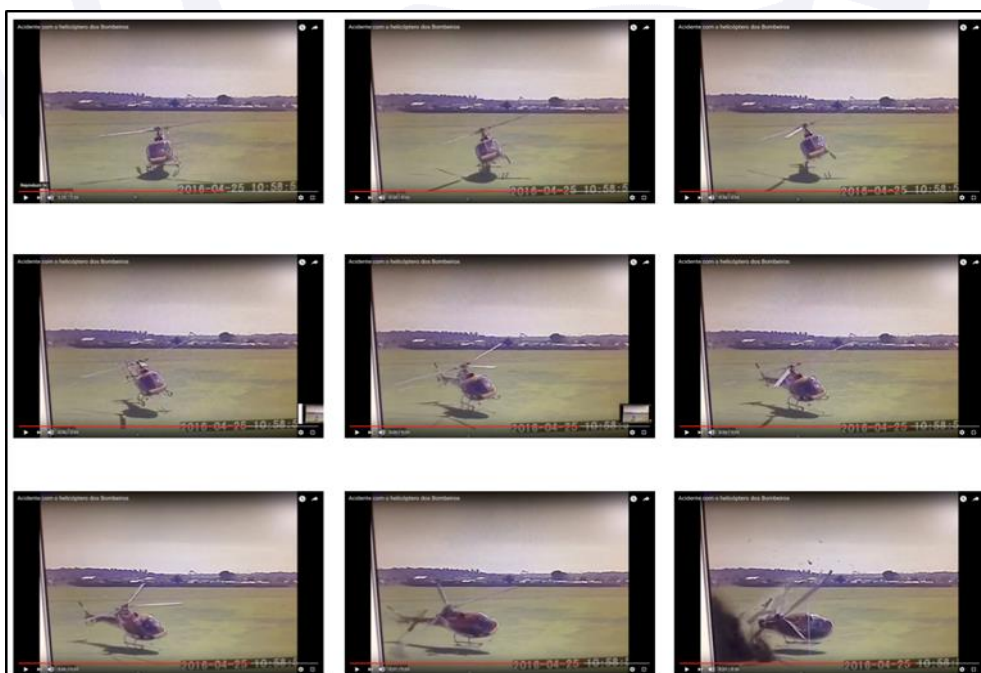
Figure 14 - Photos of the sequence of vertical take-off events arranged side by side.

By placing the photos side by side, it is possible to more clearly visualize the take-off dynamics that culminated in the accident (Figure 14).
