FINAL REPORT
IG - 191/CENIPA/2018

OCCURRENCE:	SERIOUS INCIDENT
AIRCRAFT:	PR-AQZ
MODEL:	ATR-72-212A
DATE:	23DEC2018

This is the Final Report of the 23DEC2018 serious incident with the ATR-72-212A model, registration PR-AQZ. The serious incident was classified as “[F-NI] Fire/Smoke (Non-Impact) – Smoke in the Cockpit”.

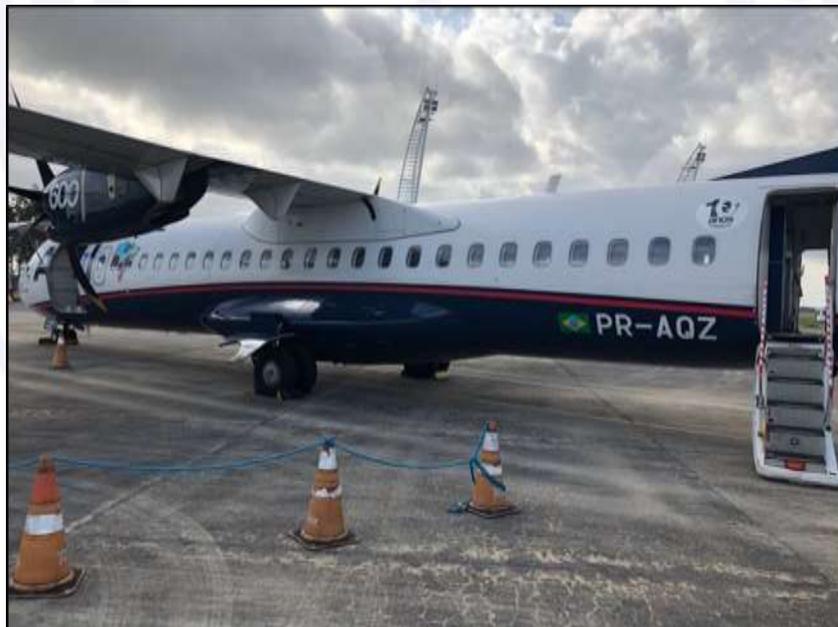
Figure 1 - Aircraft after parking.

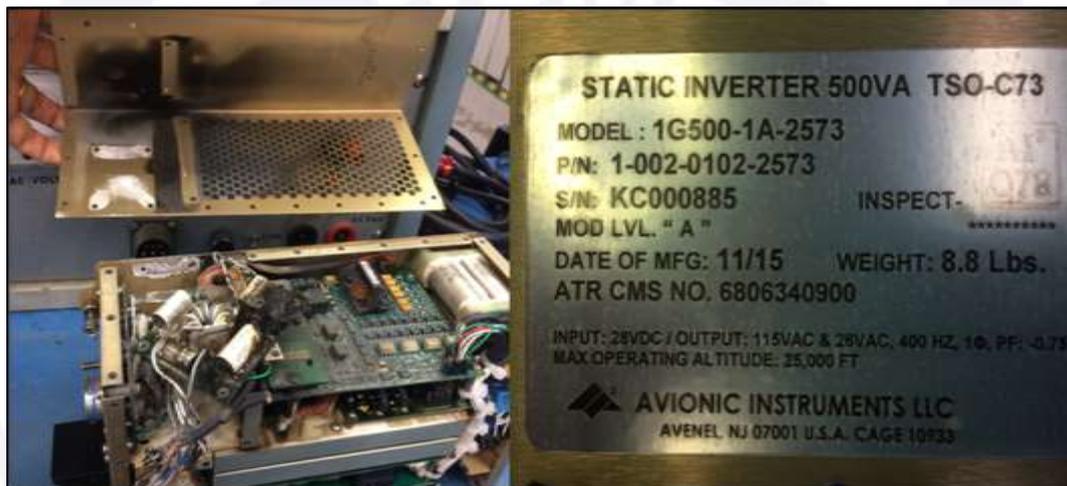
Figure 2 - Static Inverter immediately after the opening of the enclosure.

Capacitor C601 was excessively damaged and it was not possible to test it by X-ray, nor to verify the other functional characteristics. No physical damage was found on the other tested capacitors or on the board.

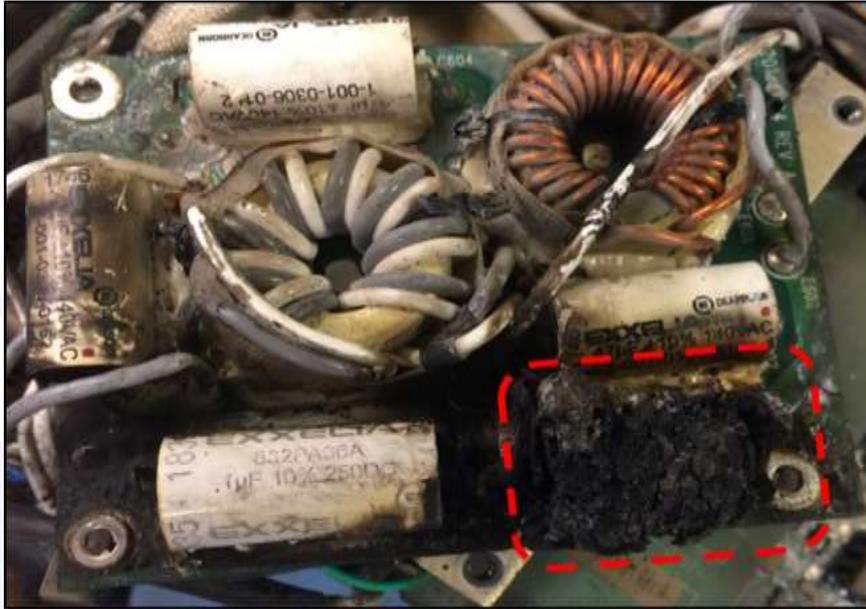
Figure 3 - Detail printed circuit board for severely damaged capacitor C601.

It was found that the component that gave rise to the sparking reported by the pilots and the smoke that took over the cockpit was the capacitor C601 that was installed on a printed circuit board of the referred inverter.

An overheating occurred which resulted in the capacitor partially melting followed by the production of large amounts of smoke.

The capacitor state (Figure 3) allowed deducting that there was an overheating, with partial melting, followed by the large amount of smoke production.

Considering the tests performed, the data found during the #1 inverter disassembly and interactions with representatives of design and manufacturing sectors, it was considered that the possible cause of the C601 capacitor failure was related to the absorption of a transient high current.

The identified scenario would have caused overheating enough to degrade the existing dielectric layers within the C601 capacitor structure.

Transient absorption could be related to an excessive level of the Equivalent Series Resistance (ESR) characteristic of the referred capacitor or the high level of transient current, or a combination of these two phenomena.

Due to the possibility that the failed C601 capacitor is from a batch of material with the date code of 1835 which may have out of range ESR characteristics, Original Equipment Manufacturer (OEM) took the following corrective action:

A square wave test have been implemented to the test protocol to help ensure capacitor robustness. A retrofit campaign has been launched for all units equipped with capacitor from this batch.
