FINAL REPORT
IG - 062/CENIPA/2018

OCCURRENCE:	SERIOUS INCIDENT
AIRCRAFT:	PR-GGE
MODEL:	737-8EH
DATE:	06APR2018

This is the Final Report of the 06APR2018 serious incident with the 737-8EH aircraft, registration PR-GGE. The serious incident was classified as “[SCF-NP] System/Component Failure or Malfunction Non-Powerplant / Unintentional/explosive decompression”.

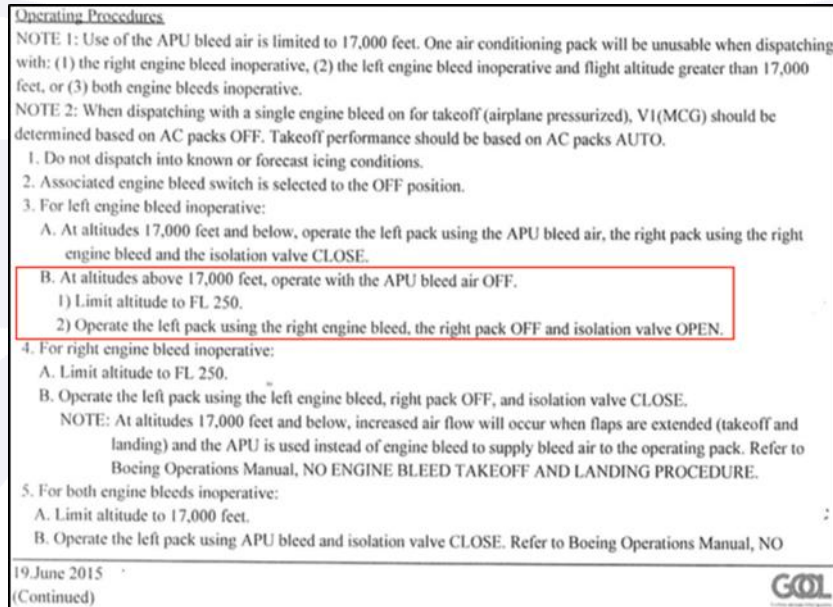
During this briefing, the pilots correctly consulted the MEL by reading the operating procedures for item 36-5-2, step 3, letter "B" (For left engine bleed inoperative) shown in Figure 4. Both pilots agreed verbally that according to MEL procedures, Bleed 2 would be used to supply air bleed to Pack 1 and for this, Isolation Valve should remain in the OPEN position during the flight at cruising altitude.

Figure 4 - MEL Item 36-5-2, highlighting step 3, letter "B".

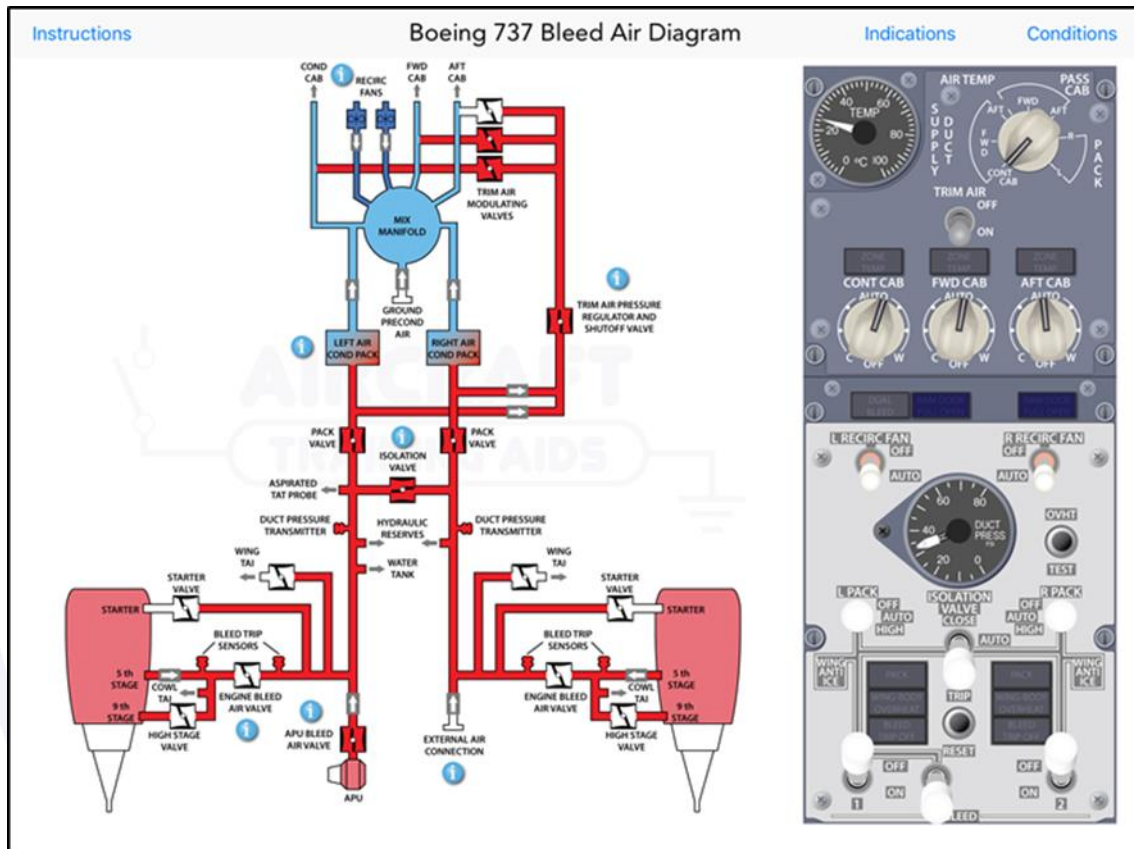
Upon taking off in this configuration, the aircraft began to be pressurized by APU's Bleed, which fed both Packs, as shown in Figure 7.

Figure 7 - Pressurizing panel, as configured for taxi start. In this configuration, the APU Bleed was powering the Packs.

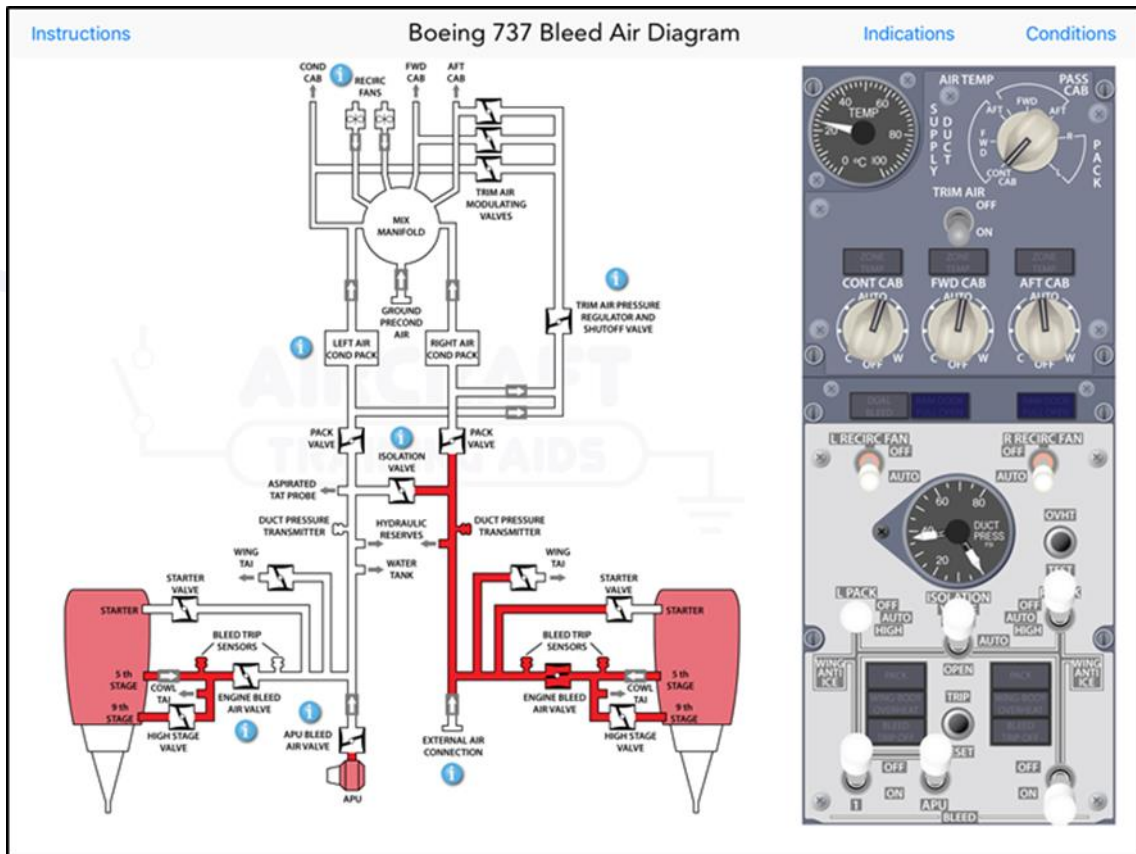
Figure 8 - Pressurization panel, as configured after take-off. In this configuration, none of the Packs was being powered.

In this configuration, with the Isolation Valve closed, Bleed 2, despite being in the ON position, was not providing bleed air to Pack 1 and could not cause the bleed air of engine 2 to power Pack 2, as this Pack was in the OFF (closed) position.

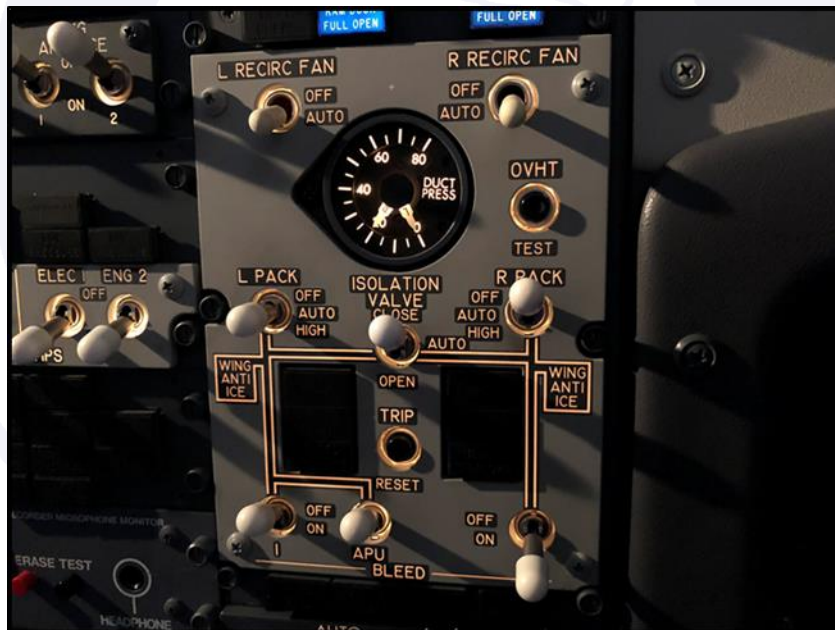
Figure 9 - Pressurization panel of a B737-800 flight simulator, reconstituting the configuration adopted after take-off.

It is noted in Figure 9 that the pointer corresponding to the left duct (identified with the letter "L") was set to zero in that configuration. This indicated that the duct on that side was not pressurized and that the Pack on the left side was not receiving bleed air from any source.

The pilots did not check an important instrument, the manometer that indicated the pressure in the ducts. This instrument was indicating pressure equal to "zero" on the pointer with the letter "L" (left duct). This information, if observed, would show pilots that there was no pressurized air in the left duct, which would be indicative that Pack 1 was not receiving bleed air from any source.

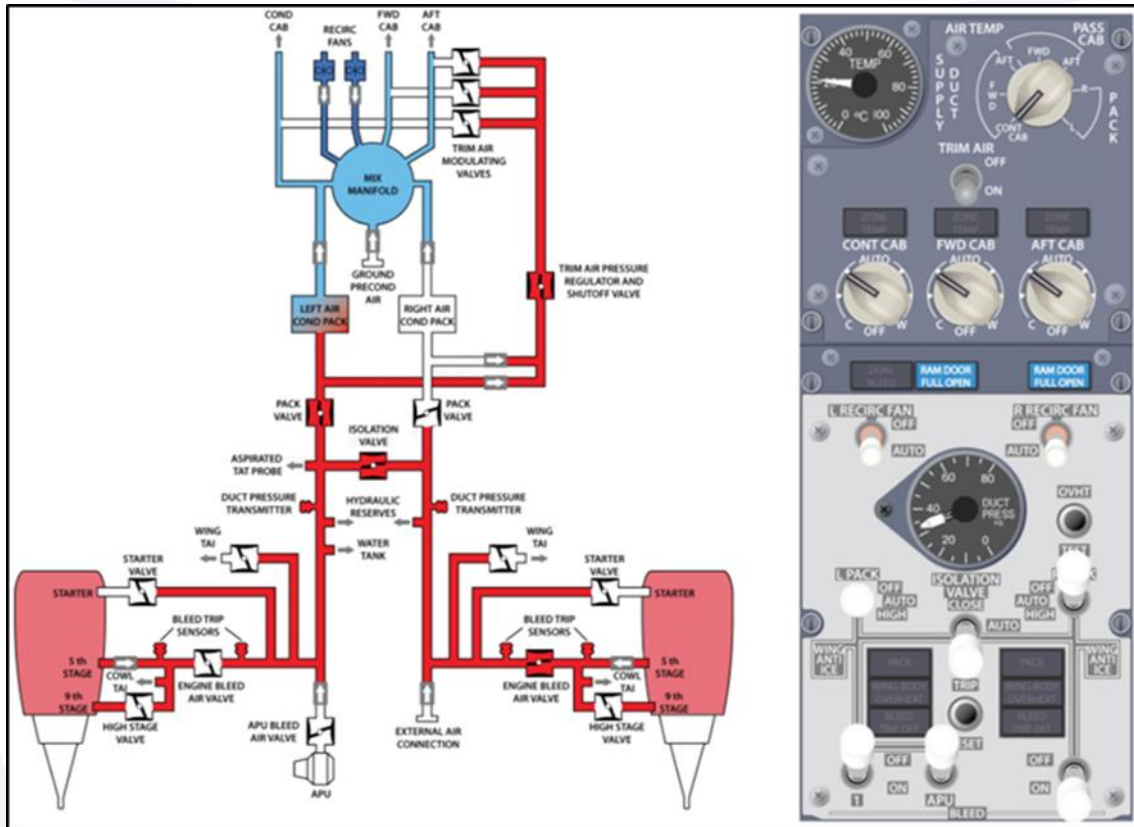
Figure 10 - Pressurization panel, as recommended by MEL item 36-5-2, step 3, letter "A" (For left engine bleed inoperative). In this configuration, Pack 1 would be powered by Bleed 2.
