COMANDO DA AERONÁUTICA
CENTRO DE INVESTIGAÇÃO E PREVENÇÃO DE
ACIDENTES AERONÁUTICOS

FINAL REPORT
A - 004/CENIPA/2017

OCCURRENCE:	ACCIDENT
AIRCRAFT:	PR-GRS
MODEL:	172S
DATE:	05JAN2017

This is the Final Report of the 05JAN2017 accident with the 172S aircraft, registration PR-GRS. The accident was classified as “[CTOL] Collision with Obstacle during Take-Off and Landing”.

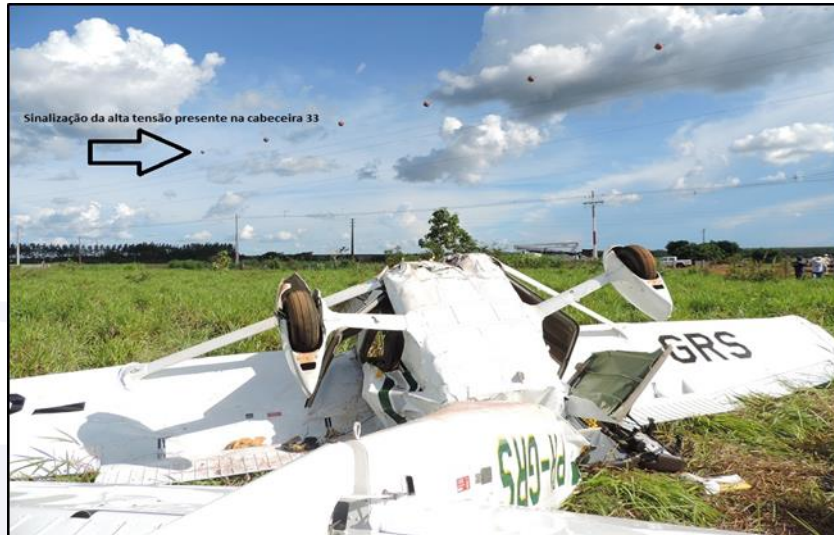
There was a power line near SDVI threshold 33. This line had orange signs (Figure 1).

Figure 1 – Power line near the threshold 33 of SDVI.

The power line had orange signs, so that they could be viewed during, for example, an aerodrome check pass.

However, as reported by survivors, the approach was direct to landing and, possibly, this signaling was not seen by the pilot.

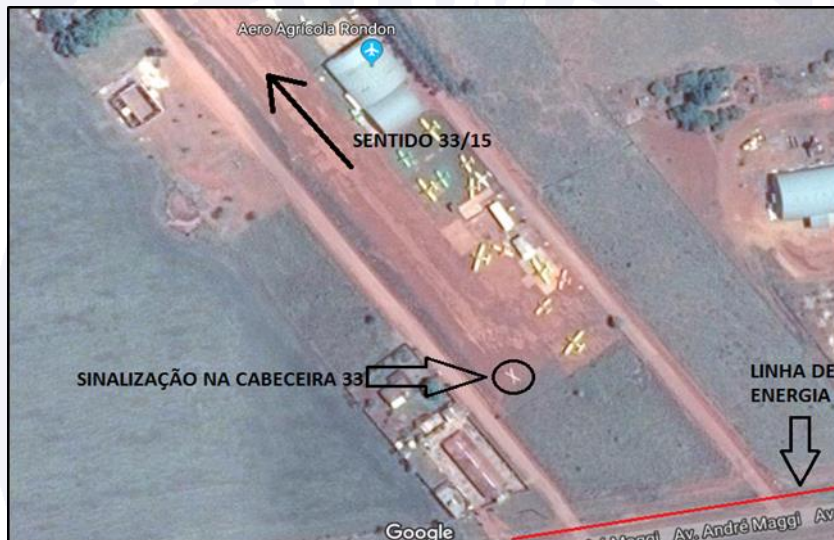
At threshold 33 there was an "X" marking, which was inserted by the Aerodrome administrator to indicate that landing at that threshold was not available (Figures 2 and 3).

Figure 2 - Air view of the "X" marking at threshold 33.

At threshold 33 of the aerodrome, there was an "X" mark, which was inserted by the aerodrome administrator to indicate that landing at that threshold would be impracticable. However, this information was not included in the current ROTAER, since there was no request for inclusion by the aerodrome administrator to the competent body.

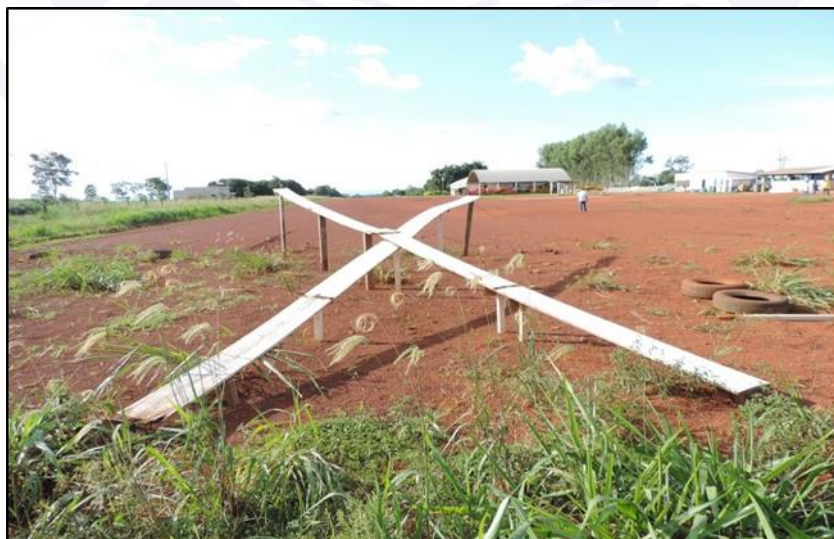
Figure 3 - "X" marking at SDVI threshold 33.

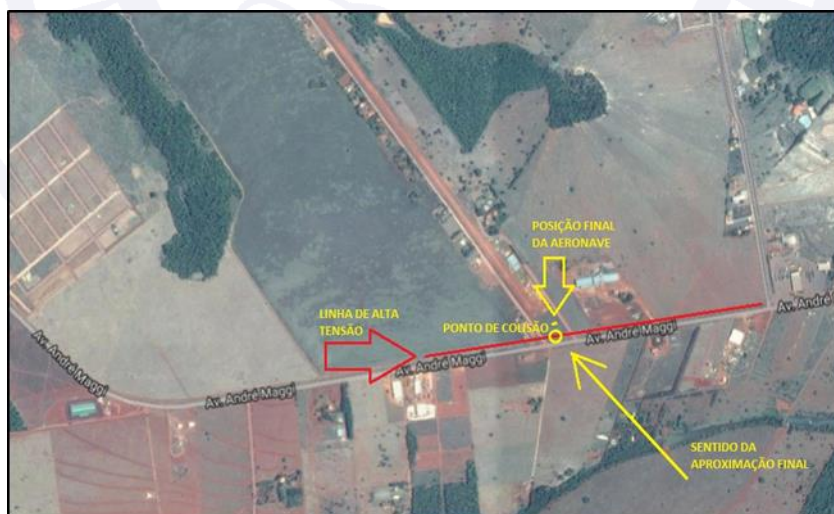
The first impact occurred against the power line near the threshold 33 of SDVI. The aircraft was in the normal attitude of a final approach. After the impact, the aircraft appeared to have a pitch down attitude, apparently without control.

The second impact occurred against the ground, near the threshold 33, maintaining an angle of approximately 135° to the axis of the runway (Figure 6).

Figure 6 - Diagram of the accident.

The wire provided sufficient resistance to cause loss of control of the aircraft, leading to lowering of the nose.

Due to the proximity to the ground, there was no time for the pilot to correct the attitude of the pitch flight, resulting in the collision against the ground.
