**FINAL REPORT**  
**A - 063/CENIPA/2017**

<b>OCCURRENCE:</b>	<b>ACCIDENT</b>
<b>AIRCRAFT:</b>	<b>PR-LPW</b>
<b>MODEL:</b>	<b>172N</b>
<b>DATE:</b>	<b>14APR2017</b>

This is the Final Report of the 14APR2017 accident with the 172N aircraft, registration PR-LPW. The accident was classified as “[CTOL] Collision with Obstacle during Take-Off and Landing”.

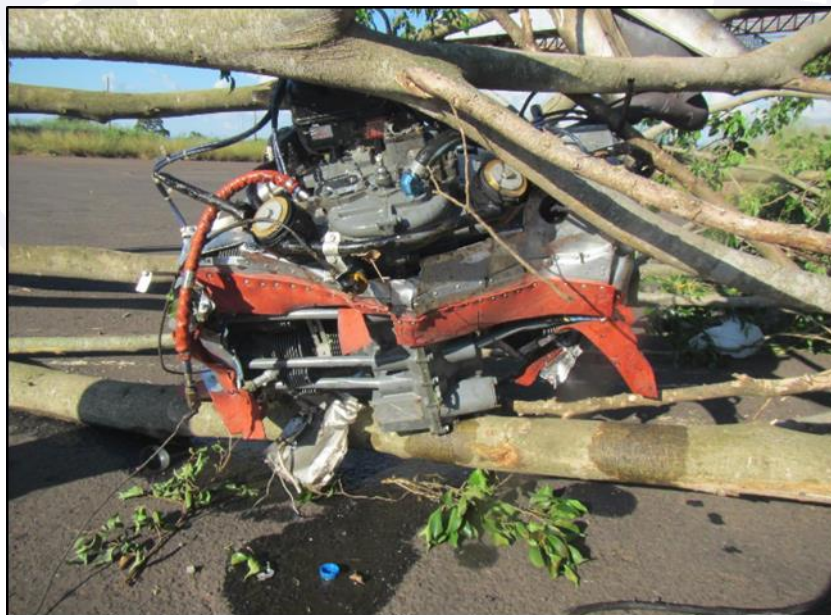
The plane crashed into a tree with considerable energy. The aircraft had substantial damage. The engine got detached from the airframe and was thrown ahead (Figure 1).

Figure 1 - Engine that got detached from the aircraft.

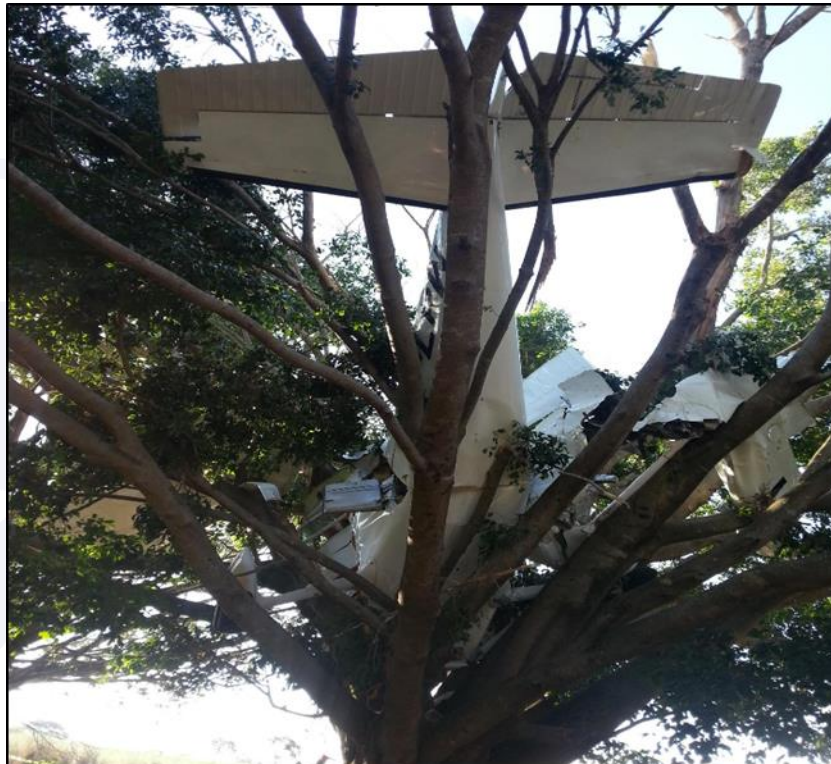
The fuselage was damaged to its full extension. The landing gear had considerable damage.

The cabin was destroyed and the aircraft instrument panel and its equipment had severe damage. The wings had significant damage, but did not detach from the rest of the structure. The wreckage of the aircraft remained attached to the tree branches (Figure 2).

Figure 2 - Aircraft after the occurrence.

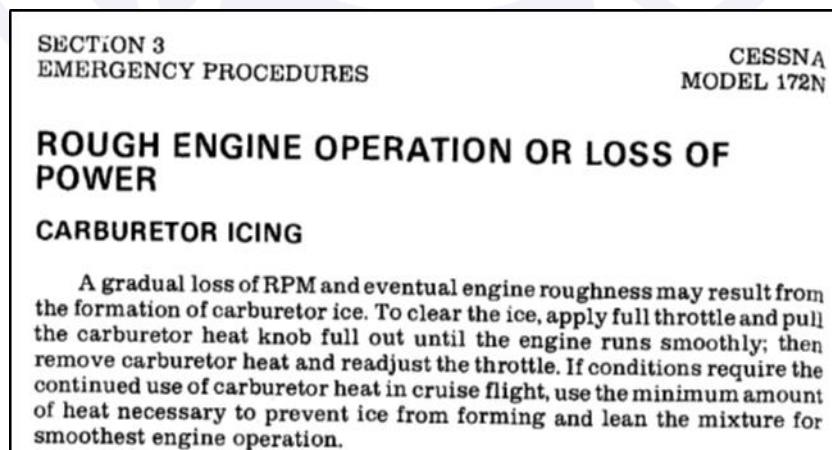
According to the Cessna 172N Pilot's Operating Handbook, Section 3 - Emergency Procedures, a gradual loss of RPM could be caused by ice formation in the carburetor. In this case, the pilot should position the carburetor heat switch to the ON position (Figure 3).

Figure 3 - Cessna 172N Pilot's Operating Handbook Excerpt.

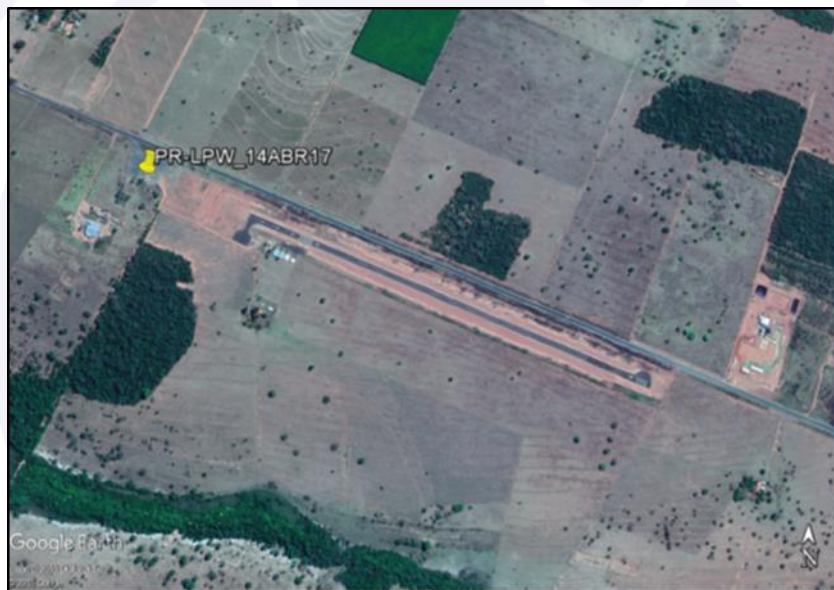
The impact occurred in the final for SSCL runway 13. The aircraft crashed into a tree and remained in that position.

Figure 4 - Location of the occurrence.

Fuel was scattered around the place where the aircraft crashed, signaled by the vegetation color.
