COMANDO DA AERONÁUTICA
CENTRO DE INVESTIGAÇÃO E PREVENÇÃO DE
ACIDENTES AERONÁUTICOS

FINAL REPORT
IG - 155/CENIPA/2017

OCCURRENCE:	SERIOUS INCIDENT
AIRCRAFT:	PR-MBG
MODEL:	A320-232
DATE:	30NOV2017

This is the Final Report of the 30NOV2017 serious incident with the A320-232 aircraft model, registration PR-MBG. The serious incident was classified as “[OTHR] Other / Caused by in-flight weather phenomenon and [RE] Runway Excursion”.

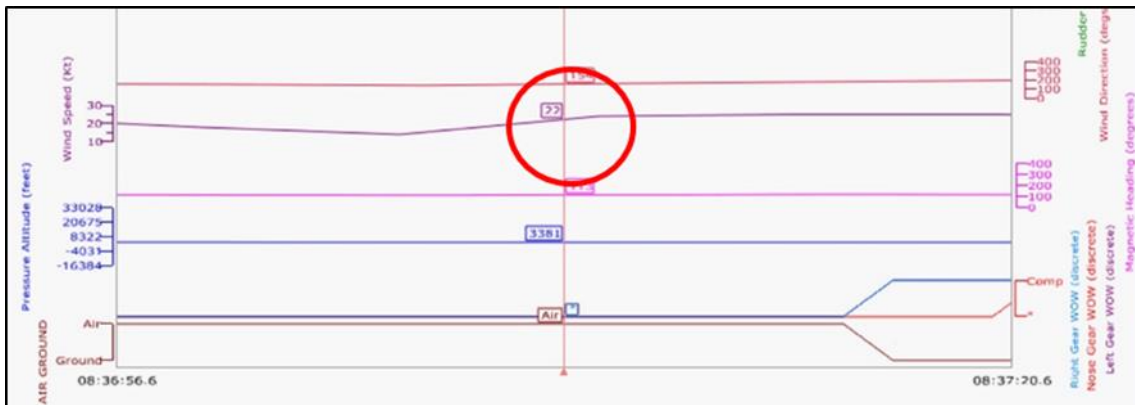
According to the data recorded in the SSFDR, ten seconds before landing, the wind direction was 154° and the intensity was 22kt (Figure 5), at the time of landing, the direction had changed to 181° and the intensity increased to 25kt (Figure 6).

Figure 5 - Wind ten seconds before touch (154° / 22kt).

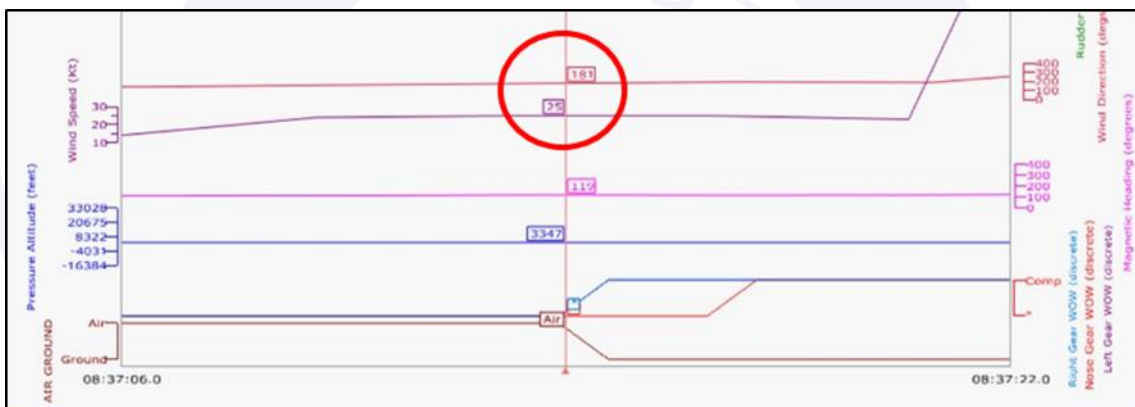
Figure 6 - Wind at the moment of touch (181° / 25kt).

- left pedal control, at about 30ft RA, in order to align the fuselage with the runway axis, followed by right pedal controls, associated with an increase of 10kt in the lateral wind component just before the touch. These data are consistent with the left lateral displacement of the aircraft during landing, which caused the tires of the left main landing gear to collide with four runway beacon lights, in addition to damage to four electrical boxes.

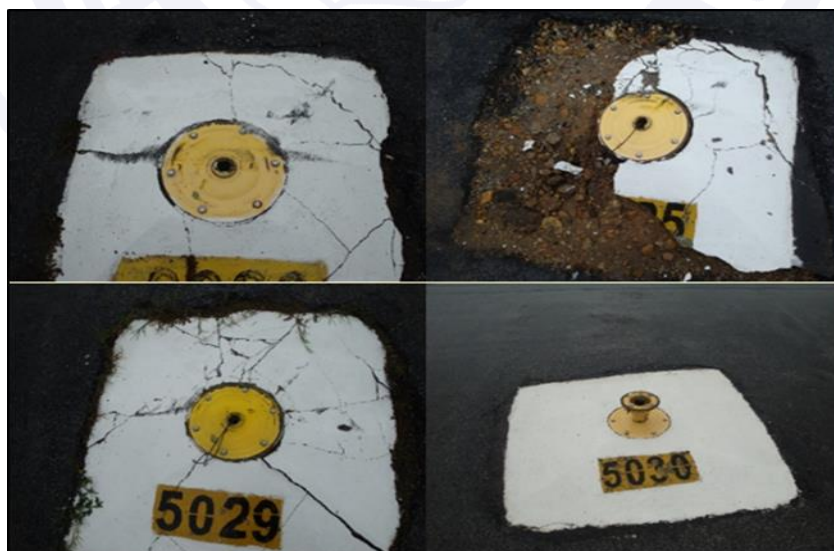
During landing, there was an impact between the tires of the left main landing gear, wheels numbers one and two, and four side markings on the runway 11L / 29R (Figures 7 and 8).

Figure 7 - Damage to the vertical markings of runway 11L.

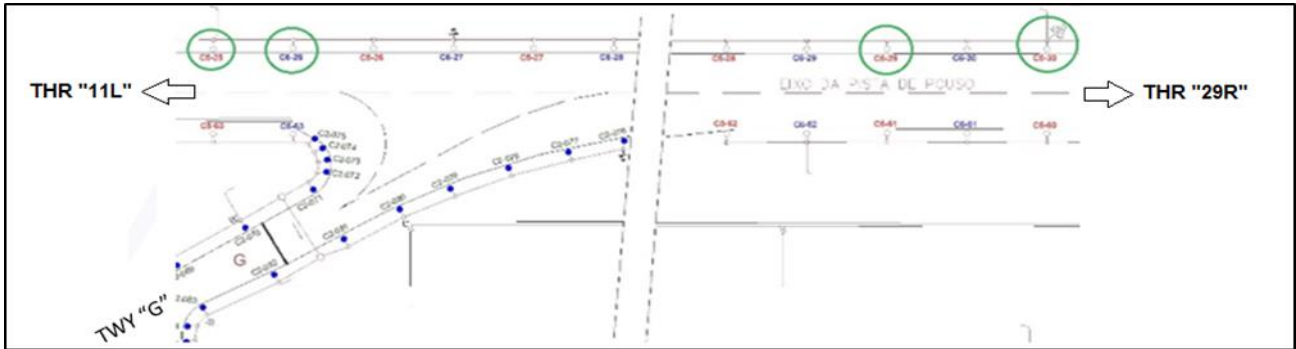
Figure 8 - Sketch with the positioning of the damaged markings.
(Source: Google Earth).

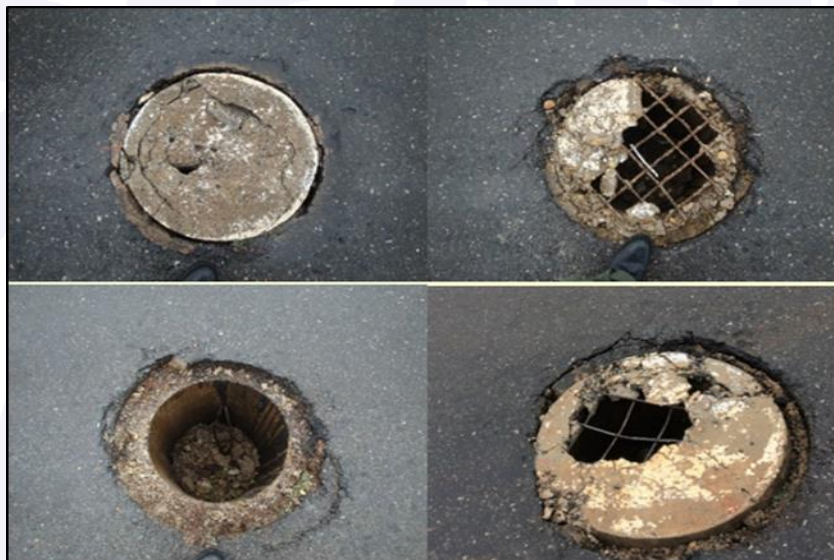
Due to the passage of the wheels of the left landing gear out of the runway, there were also failures in four electrical passage boxes (Figure 9).

Figure 9 - Damaged electrical passage boxes.

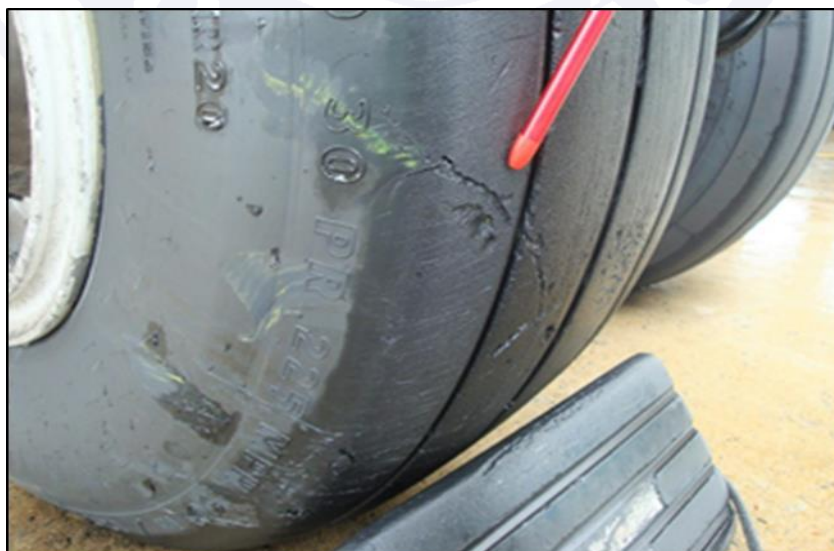
The aircraft had minor damage restricted to the tires of the left main landing gear, wheels nº 1 and nº 2.

Figure 10 - Damage to the tire of the left main landing gear.
