FINAL REPORT
A - 020/CENIPA/2021

OCCURRENCE:	ACCIDENT
AIRCRAFT:	PS-EBI
MODEL:	DA 62
DATE:	04FEB2021

This is the Final Report of the 04FEB2021 accident with the DA 62 aircraft model, registration PS-EBI. The accident was classified as “[LOC-G] Loss of Control on the Ground and [RE] Runway Excursion”.

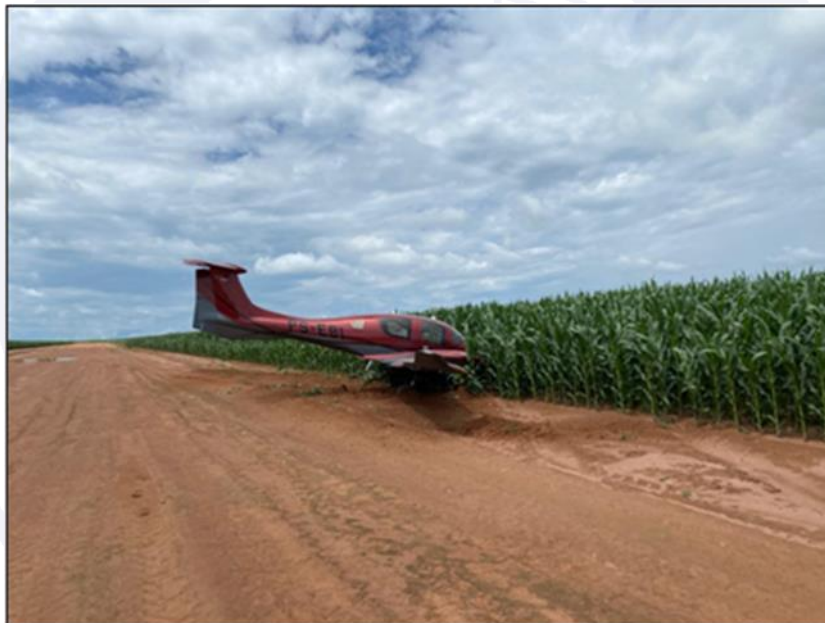
The aircraft yawed approximately 90° to the left and stopped with the front part in the cornfield.

Figure 1 - Image of the aircraft after a complete stop.

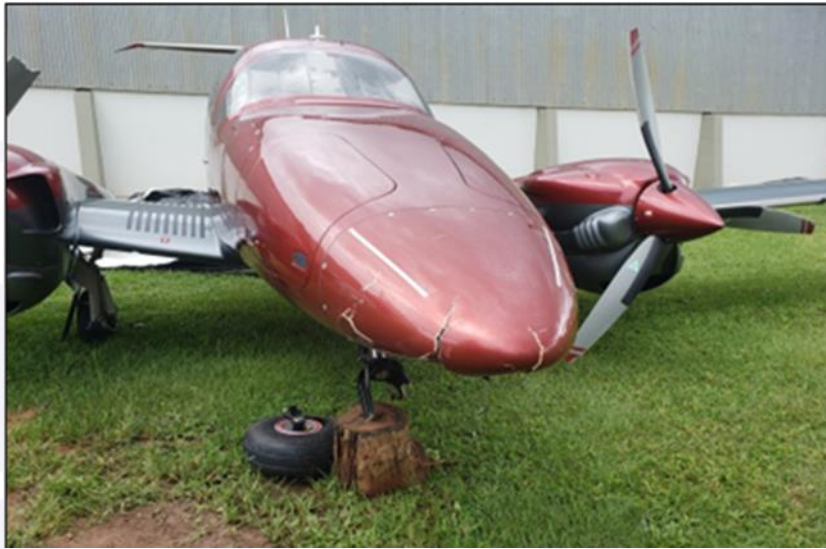
The aircraft had damage to the nose section, auxiliary landing gear, engine and right propeller assembly (Figures 2 and 3).

Figure 2 - Damage to the nose section and auxiliary landing gear.

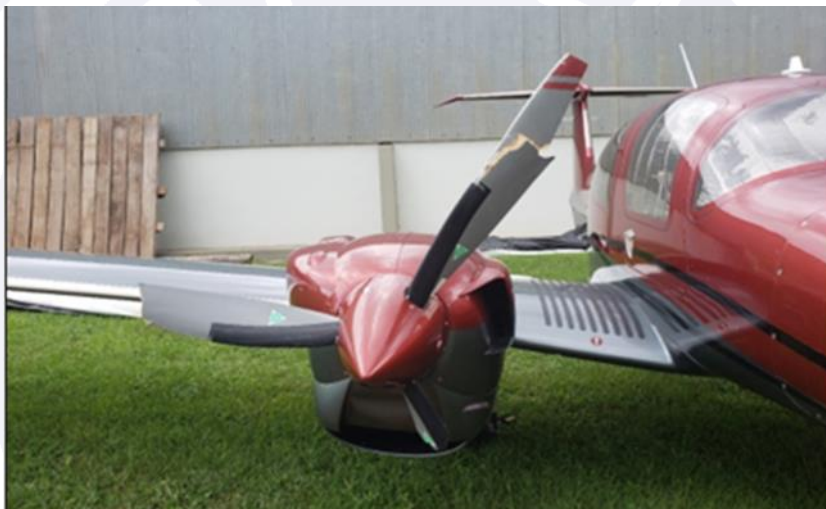
Figure 3 - Damage to the right engine propeller assembly.

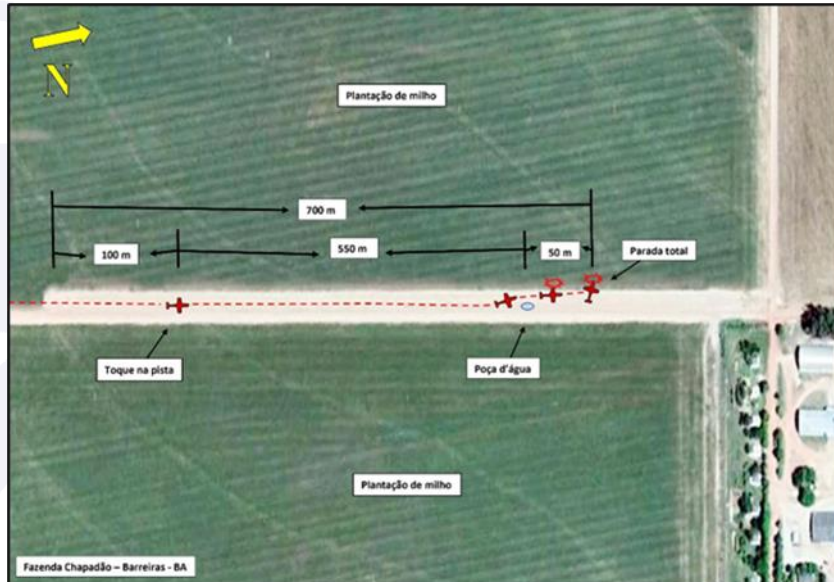
Figure 4 - Sketch of the accident.

During the run after landing, the aircraft's left wing touched the cornfield on the side of the runway. This contact caused yaw to the left and the subsequent loss of control of the plane, which stopped with the front part in the cornfield (Figure 4).

Considering the conditions prevailing at the time of landing (soft wet terrain, slippery and with accumulations of water), it is possible that, during the informed deviation attempt, an inadequacy in the use of the controls resulted in the contact of the left wing tip with the vegetation on the side of the runway, which caused an abrupt turn to the left, which could not be corrected.
