COMANDO DA AERONÁUTICA
CENTRO DE INVESTIGAÇÃO E PREVENÇÃO DE
ACIDENTES AERONÁUTICOS

FINAL REPORT
A - 105/CENIPA/2016

PT-EFQ

EMB-820C NAVAJO

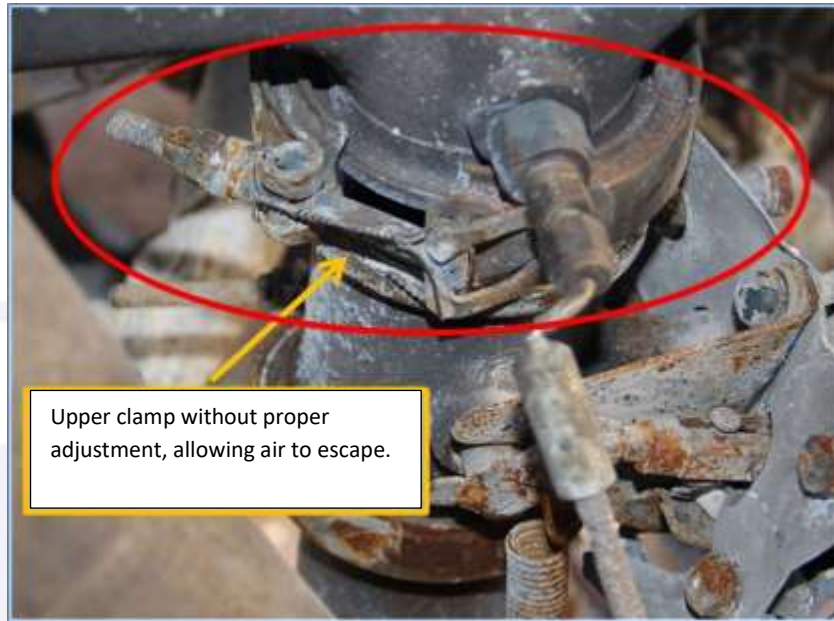
During the analysis performed on the Lycoming LTIO-540-J2BD right engine, L / 769-68A, it was found that the upper clamp securing the bypass valve to the turbocharger transition duct was not properly adjusted; there was a gap in its attachment, as shown in Figures 1 and 2.

Figure 1 - Detail of the upper clamp installed in the bypass of the turbocharger without adequate adjustment.

As the bypass valve clamp was loose, it allowed air to escape from the exhaust, reducing the amount of air that would be directed to the turbine, thereby reducing the efficiency of the turbocharger and, consequently, not allowing the engine to reach its maximum performance.

It was not possible to determine the decrease in power and efficiency of the engine caused by the bypass valve clamp clearance. However, according to the EMB-820C Operation Manual, if the turbocharger failed and the engine only aspirated the outside air, its maximum continuous power delivered would be of approximately 75% or 262hp at sea level.

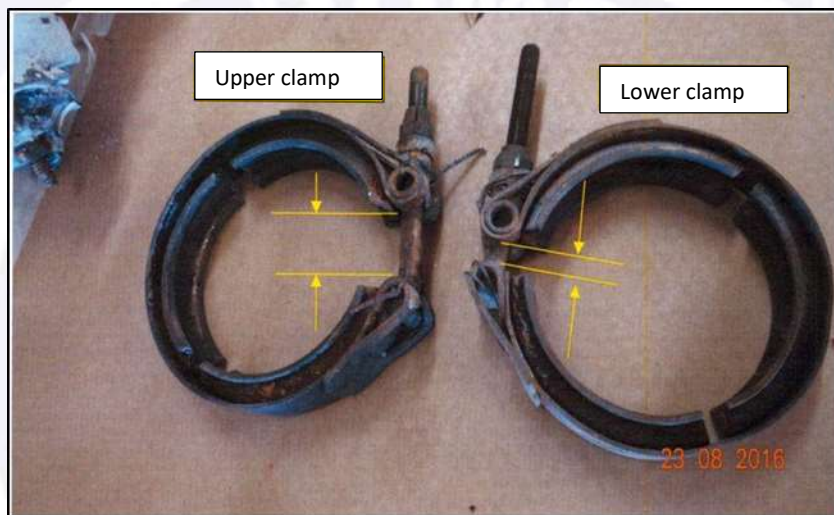
Figure 2 - Comparison between the upper and lower clamp adjustments of the turbocharger bypass valve.

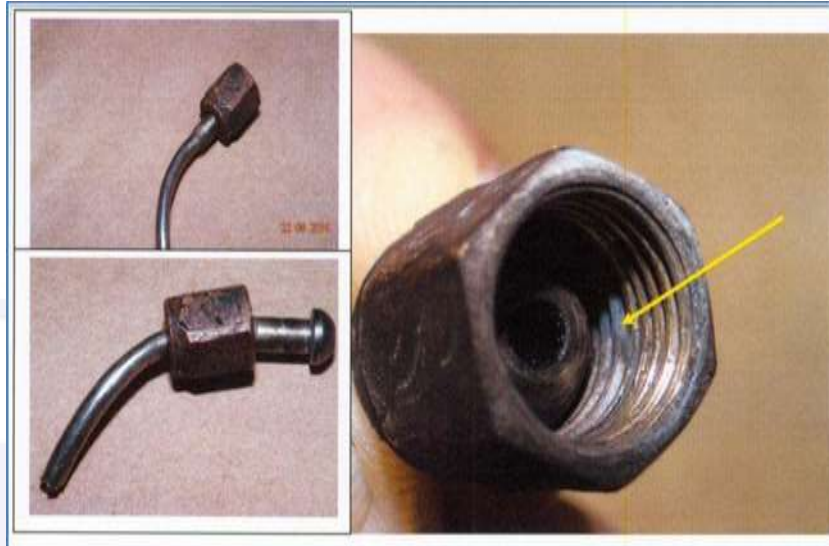
It was further noted in this engine that the fuel tube nut, which exited from the distributor to cylinder No. 3, was not properly tightened. The loosening of the tube fixing nut was corroborated by the presence of soot deposited on the last threads of the nut, due to the fire caused during the collision of the airplane against the building (Figure 3).

Figure 3 - Detail of the connection of the distributor's fuel outlet pipe to the cylinder # 3 with presence of soot in the last threads of the nut.

The characteristics of the combustion residues found inside the odd cylinders indicated that they worked at high temperatures, possibly due to the impoverishment of the air / fuel mixture caused by a leakage of fuel in the nut of the tube that was improperly fixed.

This leakage, besides having caused irregular burning in the cylinders, caused excess temperature and loss of efficiency of the engine.

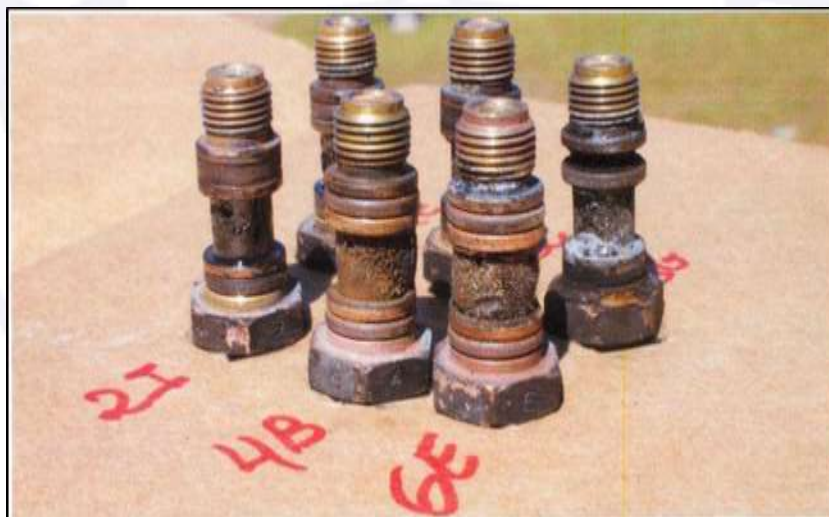
In the left engine analysis, Lycoming TIO-540-J2BD, n / s L-3999-61A, it was observed that in nozzles no. 2, 4 and 6 there was the deposit of strange material on its external surfaces, causing obstruction of the side holes. This residue was collected to perform a laboratory test.

Figure 4 - View of the even injector nozzles, of the left engine, with lateral contamination.

Laboratory tests indicated that the material collected was likely to be composed of an agglomerated soil and fuel which, when deposited in the orifices of the injector nozzles, obstructed the passage of the fuel.

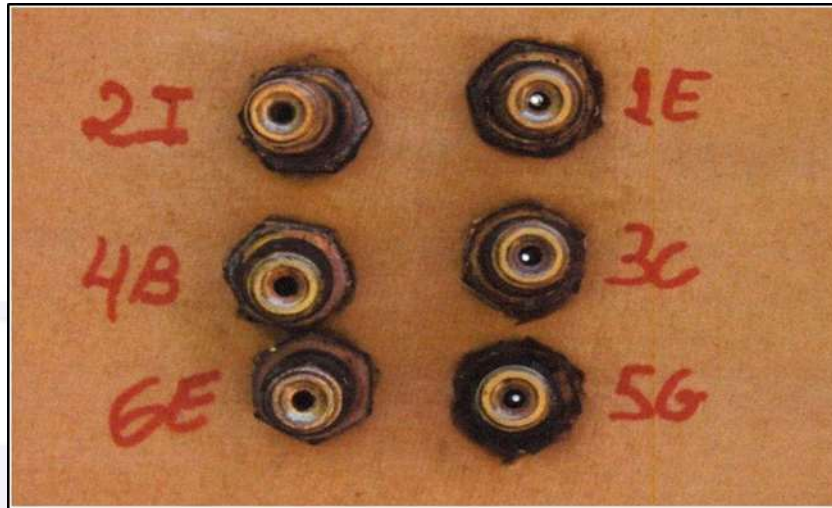
Figure 5 - Detail of the obstruction of the injector nozzles of the left engine.

On the left engine, impurity composed of an agglomerate of soil and fuel were found on the side of the nozzles n° 2, 4 and 6, which migrated to the inside of these nozzles, causing them to become clogged.

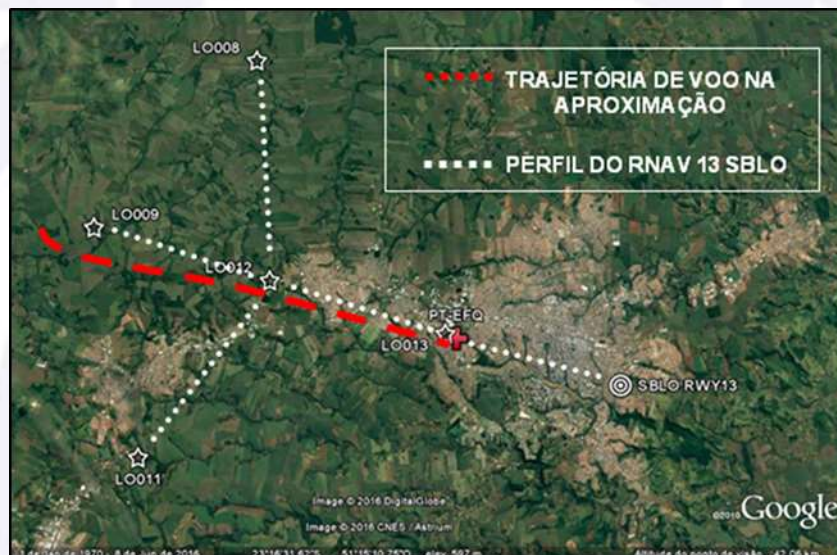
The location where the aircraft crashed was practically in the RNAV procedure (GNSS) RWY 13, located 0.5 NM from position LO013 and 4.65 NM from threshold 13.

Figure 7 - Displacement of PT-EFQ in the approach for SBLO.
