FINAL REPORT
A - 120/CENIPA/2015

OCCURRENCE:	ACCIDENT
AIRCRAFT:	PT-EPD
MODEL:	EMB-721C
DATE:	30AUG2015

This is the Final Report of the 30AUG2015 accident with the EMB-721C aircraft, registration PT-EPD. The accident was classified as “[SCF-PP] System/Component Failure or Malfunction Powerplant / Engine Failure in-Flight”.

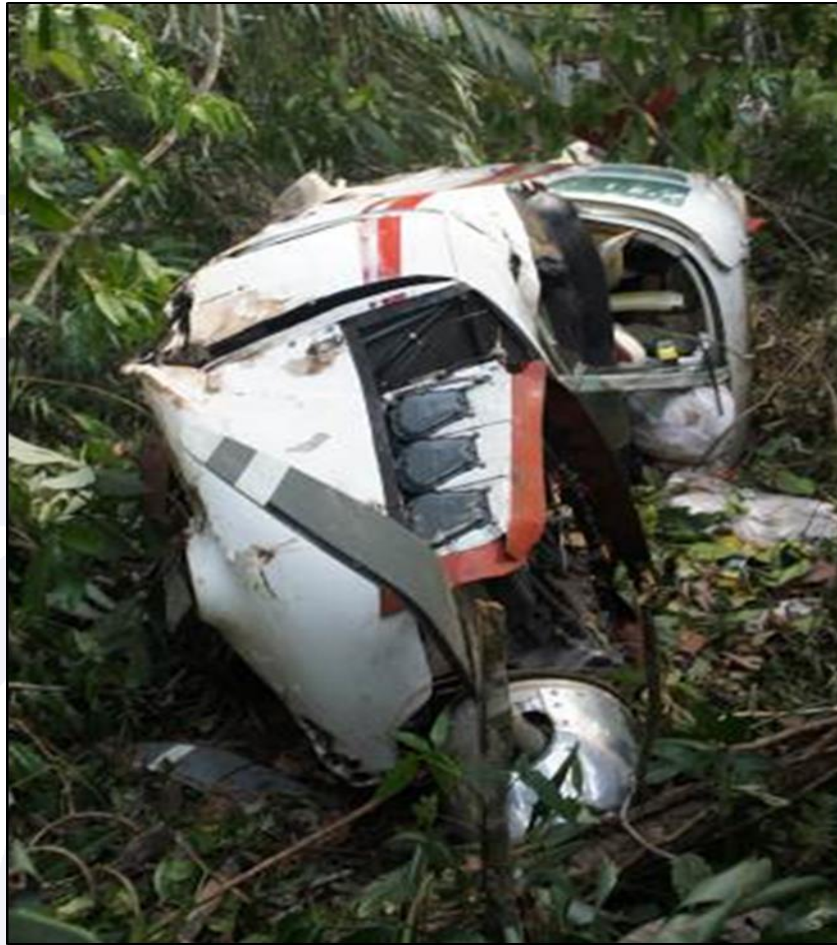
The fuselage was tilted 90° to the left. The aircraft nose had a deformation to the left (Figure 1). The windshield was torn off at the final impact.

Figure 1 - Final position of the fuselage.

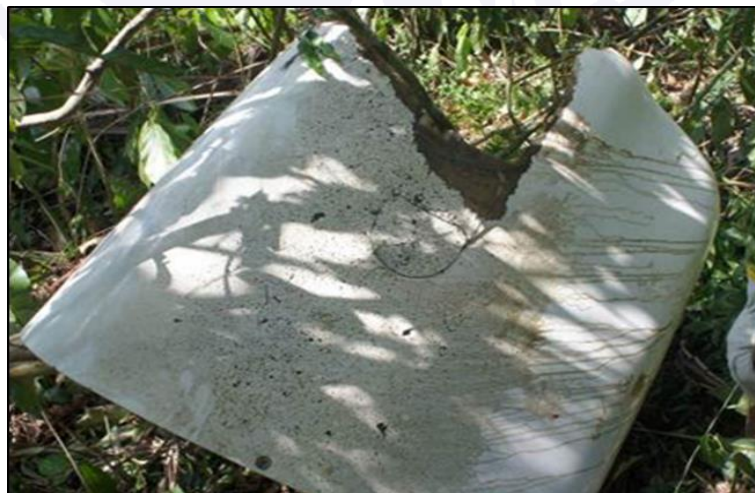
The upper fairing of the engine detached from the aircraft and had a fracture on the left front part, area that covered cylinder # 2 (Figure 2).

Figure 2 - Top fairing of the engine.

Damage to the upper fairing of the engine was probably caused by the detachment of parts of the Crankcase Assembly, and / or the cylinder, and / or the connecting rod.

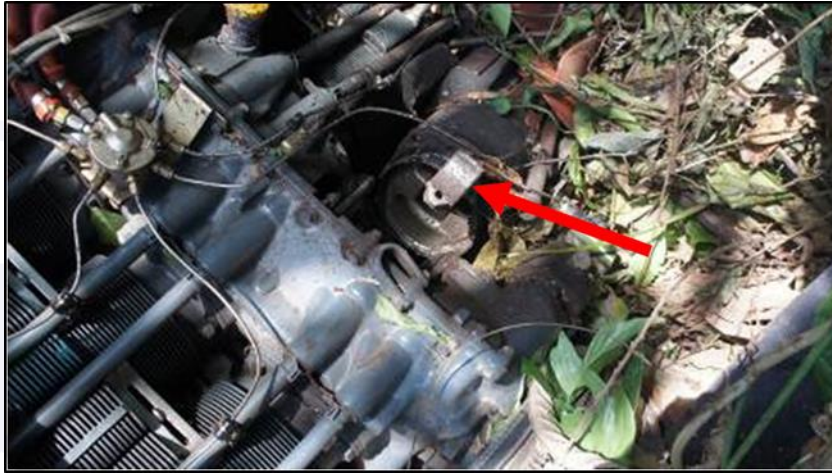
Cylinder No. 2 was displaced from its position. There was a fracture at the top of the engine (Crankcase Assembly, according to Lycoming Aircraft Parts Catalog), near the upper stud bolts of cylinder # 2 (Figure 3). The piston rod of this cylinder was fractured on the head and was found detached from the crankshaft.

Figure 3 - Block of the engine fractured at the base of cylinder # 2 and head of the fractured connecting rod.

The connecting rod fracture was considered a consequence of the cylinder having worked loose and misaligned.

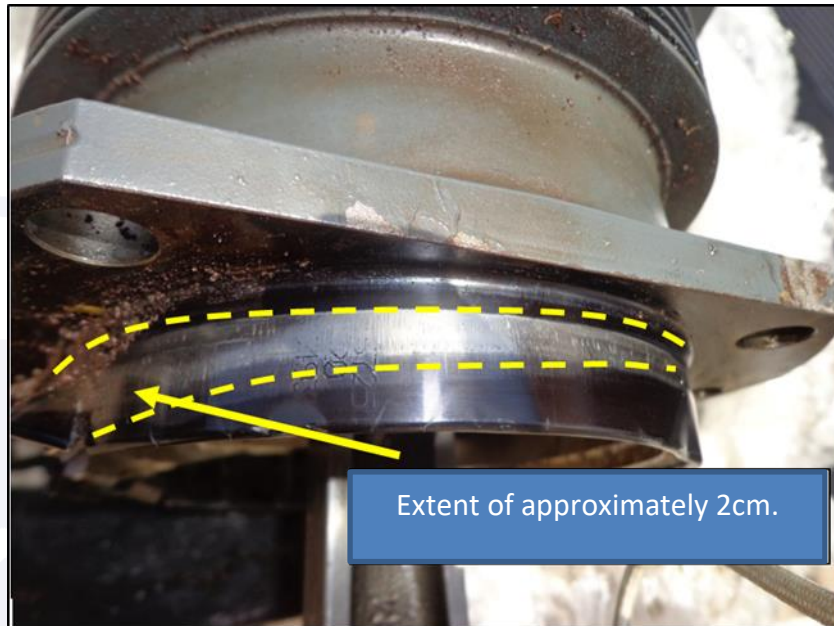
The visual analysis of cylinder #2 indicated mirror marks on its skirt, below the fixation flange, as can be seen in Figure 4.

Figure 4 - Mirror markings on cylinder skirt #2.

The mirror marks, shown in Figure 4, indicated that the cylinder worked loose for a certain period, prior to the total release of all bolts.

According to the technical report drawn up by the IAE, the marks on the cylinder skirt, below the fixing flange, were in fact an indication that it worked loose on its fixing base.

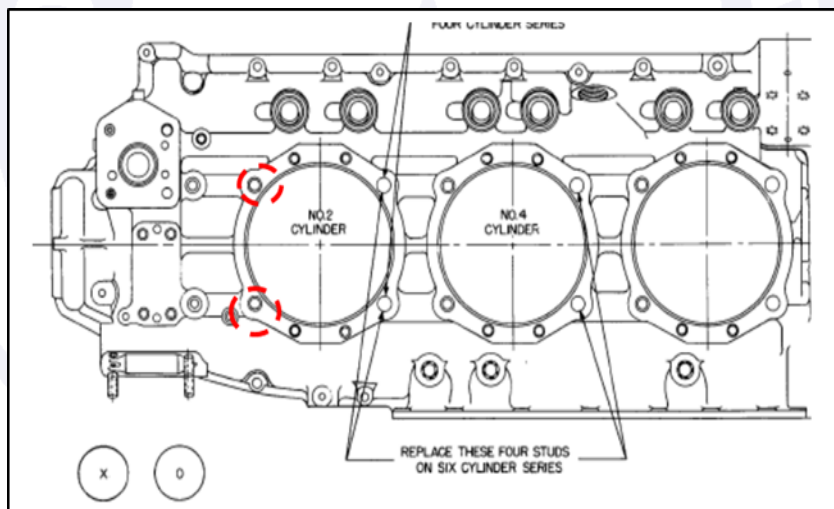
These marks also suggested that the fracture process was initiated by the 0.5 inch, PN 50-15, front studs shown in Figure 5, as they formed an arc between the passing bolts, as shown in Figure 6.

Figure 5 - 1/2" stud bolts.

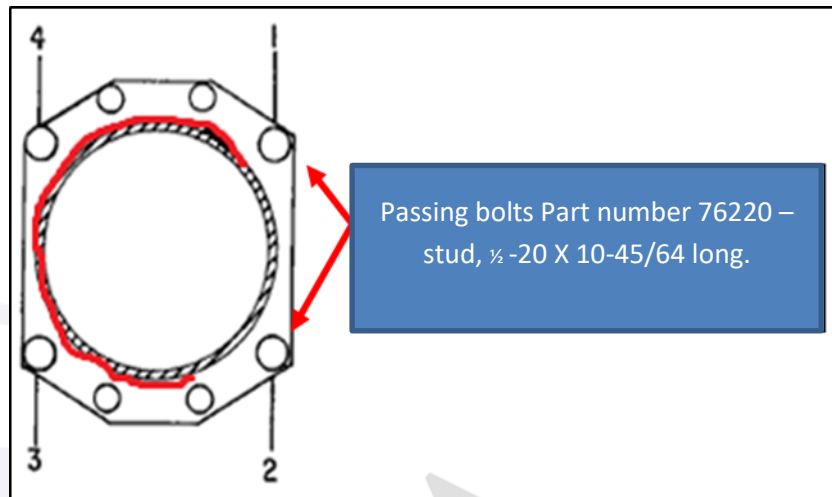
Figure 6 - Illustration of the area where the mirror marks were found in the cylinder skirt #2.

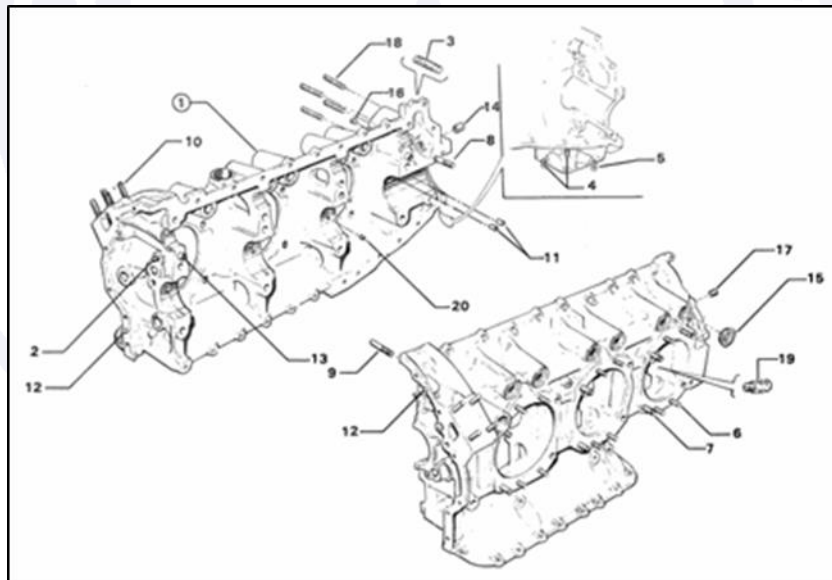
Analysis of engine maintenance documentation indicated that the Crankcase Assembly PN 11F20022-D3, installed in the latest revision, was not the one for the Lycoming engine model IO-540-K1G5D. This component was suitable for Lycoming TIO, LTIO-540 and series engines (turbocharged engines).

Figure 7 - Image of the Crankcase Assembly TIO, LTIO-540 Series extracted from Parts Catalog.

The Part Number of the Crankcase Assembly planned for the Lycoming IO-540-K1G5D engine would be the 11F24020-D1-S.
