FINAL REPORT
A - 007/CENIPA/2015

| OCCURRENCE: | ACCIDENT |
| AIRCRAFT: | PT-FFH |
| MODEL: | A-188B |

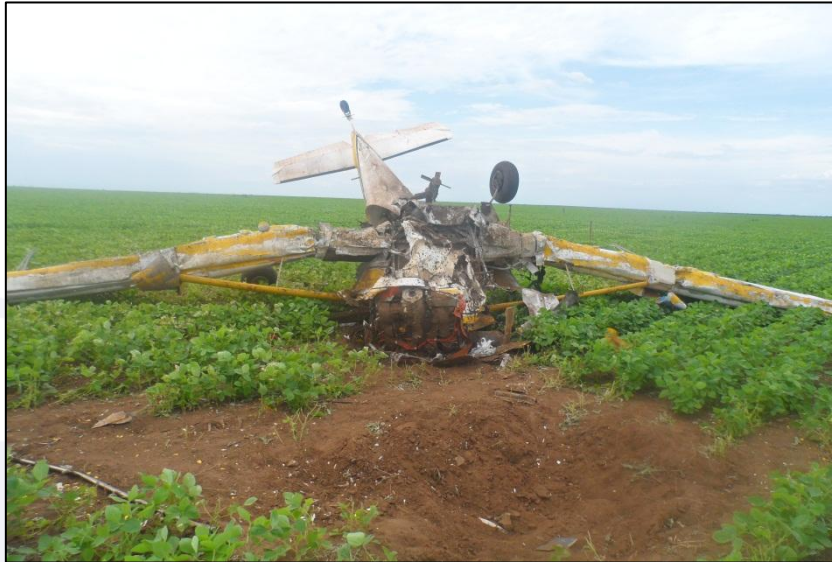
[The aircraft collided with a concrete pole located in the direction of the application pass. The airplane hit the ground 230 meters ahead of the initial point of impact, and stopped with its upside down. A piece of the pole was later found in the mid of the wreckage.]

Figure 1 – Wreckage of the aircraft.

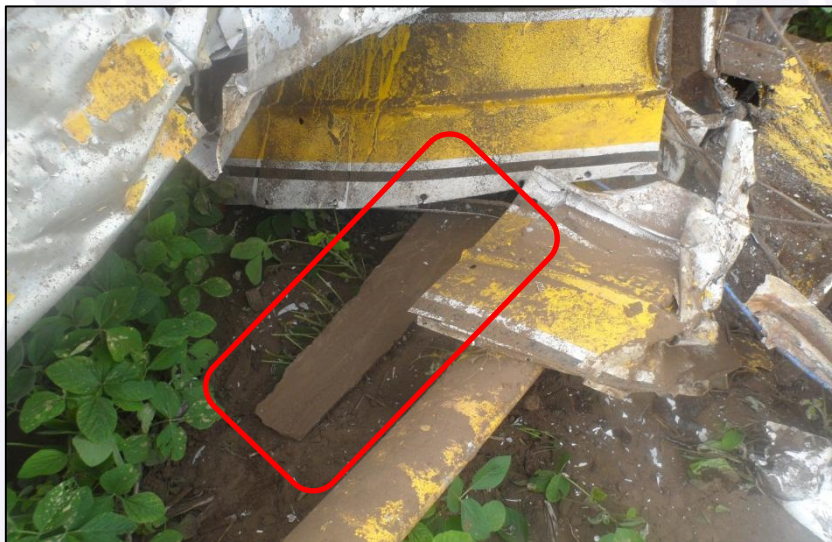
Figure 2 – Fragment of the concrete pole amid the aircraft wreckage.

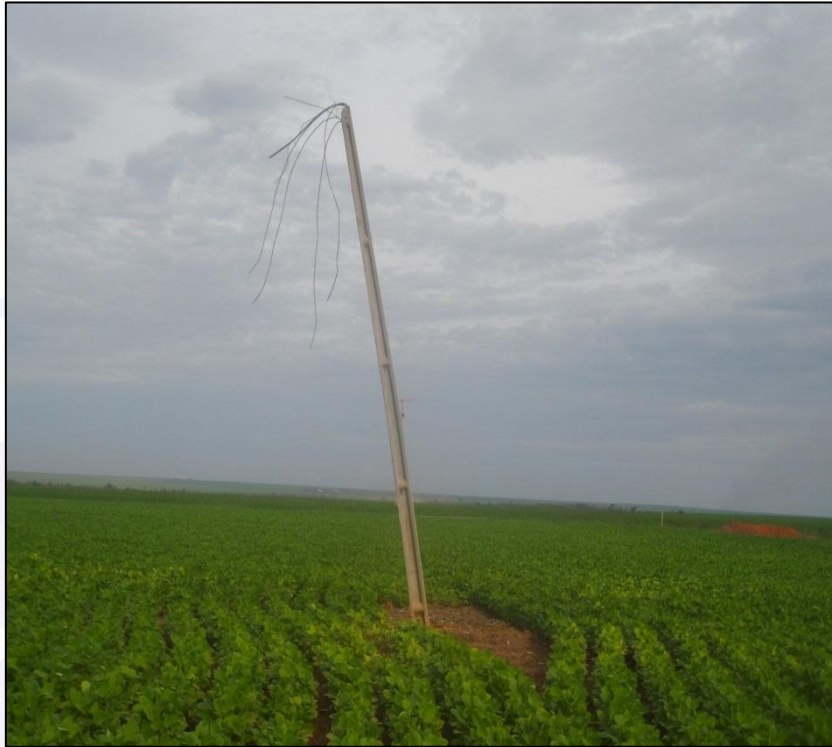
Figure 3 – Pole hit by the aircraft.

The distance between the concrete poles was approximately 90 meters. The pole that was hit was located in the direction of the aircraft movement, close to the end of the corn plantation.

There were no electric wires connecting the poles.

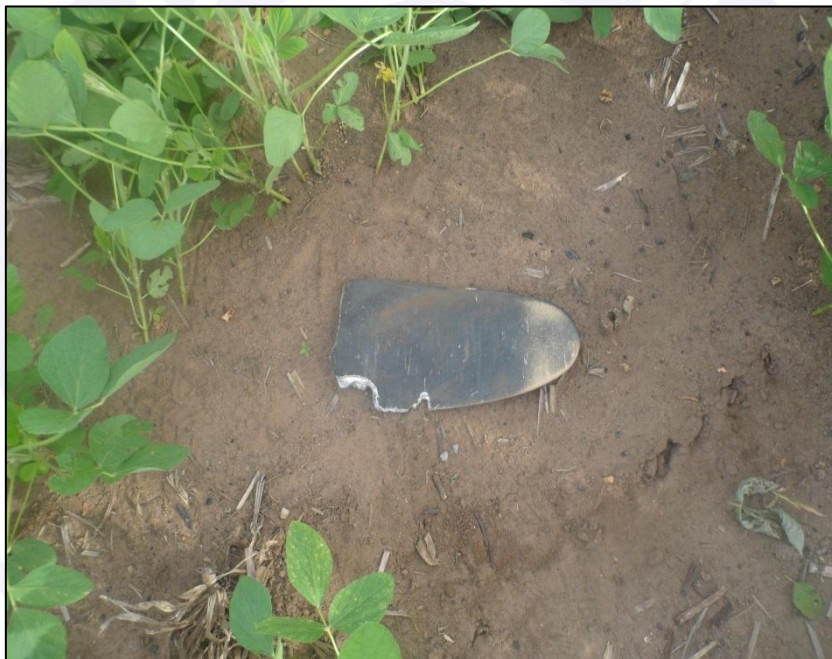
There were small fragments of the aircraft near the concrete pole involved in the collision. The majority of the aircraft components remained concentrated at the final resting position of the airplane.

Figure 4 – Fragment of the propeller blade found near the concrete pole hit by the aircraft.

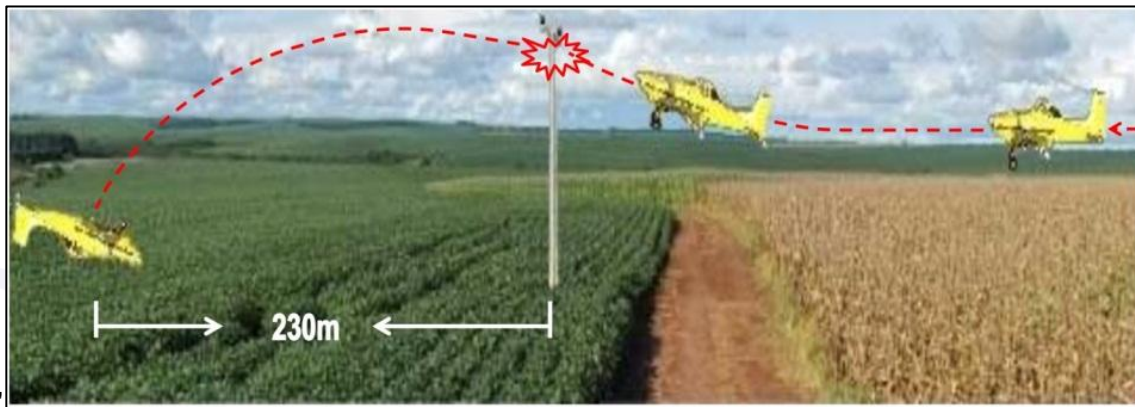
Figure 5 – Vertical profile of the aircraft trajectory relative to the pole.

The fact that the lines had not been installed in the poles may have diminished the pilot's perception, since the aircraft could fly at low altitude between the poles without having to climb to stay clear of the lines.

The pilot may not have seen the pole, since the absence of lines and its isolated location made it difficult to be sighted.

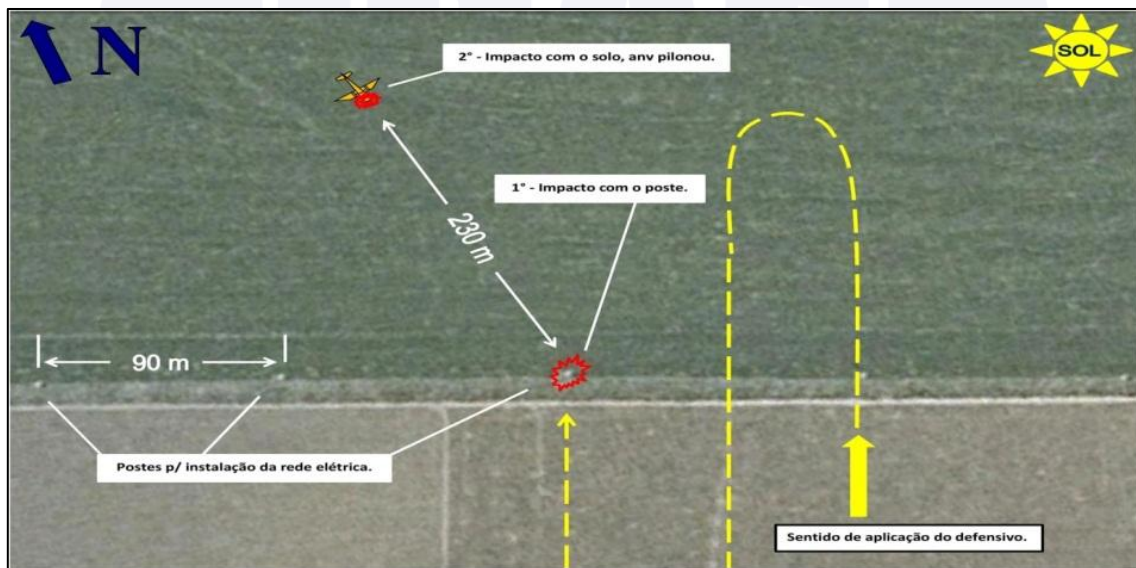
At the moment of the accident (07:50 local time), the fact that the low pass was being made in the direction southeast/northeast left the sun at the 1 o'clock position in relation to the aircraft trajectory.

Figure 6 – Horizontal profile of the aircraft trajectory relative to the obstacles and position of the sun.

Considering that the direction of the low pass was in the direction southeast/northeast, in addition to the position of the sun at the moment of the accident, it is possible that the pilot's was impaired, making it even more difficult for him to sight the concrete pole.

The position of the sun at the moment of the occurrence may have impaired the pilot's vision, making it difficult for him to sight the concrete pole.

Take the necessary measures before the Operator, aiming at verifying the effectiveness of the Managerial Oversight mechanisms relative to the agricultural aviation activities, mainly with respect to the identification and management of the operational risks.
