**COMANDO DA AERONÁUTICA**  
**CENTRO DE INVESTIGAÇÃO E PREVENÇÃO DE**  
**ACIDENTES AERONÁUTICOS**

**FINAL REPORT**  
**A - 172/CENIPA/2016**

<b>OCCURRENCE:</b>	<b>ACCIDENT</b>
<b>AIRCRAFT:</b>	<b>PT-ICU</b>
<b>MODEL:</b>	<b>58</b>
<b>DATE:</b>	<b>23DEC2016</b>

This is the Final Report of the 23DEC2016 accident with the 58 aircraft, registration PT-ICU. The accident was classified as “[UNK] Undetermined”.

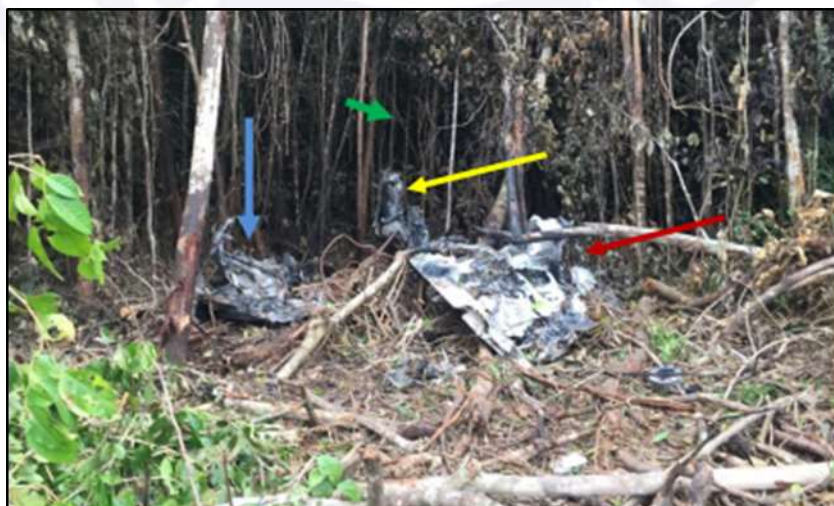
The aircraft was destroyed (Figure 1).

Figure 1 - The red arrow identifies the right wing, the yellow arrow identifies the

left wing, the blue arrow identifies part of the fuselage and the green arrow indicates where the right engine was found.

It is estimated that the aircraft initially collided against the treetops, about 25m high, in a downward trajectory. Thereafter, it collided against the ground at an angle of approximately 30° and disintegrated in fan form for about 10m.

The occupants and most of the aircraft were concentrated near the area where the impact had hit the ground, so that only the right engine was found away, about 15m, in the middle of the dense forest.

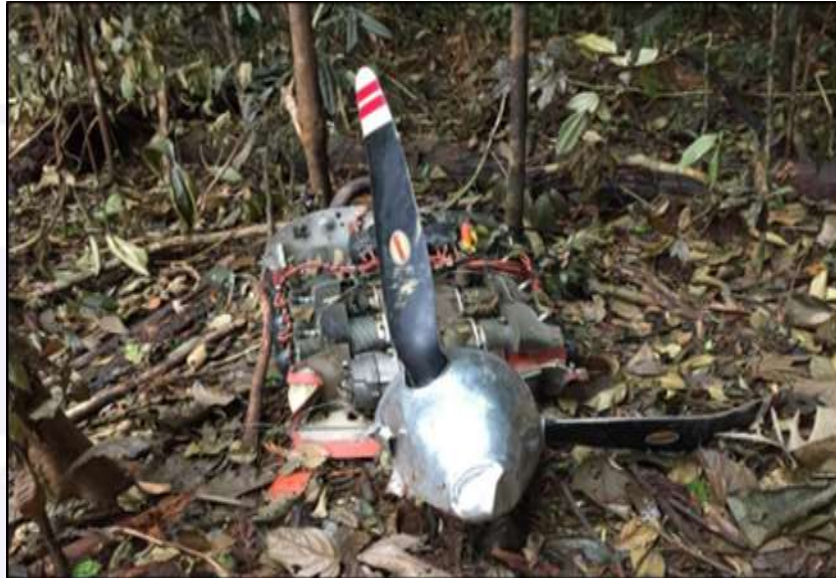
During the external inspection, it was observed that the fire did not affect the Continental, IO-520-C-CB model, n/s 571510, after the aircraft fall (Figure 2).

Figure 2 - Front view of the right engine, with no signs of fire. Local people removed one of the blades.

The engine presented kneading in the crankcase due to impact against obstacles.

The right engine propeller showed evidence that it was powerless at the moment of collision against the obstacle. The spinner presented localized kneading. The propeller had one of the blades pulled out of the hub, and this blade had no other damage like deformation or impact marks on its leading edge, bending or fracture at its end. The other blades were folded backwards.

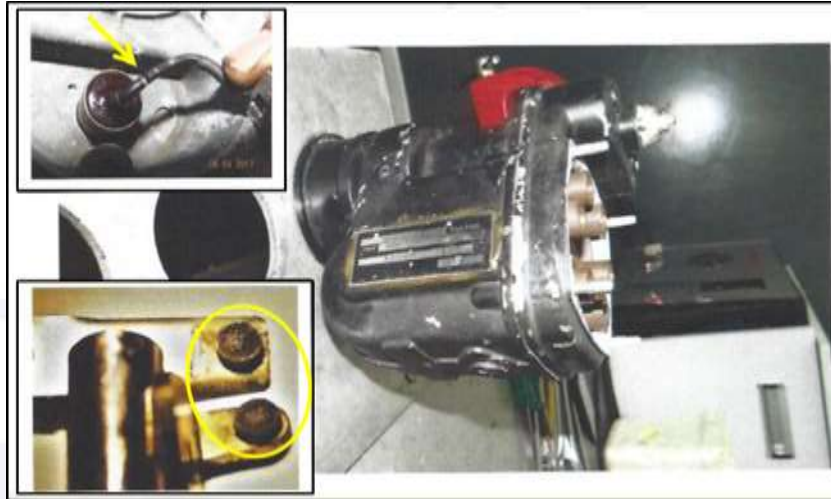
The right magneto was flashing intermittently. It was dismantled and, on inspection, it was observed that the platinum was burnt. It was also verified that the capacitor wire was with its protection damaged (Figure 3).

Figure 3 - Overview of the right engine's right magneto. The highlights show the damaged capacitor cable and the burnt platinum contacts.

The primary coil winding of the magneto was with the resistance below the one specified by the Maintenance Manual, System Support Manual, S-1200 Magneto Ignition System, Chapter 7, Section 7.2.6 Inspect Coil.

It was further found that Pin-Dowel 19x.50LG, PN630873, that supported Bushing-Idler, PN630871, which was connected to Idler Gear, PN629360, magneto-drive gear, was loose, with wear marks. The hole where it was installed was oval, also showing work marks and wear of the bushing on the housing.

The discrepancies found and related to the ignition system would also not be grounds for this engine to stop working, but would justify an increase in lubricating oil consumption, spark plug charring or even a power deficiency.

Discrepancies related to the ignition system also would not be grounds for the engine to stop working. However, if the right magneto failure occurred during the flight, this would result in a power deficiency and could contribute to the occurrence on 23DEC2016.

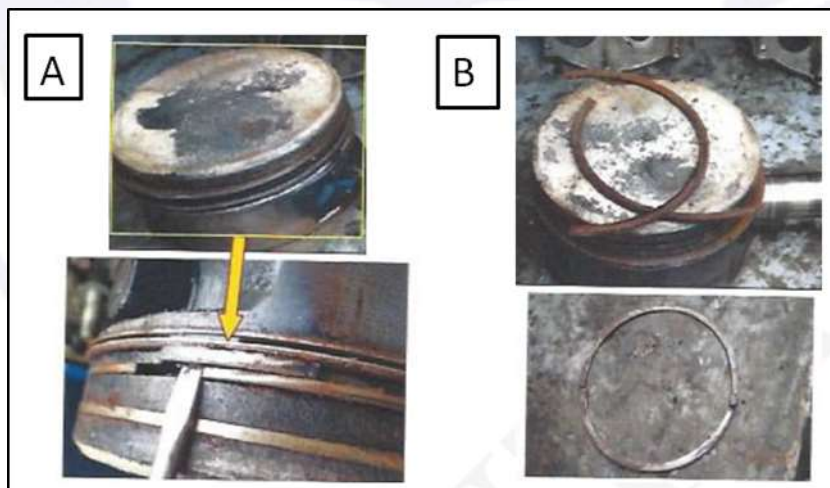
Another discrepancy found in this engine was observed in the removal of the cylinders. The piston of the engine cylinder 1 had a fracture on its side, between the compression ring and the oil scraper ring, as shown on Figure 4, letter A.

In the cylinder piston 5, it was observed that the compression ring was broken inside its housing, according to Figure 4, letter B.

Figure 4 - A) Broken wall of the cylinder 1 piston, between the scraper ring and the oil-distributing ring. B) Broken cylinder compression ring 5.

Despite these discrepancies, no scratches were found on the cylinder liners and no evidence was found that there was not a proper fuel ignition in the chamber.

Individually, the reported discrepancies should not cause problems in the engine's operation and it could be inferred that it operated even with the discrepancies found in the pistons.

Such inconsistencies would justify an increase in the consumption of lubricating oil, leakage, carbonization of the spark plugs or even a loss of power, which could have contributed to the accident in question.

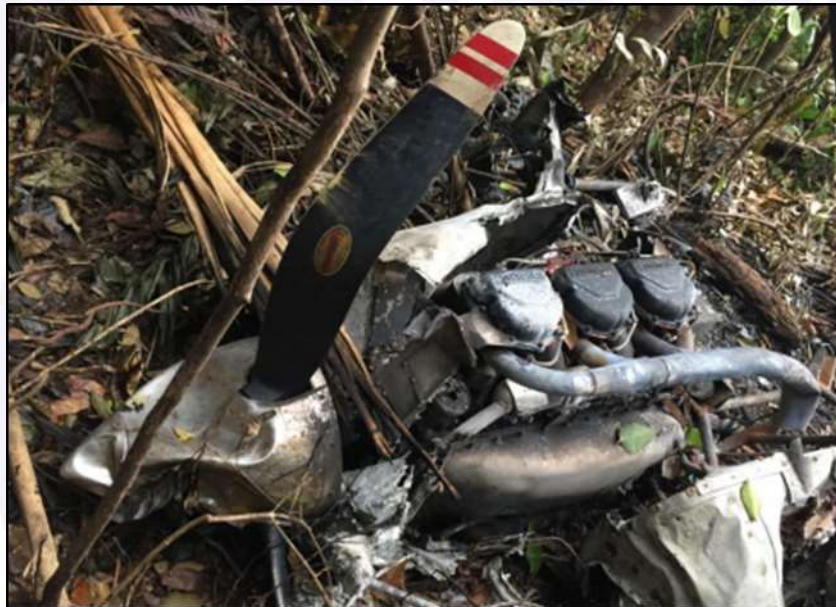
During the external inspection, it was observed that the left engine Continental, model IO-520-CB (7), n/s 299088R, was exposed to the fire that occurred after the fall of the aircraft.

Figure 5 – Left engine view.

All of its external components showed evidence of long exposure to fire. It was also observed that it was jammed and had kneading in the crankcase due to the impact against obstacles.

In the engine lubrication system, no malfunction was observed which could jeopardize its operation. The engine jam was caused by the carbonization of the lubricating oil that was housed between the trunnions and the rear bearings, which occurred during the post-impact fire.

It was noted that at the junction of the mechanical fuel pump with the accessories section there was a rubber o-ring, contrary to the Teledyne Continental Motor X30624 Maintenance Manual, IO520CB - Fuel Injection System Parts Listing, figure 69-109, where a Gasket-Fuel Pump Adapter, item no. 9, PN649982 was provided.

In addition to the previous discrepancy, it was found that the fuel pump was stuck. This was dismantled, having its axis removed with the aid of a press.

In order to know whether the binding occurred before or after the accident, an analysis was requested from the DCTA's Materials Division (AMR). The result indicated that there was increase in the microstructure of the shaft due to the long post-impact fire exposure, which suggested that the binding occurred after the accident.

The magnetos on this engine were also affected by exposure to fire. Its internal components were melted by heat and this prevented any kind of functional testing or analysis.
