FINAL REPORT
IG - 089/CENIPA/2014

OCCURRENCE:	SERIOUS INCIDENT
AIRCRAFT:	PT-JJR
MODEL:	ST-10
DATE:	01MAY2014

This is the Final Report of the 01MAY2014 serious incident with the ST-10 aircraft, registration PT-JJR. The serious incident was classified as “[RE] Runway Excursion / Overshooting”.

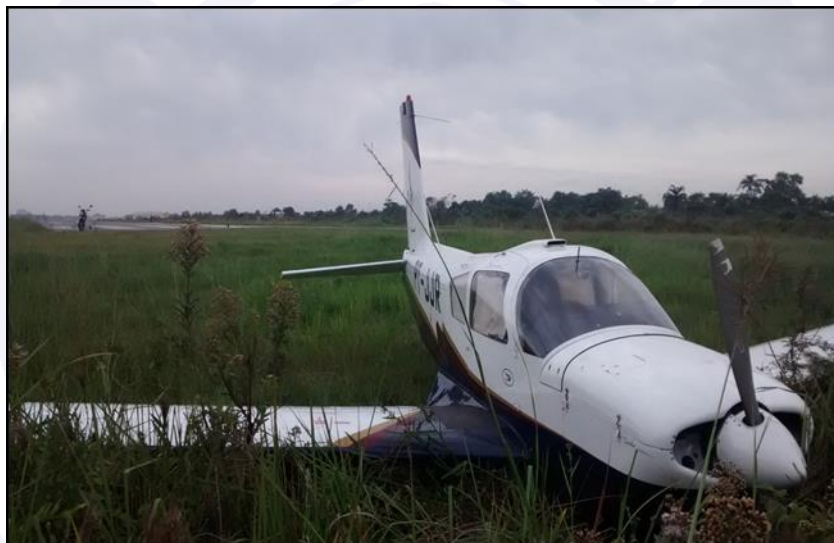
During the run after landing, the aircraft ran the entire length of the runway, exceeded the limits of SDIM's threshold 15 in approximately twenty meters, stopping over underbrush.

The aircraft had minor damage.

Figure 1 - Aircraft after occurrence with the runway in the background.

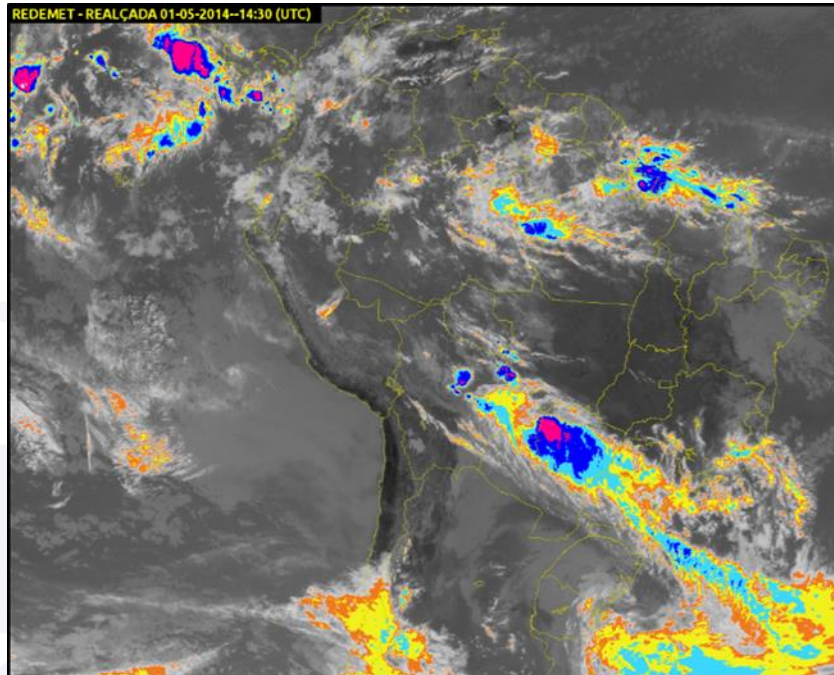
The satellite image of 1430 (UTC) presented a cold front moving in the South - Northeast direction (Figure 2).

Figure 2 - Satellite image at the moment of the occurrence.

According to the SBST METAR, there was strong wind and gusts that reached 42kt. According to the satellite image of the day and time of occurrence, there was also the presence of a cold front moving in the South - Northeast direction.

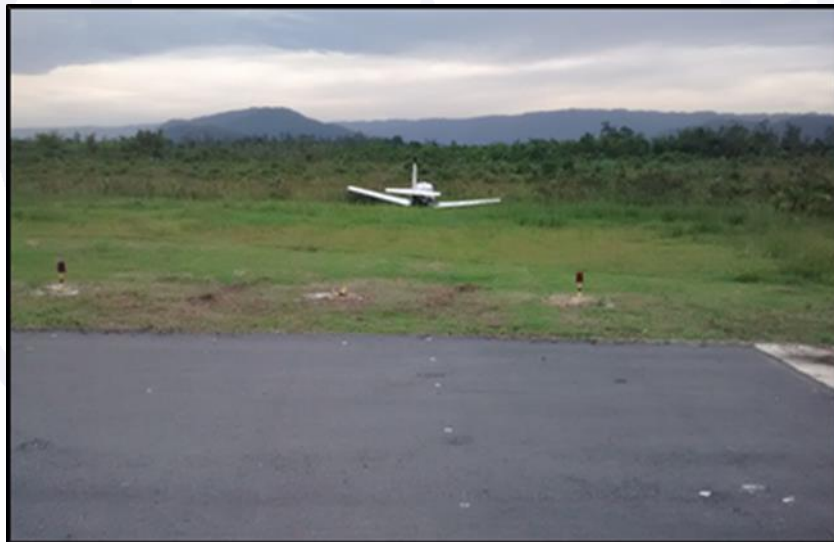
At the third approach to threshold 33, the aircraft landed. It was reported that the touch occurred after the first third of the runway, and it was not possible to stop the aircraft before the end of the opposite threshold.

The aircraft covered about twenty meters on the grass after the threshold, stopping in a wetland (Figure 3).

Figure 3 - Aircraft in the stop position, after threshold 15.

After the two go-around procedures, the pilot did not manage the risk properly when proceeding to the landing in adverse conditions of gusty winds, employing a slope with more accentuated angle. These evidences allied to a probable inadequacy of the application of the commands led to the irreversibility of the event.
