**COMANDO DA AERONÁUTICA**  
**CENTRO DE INVESTIGAÇÃO E PREVENÇÃO DE**  
**ACIDENTES AERONÁUTICOS**

**FINAL REPORT**  
**A - 140/CENIPA/2013**

<b>OCCURRENCE:</b>	<b>ACCIDENT</b>
<b>AIRCRAFT:</b>	<b>PT-LKG</b>
<b>MODEL:</b>	<b>58</b>
<b>DATE:</b>	<b>03AUG2013</b>

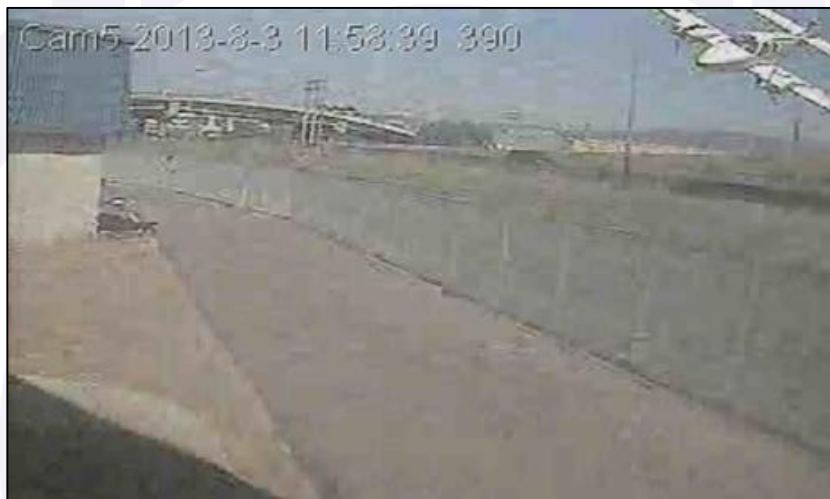
From the footage of a Security Company camera, located close to the occurrence site, the aircraft was flying with a pitch down attitude of, approximately, 15° and a lateral inclination to the left of, approximately, 45° in relation to the ground (Figure 1).

Figure 1 – Image captured from the video. Moment when the aircraft appears in the footage before colliding against the ground.

In the security camera recording, located near the place of the occurrence, it was observed that the aircraft had left lateral displacement, not coordinated in the longitudinal axis (“crabbing”).

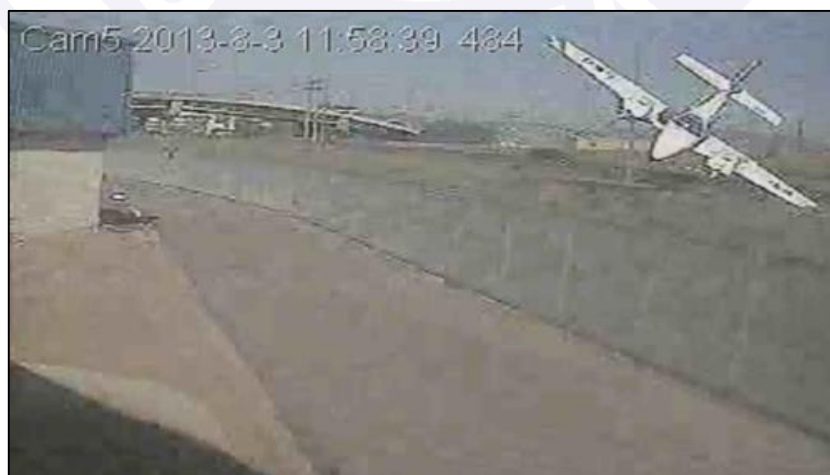
Following, the impact of the left wing tip occurred in high speed. After that, the whole aircraft crashed against the ground and fell apart. There was an explosion that consumed almost all the aircraft (Figures 2 and 3).

Figure 2 - Image captured from the video right after the aircraft touches its left wing tip against the ground.

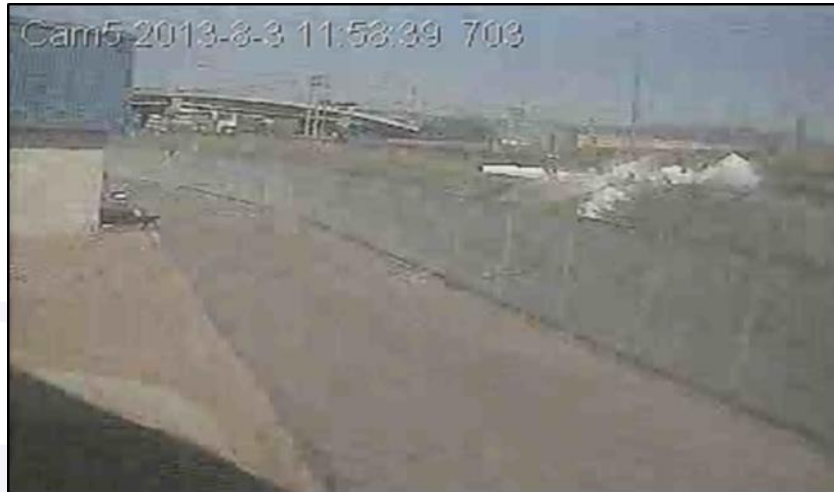
Figure 3 - Image captured from the video at the moment the aircraft explodes, after the collision of the left wing tip against the ground.

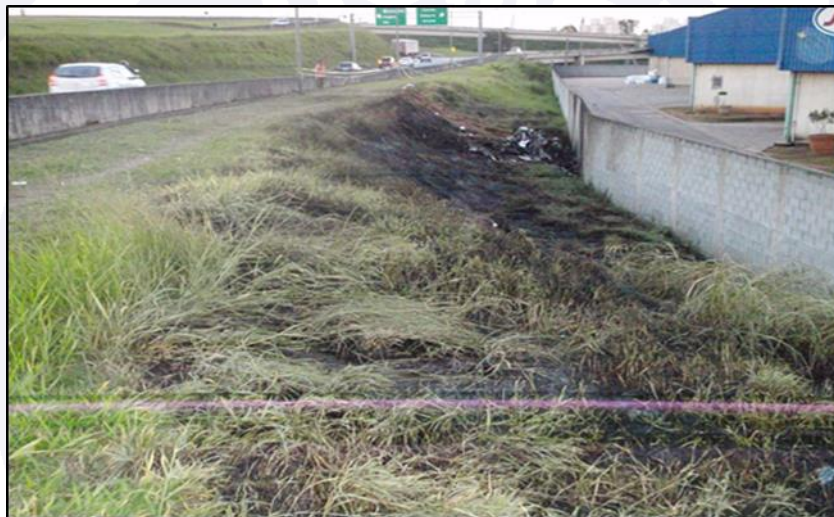
The degree of destruction and carbonization of the aircraft was quite high (Figure 4).

Figure 4 - General view of the wreckage, after the fire extinction.

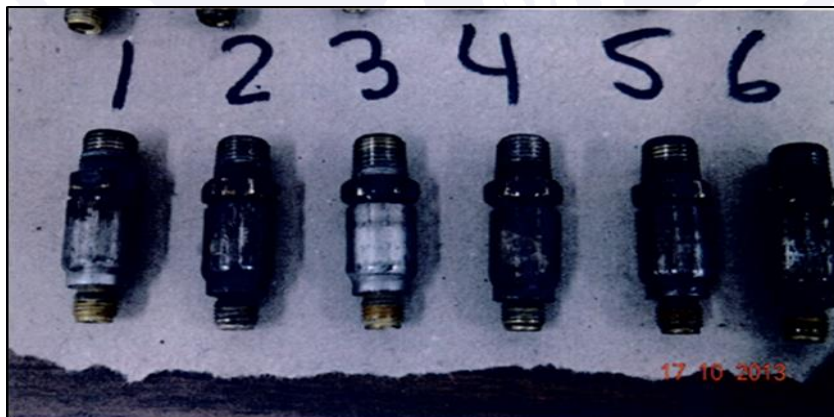
The nozzles were also checked. Only cylinder nozzle 5 had partial obstruction.

Figure 6 - Overview of the right engine nozzles.

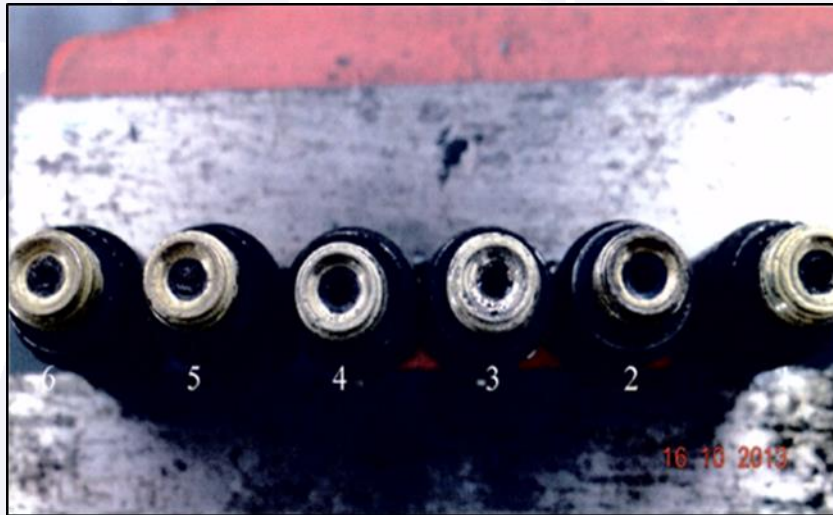
The six nozzles (Figure 7) were also checked, and five of them presented partial or total obstruction to the fuel passage. It was identified the presence of polyethylene terephthalate, which is found in the black fibers of the fuel hose.

Figure 7 - Overview of the left engine nozzles.

However, the left engine had five of its six nozzles partially or completely blocked with fuel hose material. Such a situation may have occurred because of premature failure, due to improper performance of preventive or corrective services on the aircraft.

According to the investigation report, the left engine had five of the six nozzles partially or completely blocked with fuel hose material. Such a situation may have occurred because of premature failure, due to improper performance of preventive or corrective services on the aircraft.

Work with the CONAL *Avionics e Eletrônica de Aeronaves* Ltd. Maintenance Organization, so that organization demonstrates that it owns and applies all the resources necessary for the adequate provision of maintenance services and maintenance records of BEECH AIRCRAFT, model 58, and Continental engines, model IO-520-CB, during the preventive and corrective maintenance procedures of the fuel system, notably regarding the replacement of flexible pipes regarding the traceability of parts used, as well as the possibility of contamination of this foreign material system.
