**FINAL REPORT**  
**A - 021/CENIPA/2015**

<b>OCCURRENCE:</b>	<b>ACCIDENT</b>
<b>AIRCRAFT:</b>	<b>PT-LOA</b>
<b>MODEL:</b>	<b>A188</b>
<b>DATE:</b>	<b>07FEB2015</b>

This is the Final Report of the 07FEB2015 accident with the A188 aircraft, registration PT-LOA. The accident was classified as “[LALT] Low Altitude Operation”.

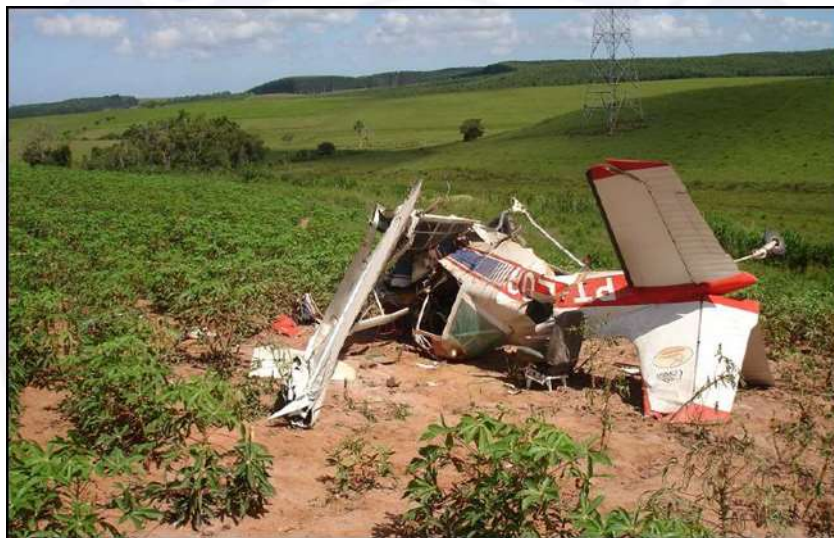
The aircraft was destroyed.

Figure 1 - Aircraft after the accident.

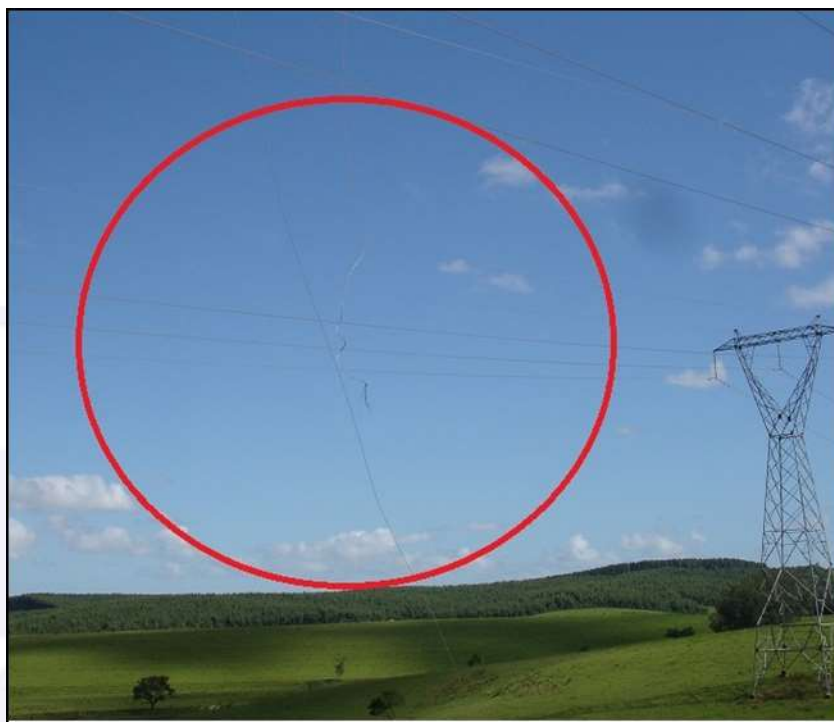
Rupture of the steel cable (lightning arrester) of the high-voltage power grid (Figure 2).

Figure 2 - Rupture of the steel cable (lightning arrester) of the power grid.

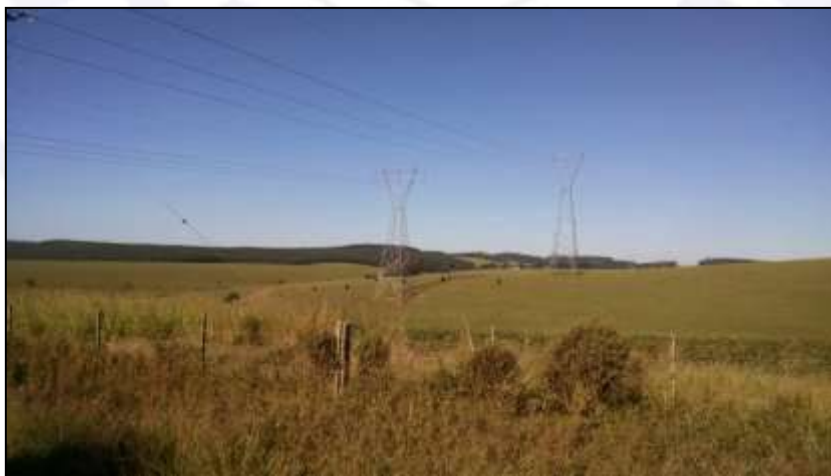
There were two parallel high-voltage power grids, and the network where the aircraft collided was 8m higher than the other one (Figure 3).

Figure 3 - Height difference between the parallel power distribution networks.

The first network had been surpassed, but the collision occurred on the second one, which was 8m higher.

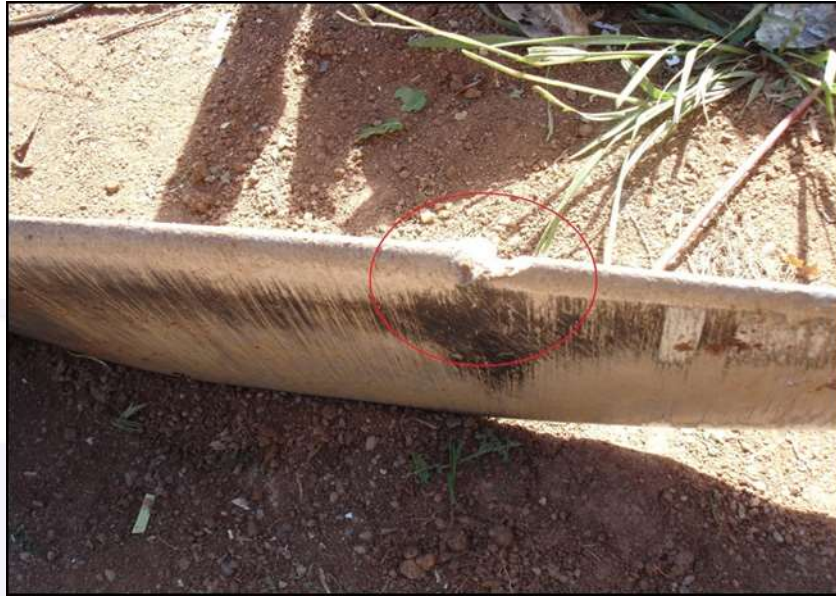
According to observers' statements and analysis of the wreckage, the aircraft was curving to the right and initially crashed its propeller against the transmission line's lightning arrester cable (Figure 4).

Figure 4 - Impact point of the propeller against the power grid (lightning arrester).

This cable was about 3m above the other power distribution cables. It had a gray color and diverged from the other cables, which were darker.

Shortly after the collision, the wire shifted down the aircraft, pulled out its spray pump and the right landing gear. There was a break in the wire after it had jammed into the right landing gear of the aircraft.

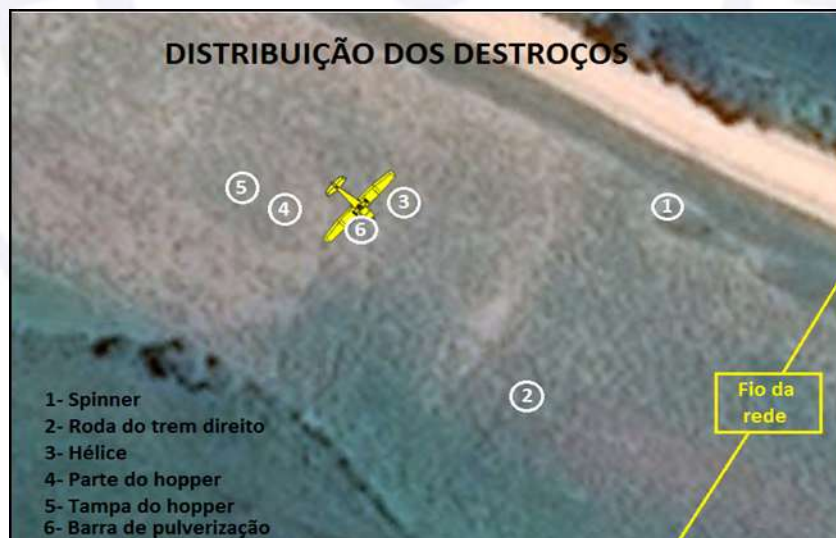
Finally, the aircraft collided with the approximate angle of 60° to the ground and overturned. The collision occurred 62m away from the transmission line.

The distribution of the wreckage was dispersed. The aircraft propeller was buried about 30cm.

The wreckage visualization indicated that the aircraft developed high speed at the moment of the impact against the ground (Figure 5).

Figure 5 - Wreckage distribution.

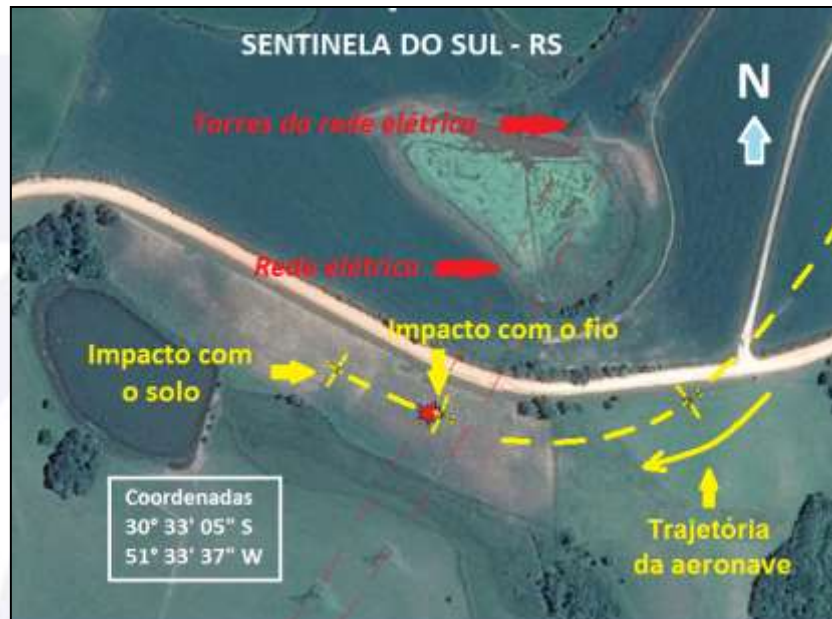
It was observed that the position of the sun did not affect the pilot's vision at the time of the accident (Figure 7).

Figure 7 - Sketch of the accident.
