COMANDO DA AERONÁUTICA
CENTRO DE INVESTIGAÇÃO E PREVENÇÃO DE
ACIDENTES AERONÁUTICOS

FINAL REPORT
A-048/CENIPA/2019

OCCURRENCE:	ACCIDENT
AIRCRAFT:	PT-LOK
MODEL:	CAP-10B
DATE:	23MAR2019

This is the Final Report of the 23MAR2019 accident with the CAP-10B aircraft model, registration PT-LOK. The accident was classified as “[LALT] Low Altitude Operations and [LOC-I] – Loss of Control in Flight”.

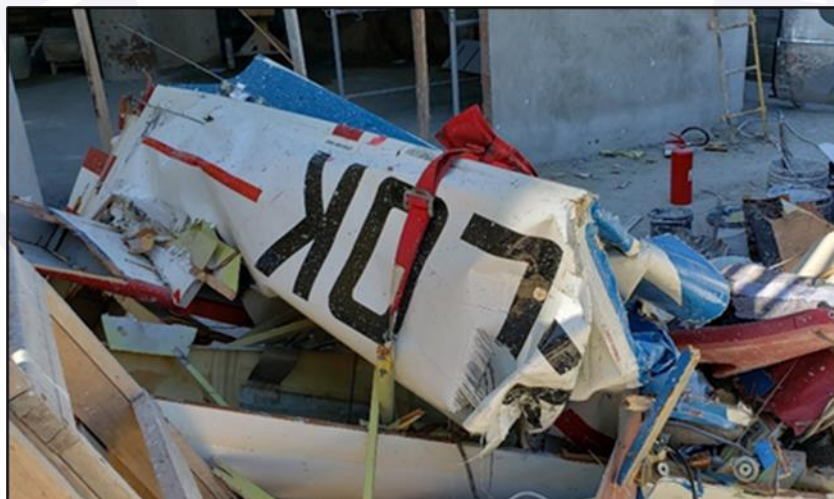
The aircraft was destroyed after the impact against a building under construction. (Figure 1).

Figure 1 - View of the PT-LOK aircraft wreckage after the impact.

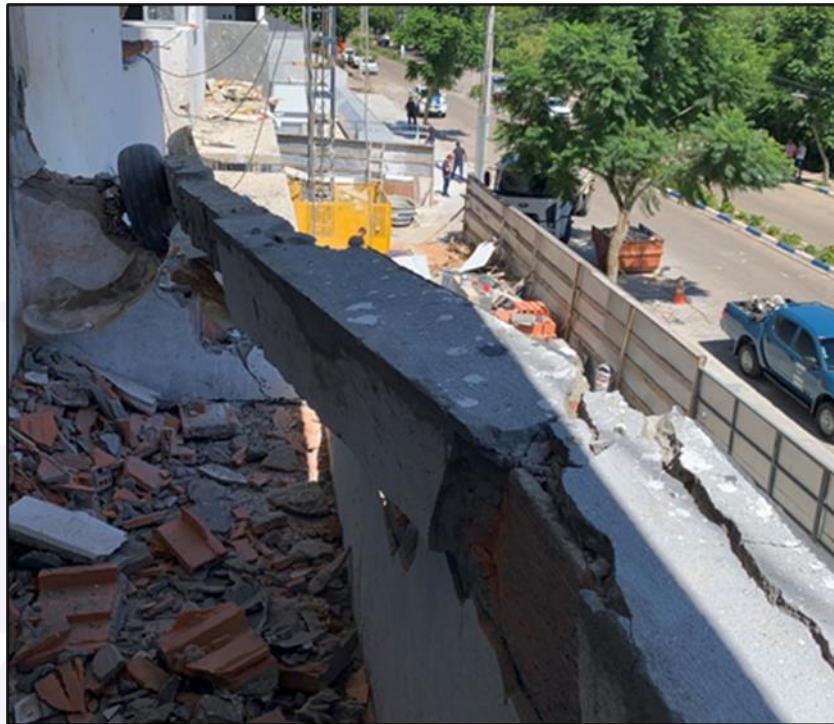
Part of the balcony of the apartment on the first floor of a building was damaged (Figure 2).

Figure 2 - View from the balcony of the apartment where the first impact occurred.

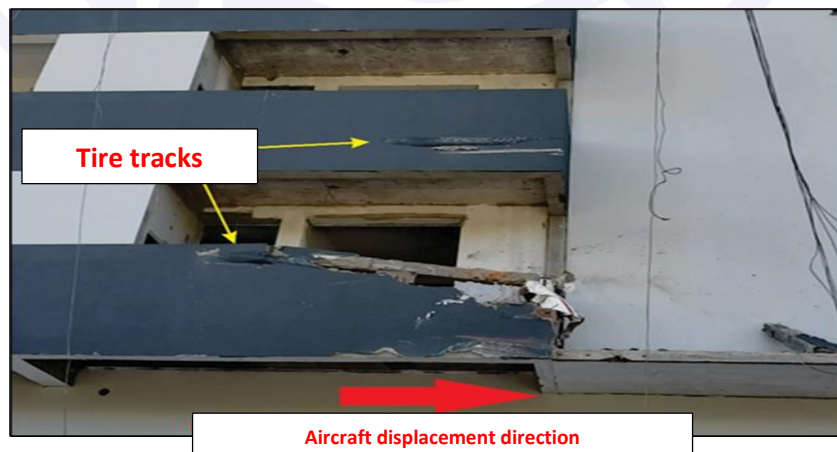
The first impact occurred in a leveled attitude and with wings inclination above 90° to the right, resulting in the collision of the main landing gears against the balcony of a building under construction, 300 m from the alignment of the SSBG threshold 31 (Figure 5).

Figure 5 - First point of impact of the PT-LOK against the building.

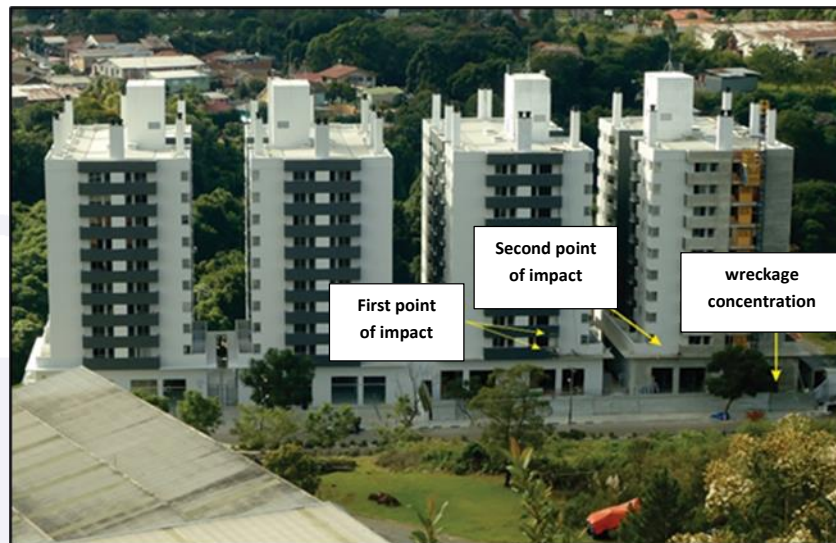
The second impact occurred in a similar way to the first one, however the collision was against the balcony of another building under construction, about 6m away from the previous

one. After the second impact, the aircraft collided with the ground and some civil construction equipment were totally destroyed (Figure 6).

Figure 6 - Overview of the aircraft impact points from SSBG threshold 31.

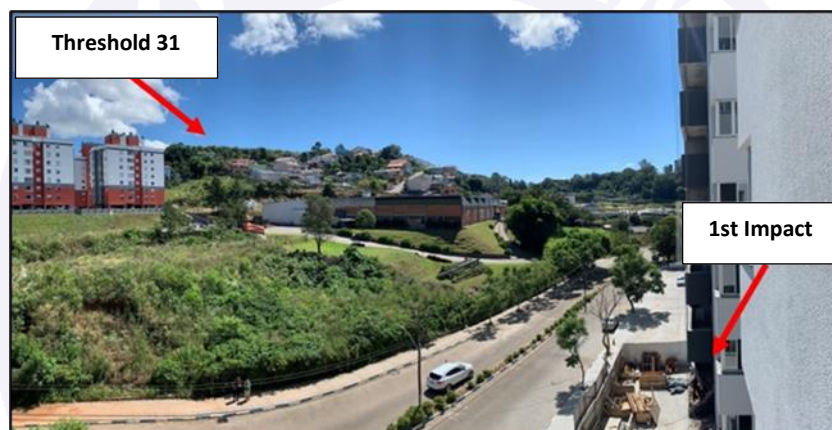
From threshold of runway 31 of SSBG, to street level at the accident site, there was a difference of 63m (Figure 7).

Figure 7 – View of threshold 31, from the building where the collision occurred.

From the threshold of the SSBG runway 31 to the street level of a building located 300m in line with the runway, there was a drop of 63m. Based on the reports of observers and on images from a security camera, which recorded the moment of impact, it was found that, after crossing the threshold 31, the aircraft descended below the level of the runway and reversed the inclination, performing a turn of great inclination to the right, until colliding with the building, with an estimated speed of 133 kt.

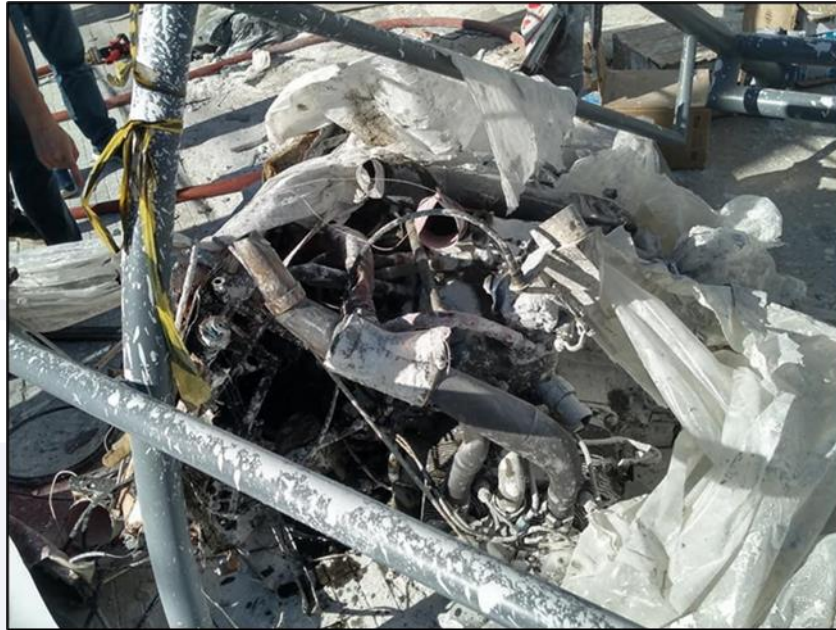
The aircraft crashed into the ground with great energy. The engine broke free and was thrown 30m away (Figure 8).

Figure 8 - View of the engine, after the impact of the PT-LOK against the building.

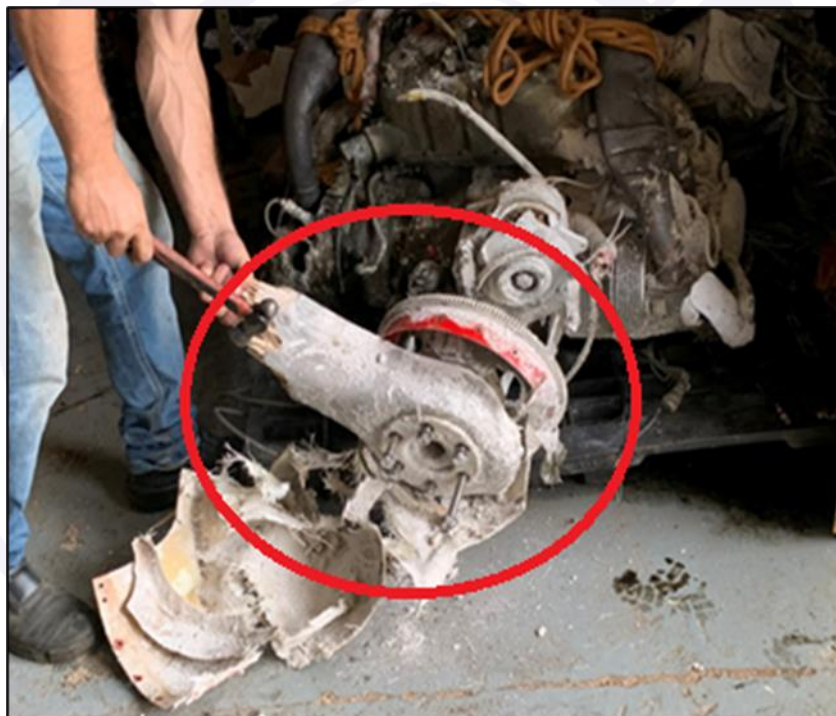
The propeller was made of wood and was destroyed on impact. Some larger pieces were found near the aircraft, and the root of one of the blades was partially intact, attached to the crankshaft (Figure 9).

Figure 9 - Detail of the root of the blade that remained attached to the shaft.

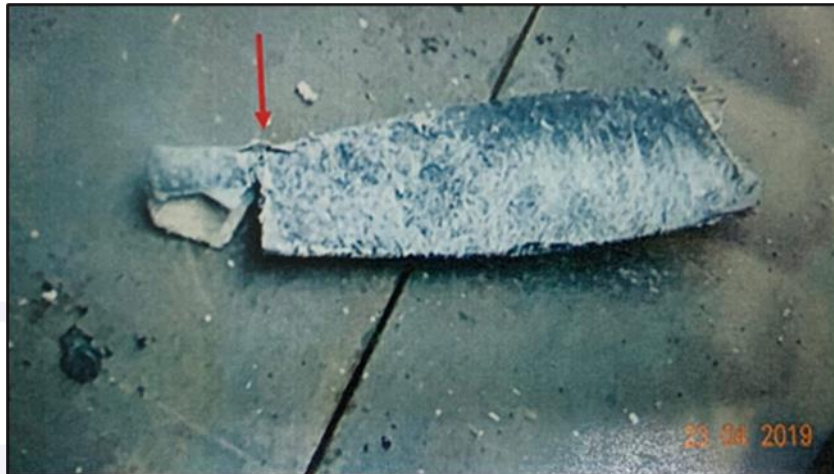
In Figure 10, the arrow indicates the point at the end of the blade where it collided with the obstacle, a fact that generated resistance to its movement and caused its breakage at the root, together with the fixation on the engine flange. It was also observed that there was a rupture at the end of this blade with a forward-facing displacement.

Figure 10 - View of the blade, highlighting the place where the collision occurred.

Analysis of the propeller identified that there was a break at the end of one of the forward-facing blades. On the opposite blade, it was observed that the point of collision with the obstacle was close to the root, resulting in a moment that caused the rupture of the wood fibers in a pattern that revealed that the engine was developing power at the moment of impact.

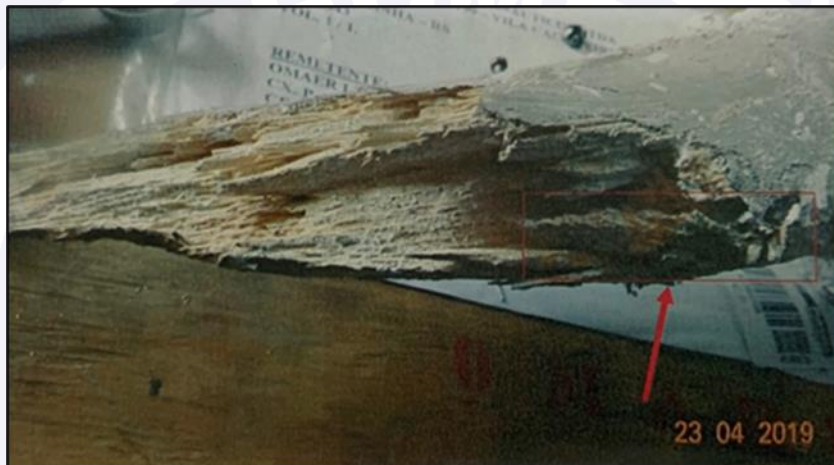
On the opposite blade, it was observed that the point of collision with the obstacle was close to the root, where the arrow in Figure 11 indicates the deformation in the wood fiber. This originated a moment that caused the rupture of fibers with different lengths, forming an angle close to 45°.

Figure 11 - View of the blade, highlighting the place where the collision occurred.

Such fractures would not be possible if the engine was stopped or with low power at the moment of the collision.

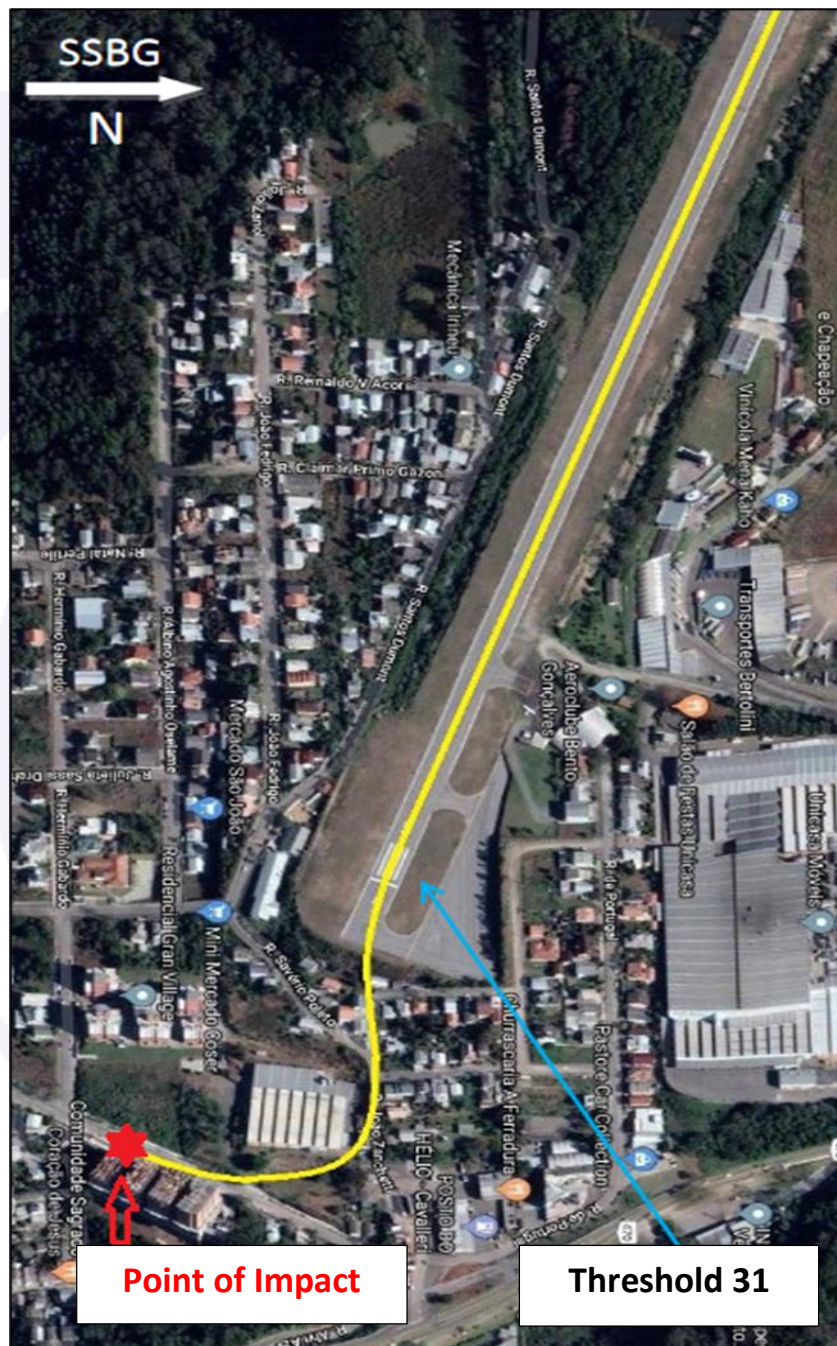
According to reports from observers who were in the region of the accident, the aircraft would have traveled a flight path as illustrated in Figure 12.

Figure 12 - Flight path estimated based on observers' information.

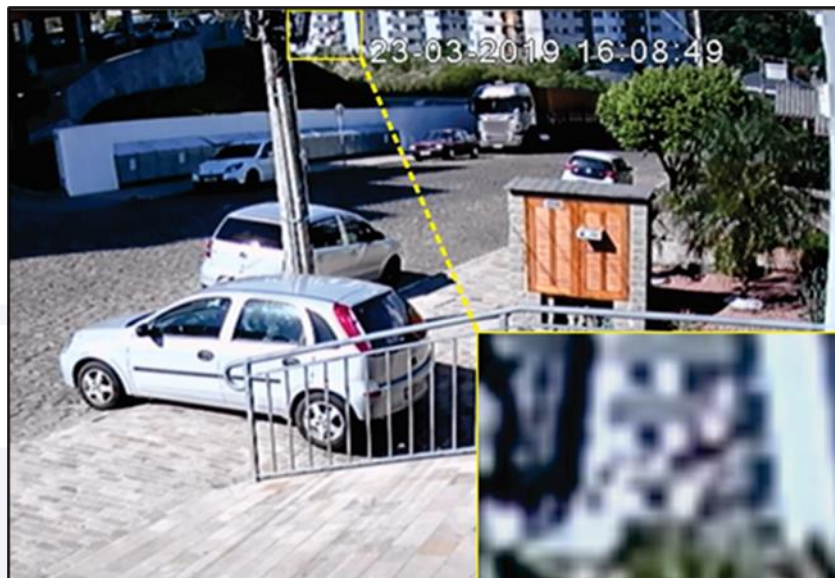
During the investigation, a video generated by a security camera was identified, and it recorded the moment of impact of the aircraft, with a recording rate of 12 Frames Per Second (FPS) (Figure 13).

Figure 13 - Image captured by the security camera with an emphasis on the aircraft.
(clock adjusted to the HBV).

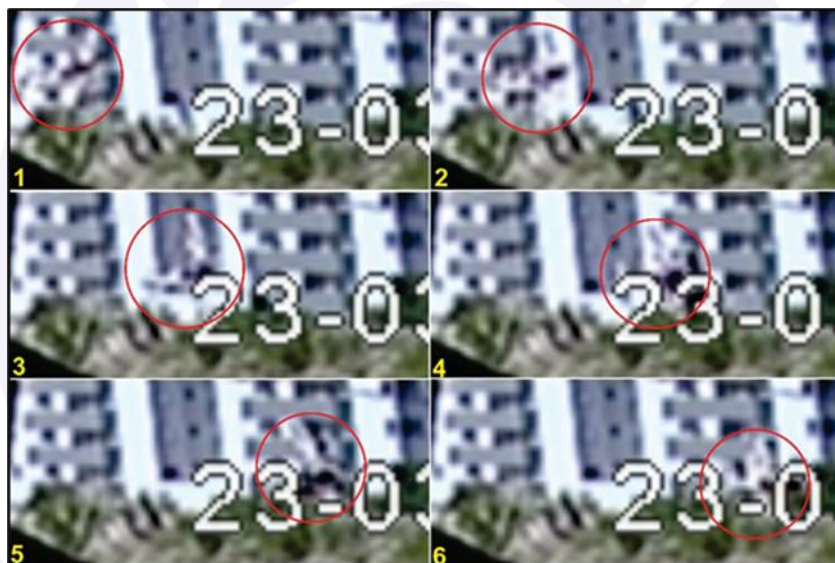
The sequence of images in Figure 14 (frame by frame numbered from 1 to 6) shows the aircraft with a 60° roll to the right (frame 1) and, in the sequence, with an inclination increasing from 90° (frame 2) until the moment of impact (frame 5).

Figure 14 - Frame sequence showing the collision between the aircraft and the building.

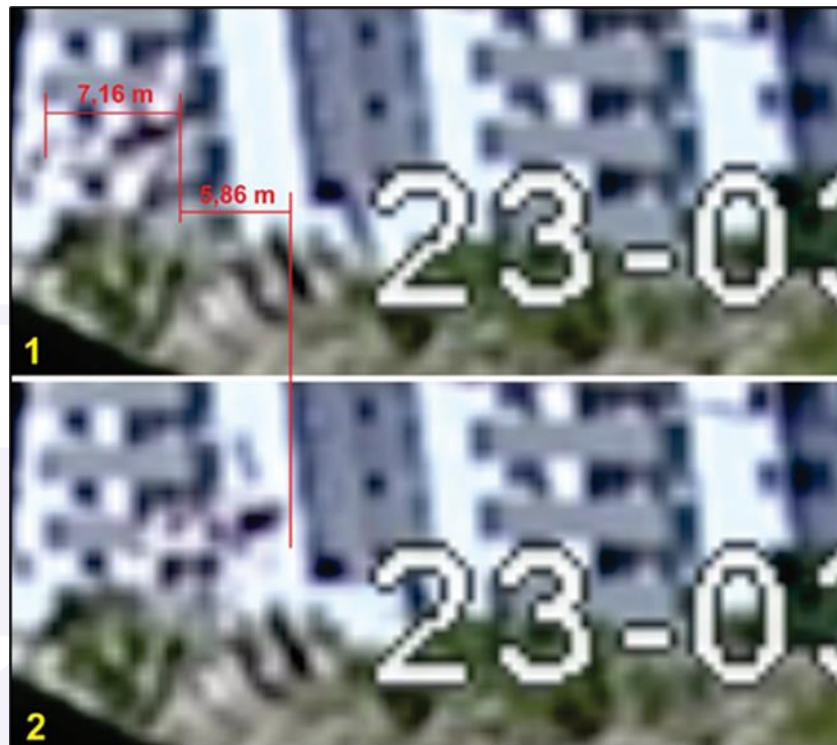
Taking as reference the first two frames of the sequence, as well as the dimensions of the CAP-10B aircraft, it was possible to calculate the aircraft's ground speed.

Thus, considering the uncertainties generated by the low image quality and the 12 FPS rate, it was possible to estimate that the aircraft's speed at the moment of impact was 133 ± 5 kt (Figure 15).

Figure 15 - Measurements for calculating the aircraft's speed during the impact.
