COMANDO DA AERONÁUTICA
CENTRO DE INVESTIGAÇÃO E PREVENÇÃO DE
ACIDENTES AERONÁUTICOS

FINAL REPORT
A - 144/CENIPA/2019

OCCURRENCE:	ACCIDENT
AIRCRAFT:	PT-LTJ
MODEL:	550
DATE:	14NOV2019

This is the Final Report of the 14NOV2019 accident with the 550 aircraft model, registration PT-LTJ. The accident was classified as “[USOS] Undershoot / Overshoot – Undershoot”.

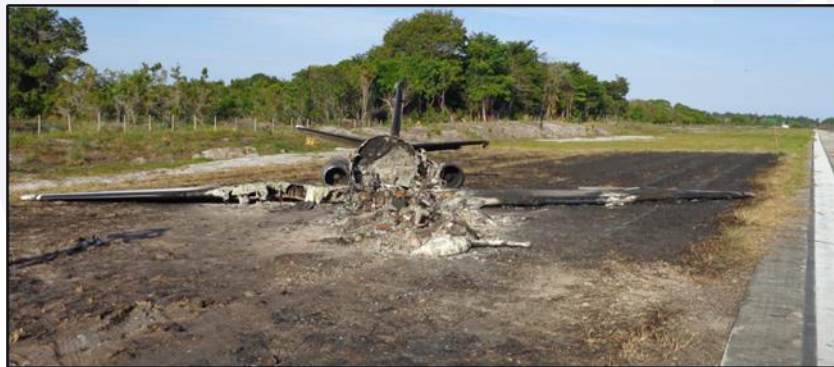
The aircraft was destroyed (Figure 1).

Figure 1 - Placement of the wreckage.

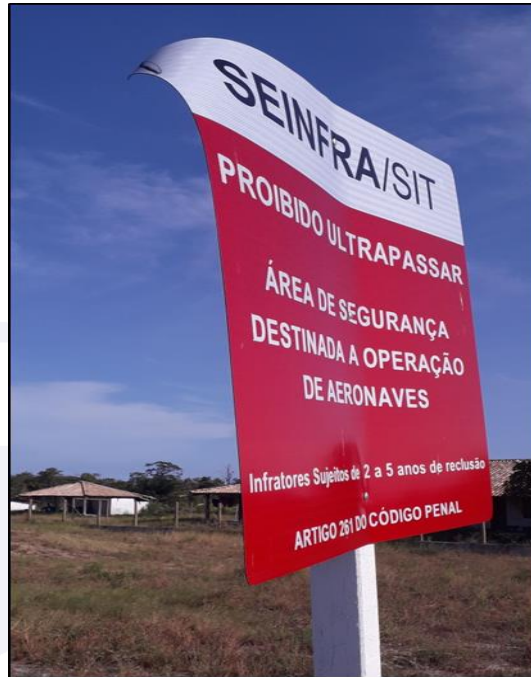
A signpost, located approximately 70 meters from the threshold 11, had damage at the top (Figure 2).

Figure 2 - Signpost damage.

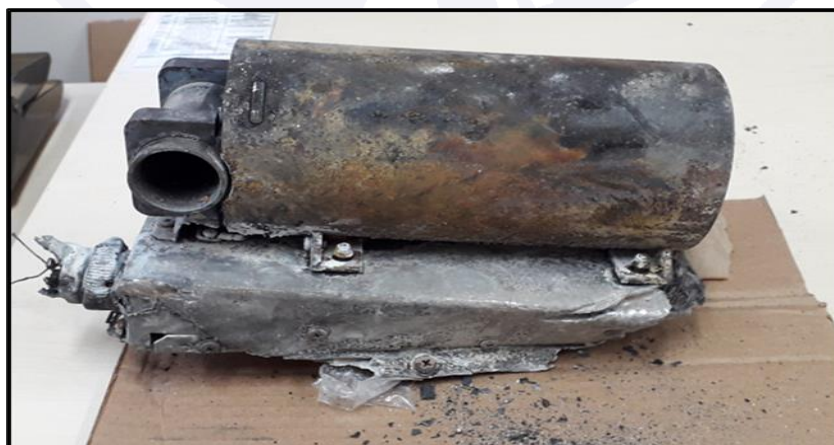
Figure 6 - Cockpit Voice Recorder that equipped the aircraft.

However, after downloading the data, it was found that the existing audio did not match the one of the accident flight.

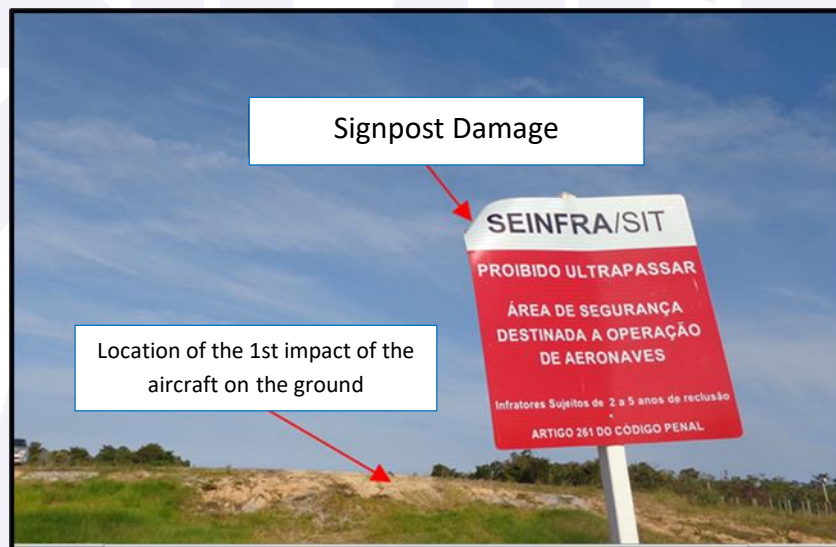
In the final approach for SIRI, the aircraft touched a signpost, located before the runway and hit a ravine 21 meters ahead (Figures 7 and 8).

Figure 7 - Damaged signpost and location of the aircraft's first impact on the ground.

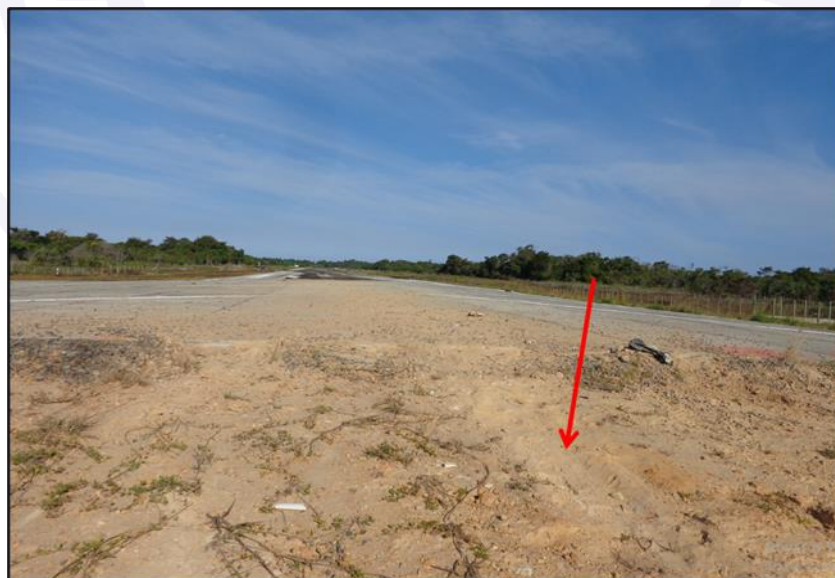
Figure 8 - Location of the first impact on the ground.

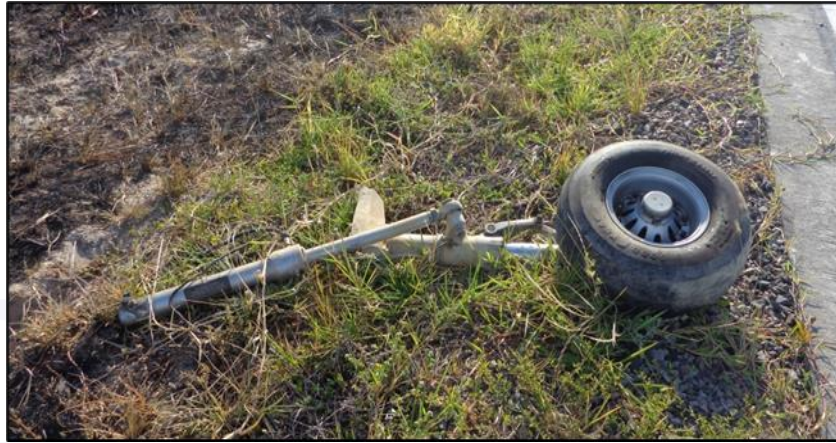
As a result of the impact with the ravine, there was the breakage of the main and auxiliary landing gears, as well as their respective doors and actuating cylinders (Figures 9, 10 and 11).

Figure 9 - Right main landing gear with the actuator cylinder.

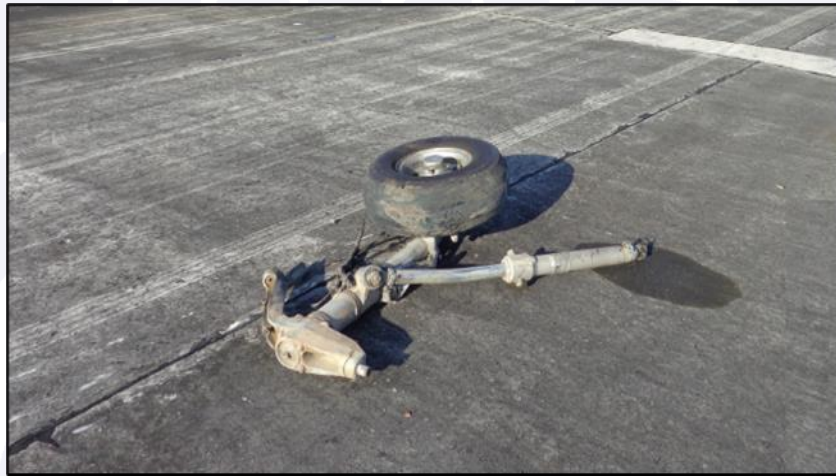
Figure 10 - Left landing gear with the actuator cylinder.

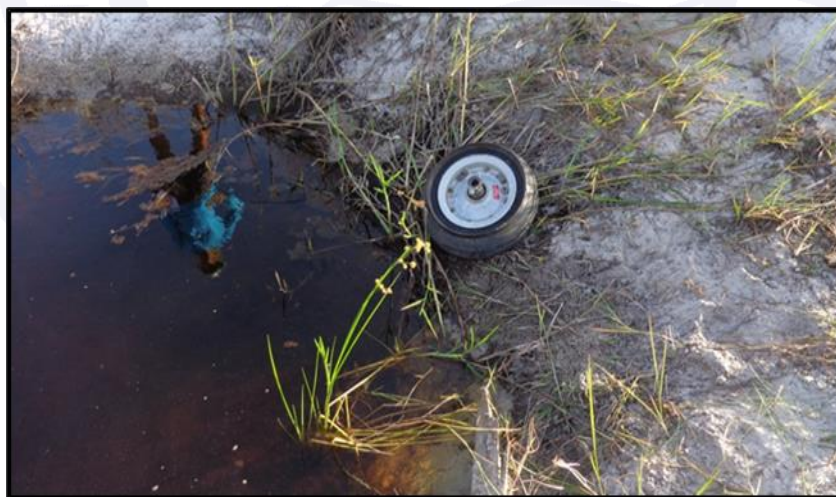
With the breakage of the auxiliary landing gear, the wheel was thrown to the right, stopping outside the Aerodrome isolation fence, approximately 250 meters away (Figure 11).

Figure 11 - Auxiliary landing gear wheel.

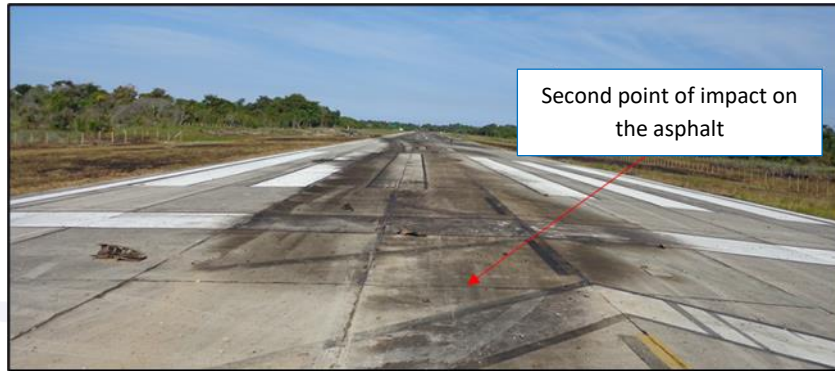
After the first impact with the terrain, the aircraft went up and surpassed the ravine. When crossing the threshold 11, the pilot commanded the touch of the aircraft on the runway, which occurred 47 meters ahead (Figures 12 and 13).

Figure 12 - Second point of impact.

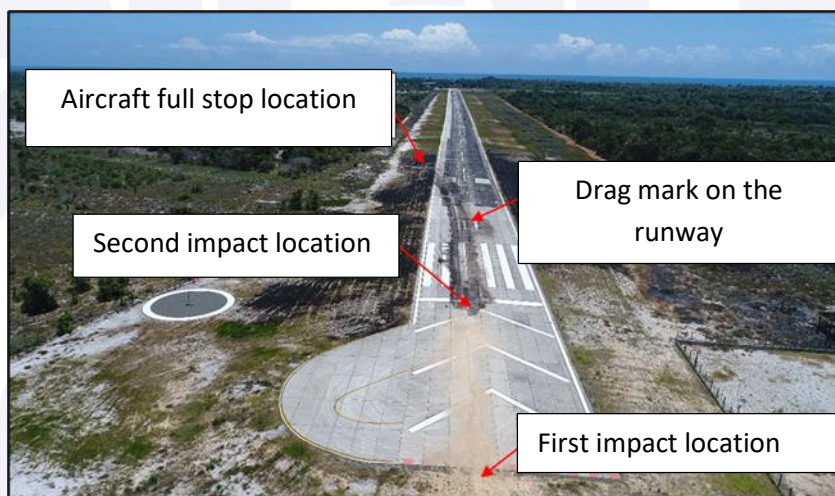
The aircraft dragged for 147 meters, catching fire. During this displacement, he left a trail of fire, turned left, leaving the runway by its left side (Figure 13), stopping with the heading lagged approximately 210° from the landing path (Figure 14).

Figure 13 - Marks on the runway indicating the impact and drag locations of the aircraft.

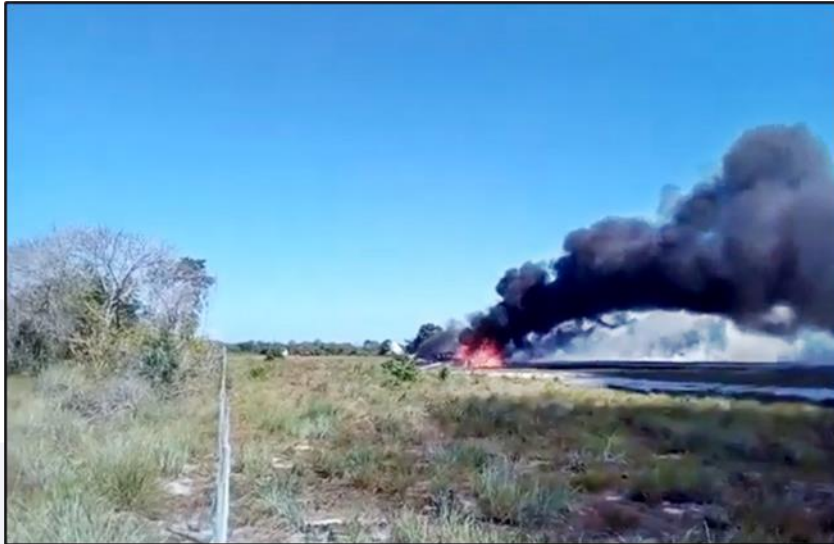
After the impact with the terrain, the tanks of the wings broke, making a trail of fuel on the runway. The fire followed the fuel trail until reaching the aircraft on its stopping point. (Figure 15).

Figure 15 – Accident site seen from a distance.

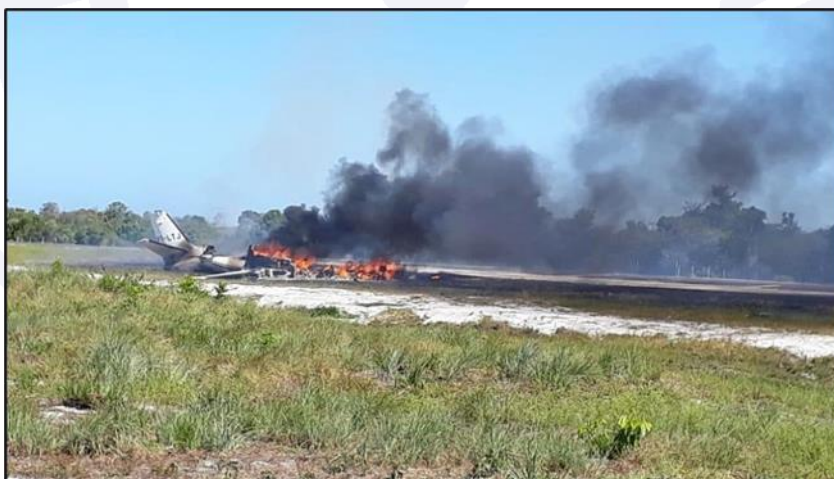
The aircraft was destroyed by fire (Figure 16).

Figure 16 - Destroyed aircraft and extension of the flames.

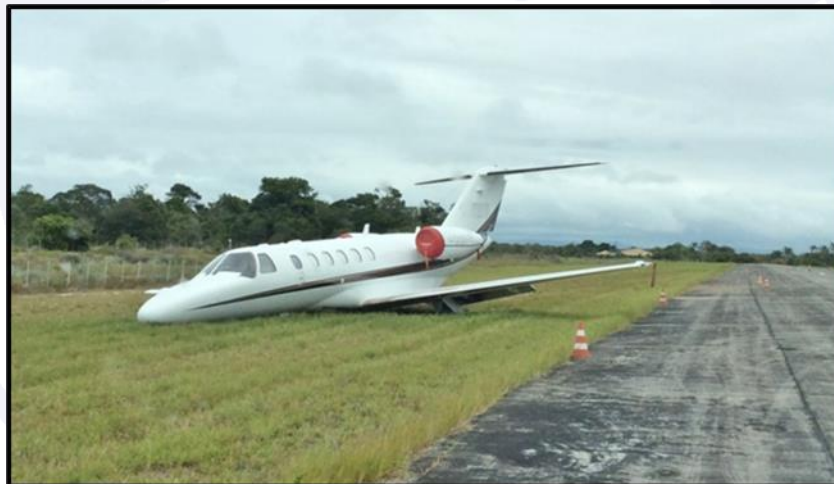
When leaving the runway, the auxiliary landing gear ruptured. The plane stopped out of the paved area, with the left-wing tip over the right side of the runway (Figure 23).

Figure 23 - View of the crashed aircraft.

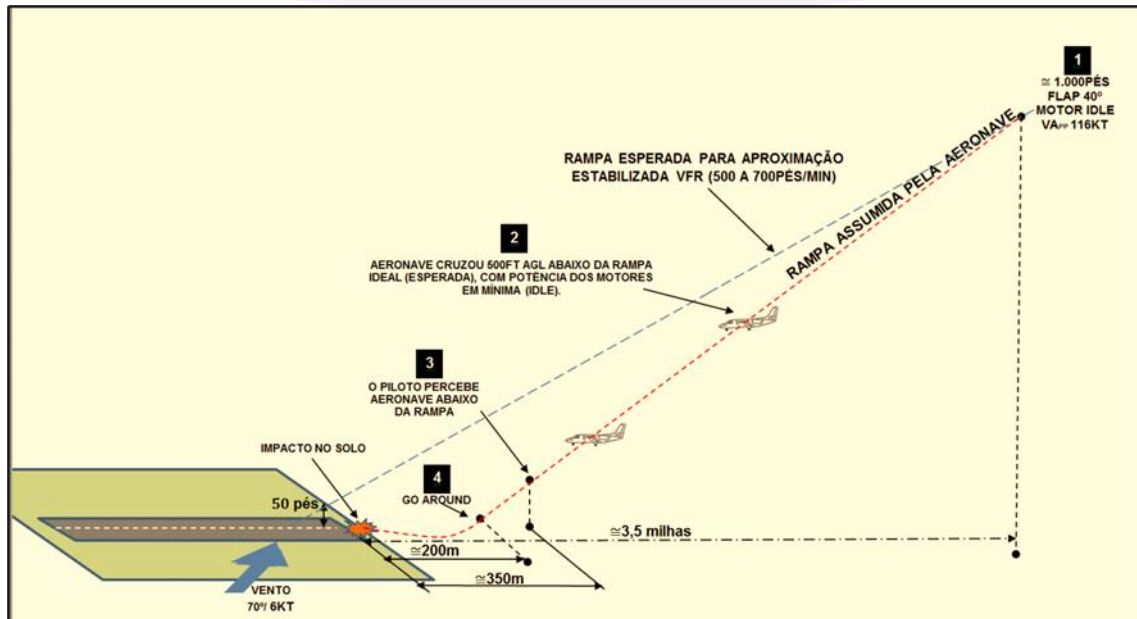
When momentarily diverting their attention from the flight, the pilots did not realize that the aircraft had crossed the 500ft AGL (n° 2 - Figure 30) with a rate of descent greater than the ideal and on a ramp below the desired for that situation, therefore, outside the recommended parameters for the VFR stabilized approach.

The aircraft remained with the engine power at a minimum, until the pilots realized they were below the ideal ramp, very close to the threshold 11, less than 1/4 of a Nautical Mile, approximately 350m (n° 3 - Figure 30), when the PF started the go-around procedure (n° 4 - Figure 30).

Figure 30 - Approach profile, according to the data from the second hypothesis.
