FINAL REPORT
IG-032/CENIPA/2017

OCCURRENCE:	SERIOUS INCIDENT
AIRCRAFT:	PT-MZY
MODEL:	A320-232
DATE:	22FEB2017

This is the Final Report of the 22FEB2017 serious incident with the A320-232 aircraft, registration PT-MZY. The serious incident was classified as “[SCF-PP] System/Component Failure or Malfunction Powerplant / Engine Failure on the Ground”, “[LOC-G] Loss of Control – Ground and [RE] Runway Excursion.”

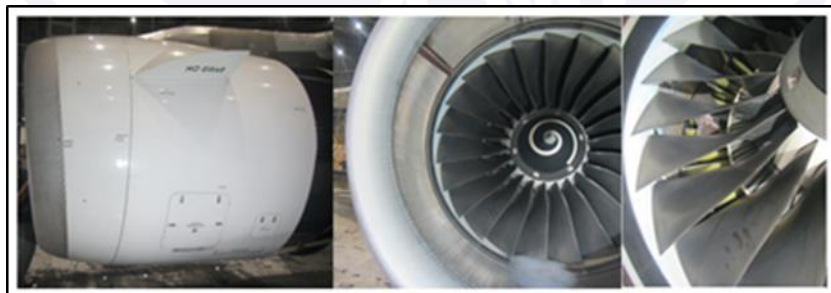
Figure 2 shows an overview of the right engine, where the location of the air intake and the region where the external damage occurred due to the separation of the annulus fillers can be identified.

Figure 2 - Right engine overview, air intake and detail of external damage.

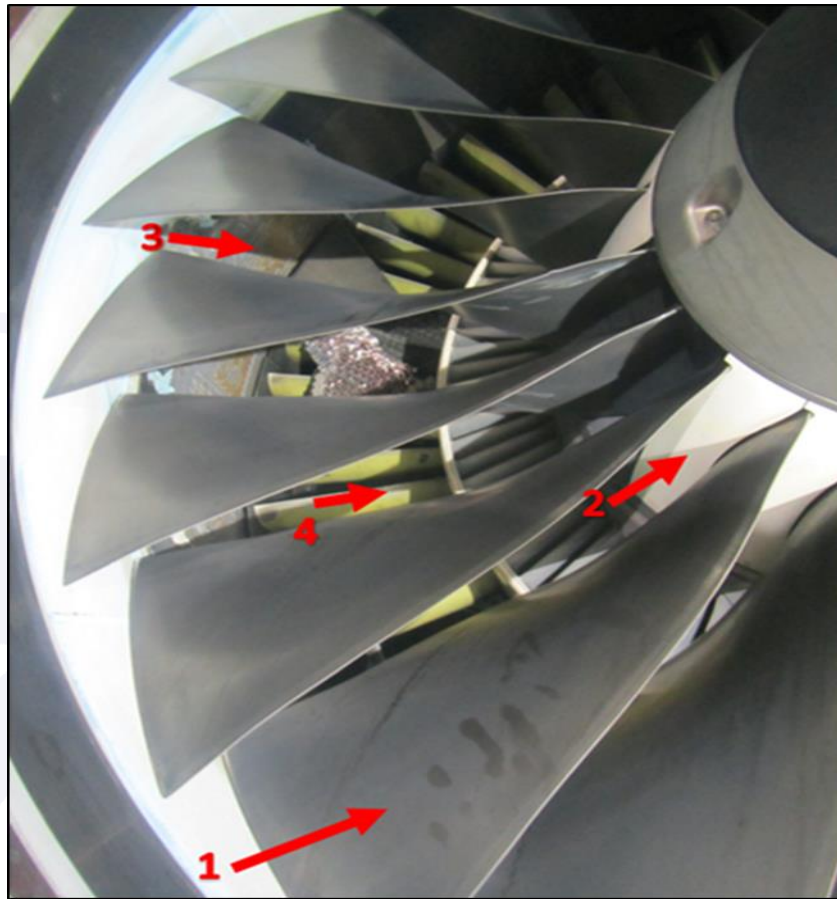
Figure 3 - Right engine, detail of fan blades (1), annulus filler (2), acoustic panels (3) and guide vanes (4).

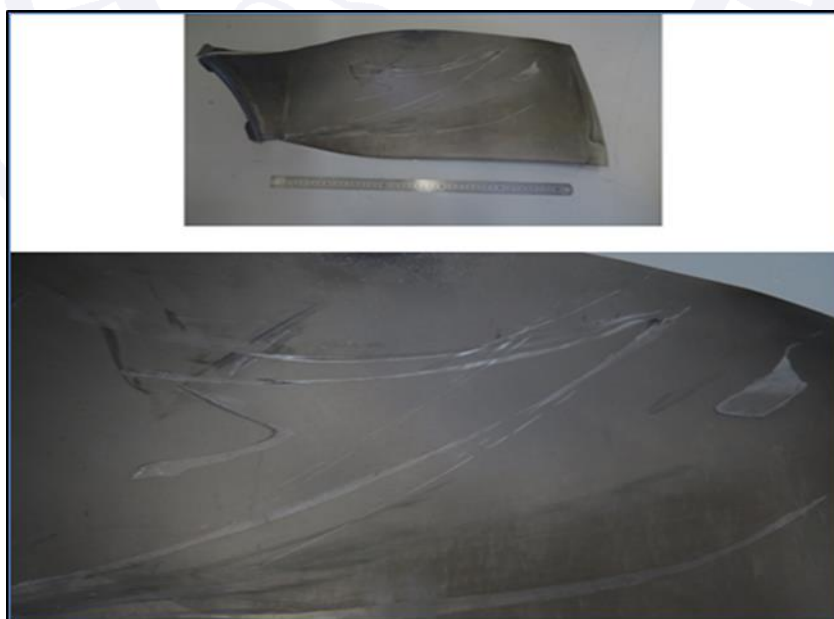
Figure 5 - Detail of damage to one of the blades.

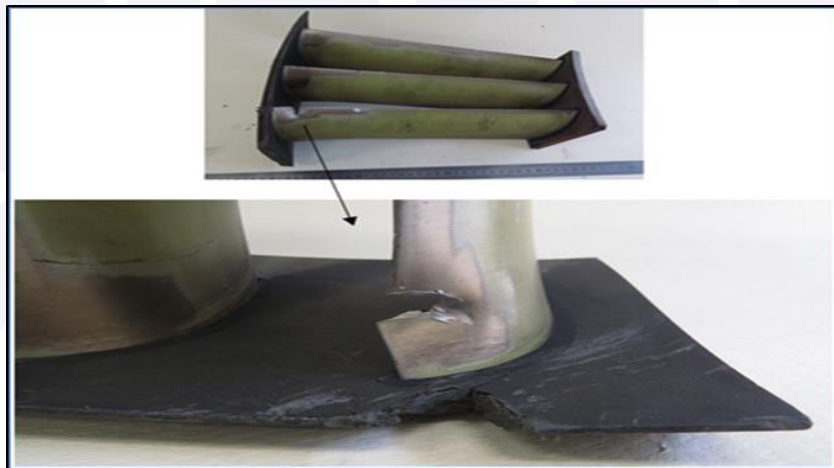
By means of a visual and stereoscopic analysis, it was observed that the fractures of the annulus fillers, acoustic lining panels and guide vanes occurred from impacts and presented typical characteristics of overload, as shown in Figures 7 to 9.

Figure 7 - Damage detail on one of the fan exit guide vanes.

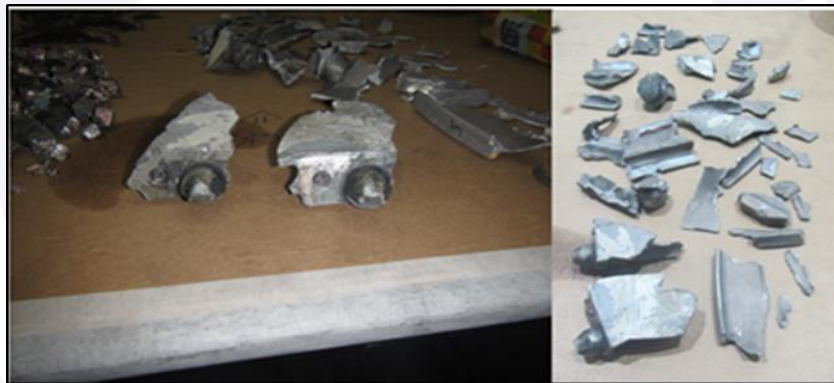
Figure 8 - Annulus filler that separated from the engine.

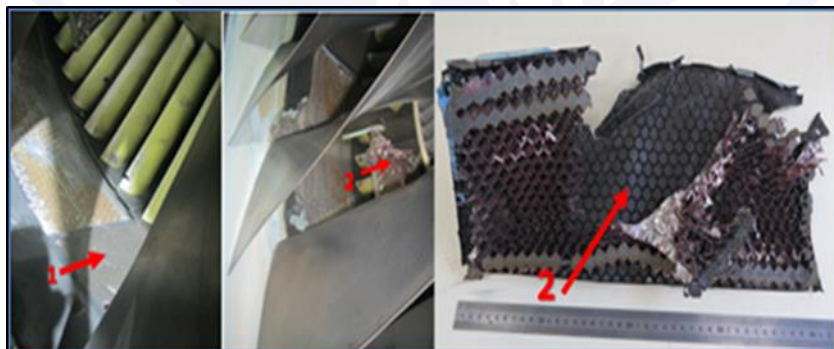
Figure 9 - Acoustic lining panels installed (1) and separated from the frame (2).

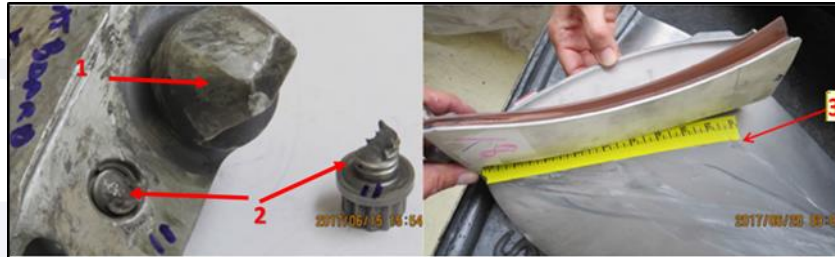
- FAN module: blades #4 and #5 of the fan disc presented impact marks compatible with the shape of an annulus filler. The white coloration of these marks was also compatible with the color of the annulus filler. Blades #18 and #19 showed small kneading at their trailing edge, about two inches from the end. The fragments of annulus fillers #5 and #6, which were recovered and submitted to analysis, were still with parts of their screws threaded, and also the front and rear attachment posts were incorporated into their structure (Figure 13);

Figure 13 - Annulus filler: post (1) and screw (2). Brands on Blade (3).

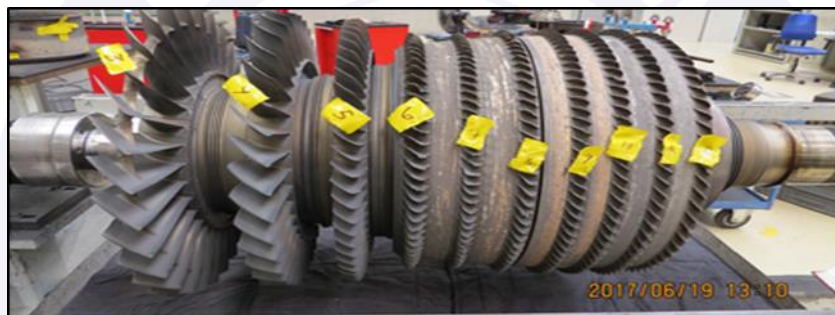
- High Pressure Compressor Module: The high-pressure module presented severe thermal and mechanical damage. Several vanes and blades from 5th to 12th stages were fractured and missing parts of their structures (Figure 14);

Figure 14 - Fractured blades of the high-pressure compressor.

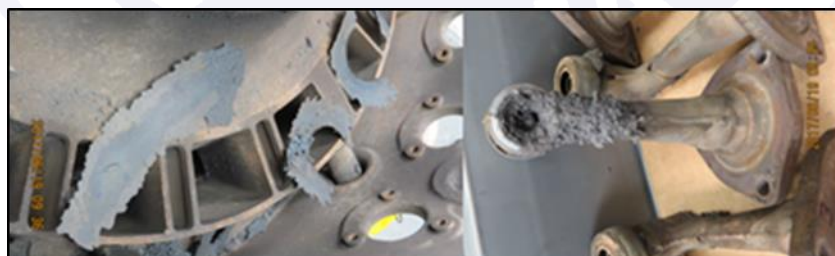
- Diffuser and Combustion Module: in the diffuser housing, there was a large amount of melted wreckage in the form of flakes. These debris were compatible with the shape and the constituent material of the combustion chamber. In the Outlet Guide Vanes (OGV) of the compressor and in all twenty fuel nozzles there were also melted debris (Figure 15);

Figure 15 - Diffuser housing and fuel nozzle with melted debris.

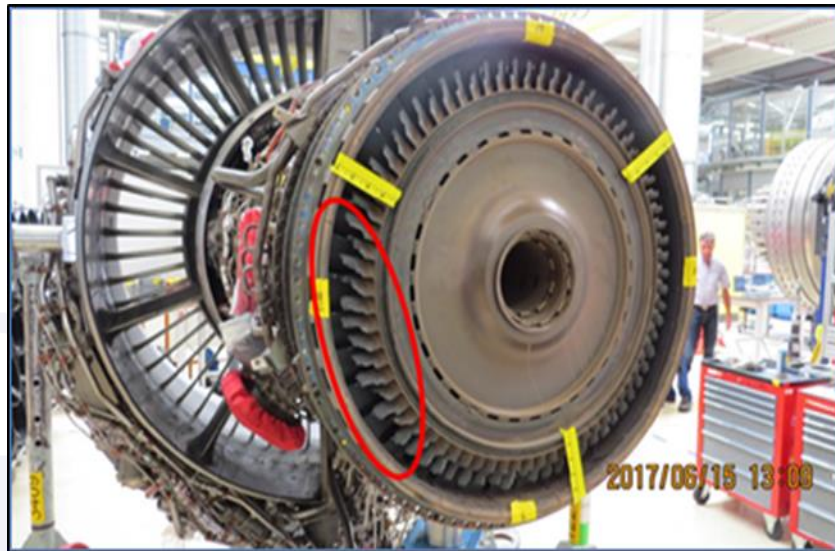
- High Power Turbine Module: all blades of the 2nd stage were fractured in different lengths, as observed in Figure 16. The blades of the 1st stage did not present fractures, but there were melted debris deposited on the leading edges of all of them;

Figure 16 - Fractured 2nd stage blades.

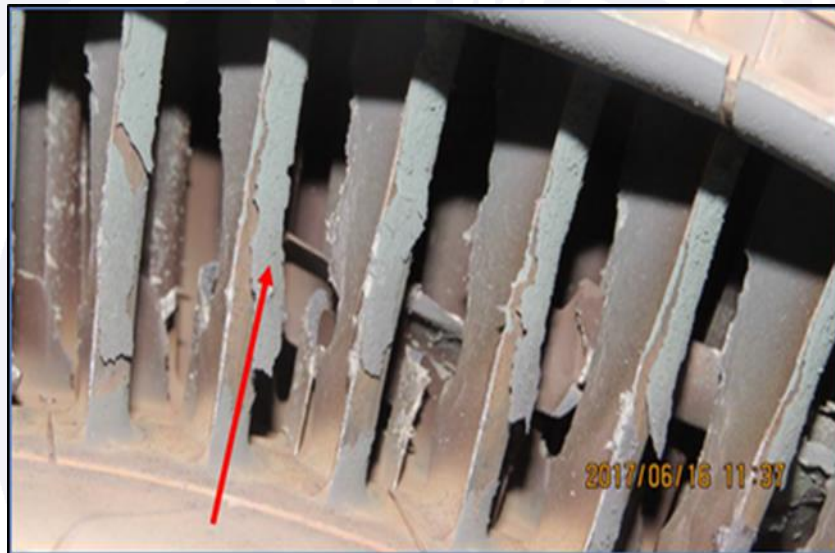
- Low Power Turbine Module: On the first set of vanes, there were melted debris and their trailing edges showed loss of material, according to Figure 17.

Figure 17 - Melted debris in low power turbine vanes.

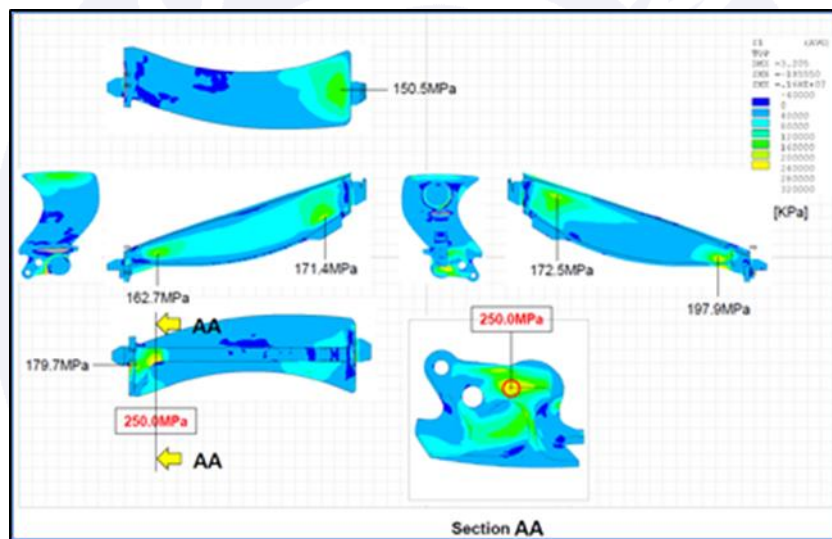
When comparing the results of the maximum main tension distribution with the fragments of annulus fillers, which were detached from the engine and which did not receive significant additional impacts, it was possible to verify a similarity between the shape of these fragments and the contour of the areas of the different main tensions, as shown in Figure 19, in the blue, green and yellow colors.

Figure 19 - Result of the maximum main tension distribution.

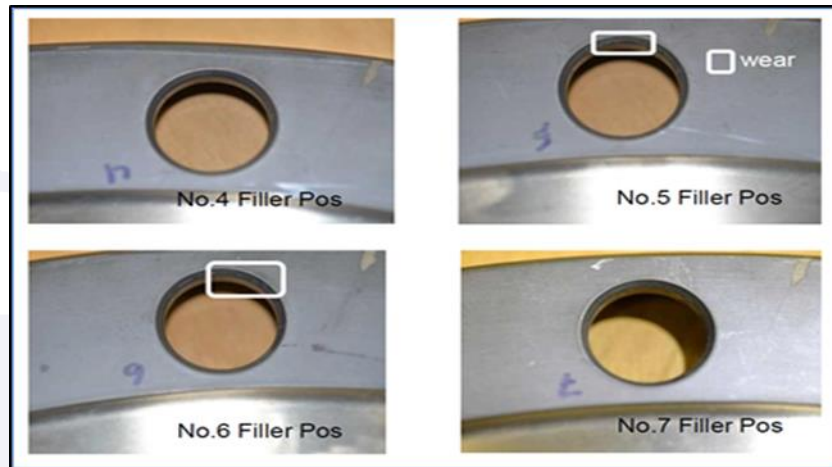
- for annulus fillers and rear blade retaining ring, a number of contact marks were identified for the rear attachment points (AFT trunnion) of all annulus fillers with the ring retainer, with the exception of annulus fillers # 4, 5, 6 and 7, as shown in Figure 23.

Figure 23 - Plug holes in the rear ring retainer without contact marks of the annulus fillers.

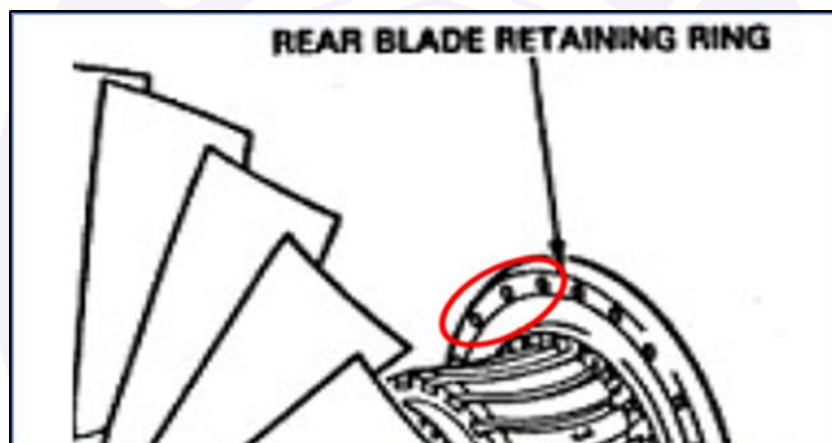
These marks occurred due to the contact with the rear ring retainer by centrifugal force. Based on these marks, it was considered that the relative axial positioning between the rear ring retainer and annulus filler #4, during the engine operation was different from a normal condition (Figure 24).

Figure 24 - Detail of the holes location in the rear ring retainer.

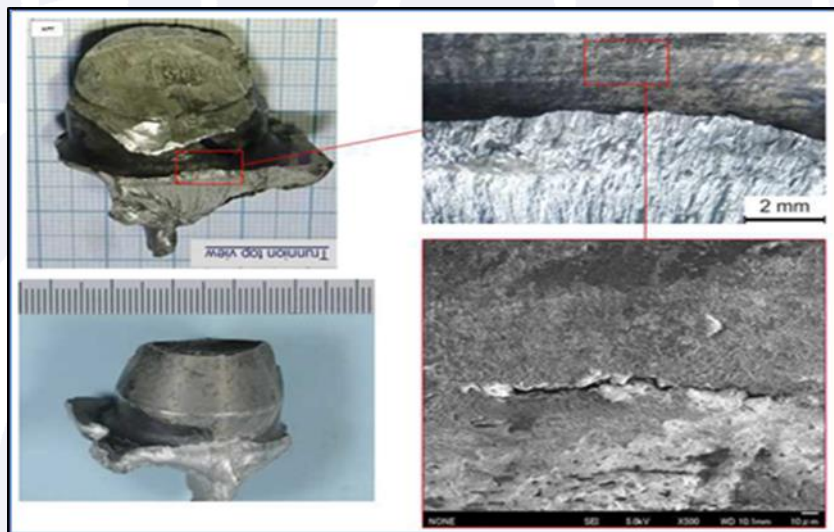
Figure 26 shows the microscopic image of a crack identified at the rear trunnion of annulus filler #5.

Figure 26 - Crack found at the rear trunnion of annulus filler # 5.

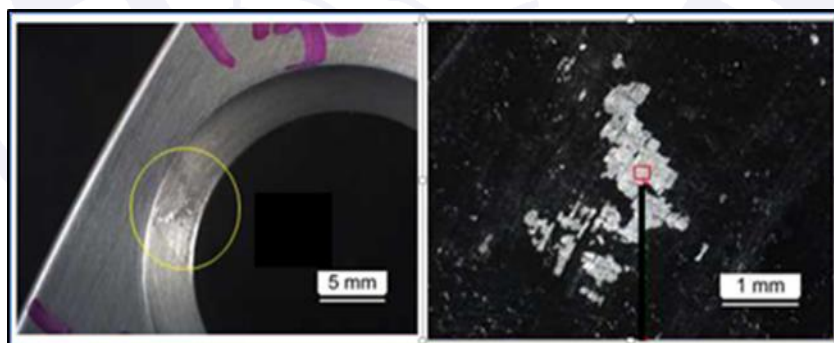
- Regarding the front blade retaining ring, aluminum alloy powder residues were found deposited in the annulus filler #5, as can be seen in Figure 27.

Figure 27 - Aluminum alloy powder waste in the front ring retainer.

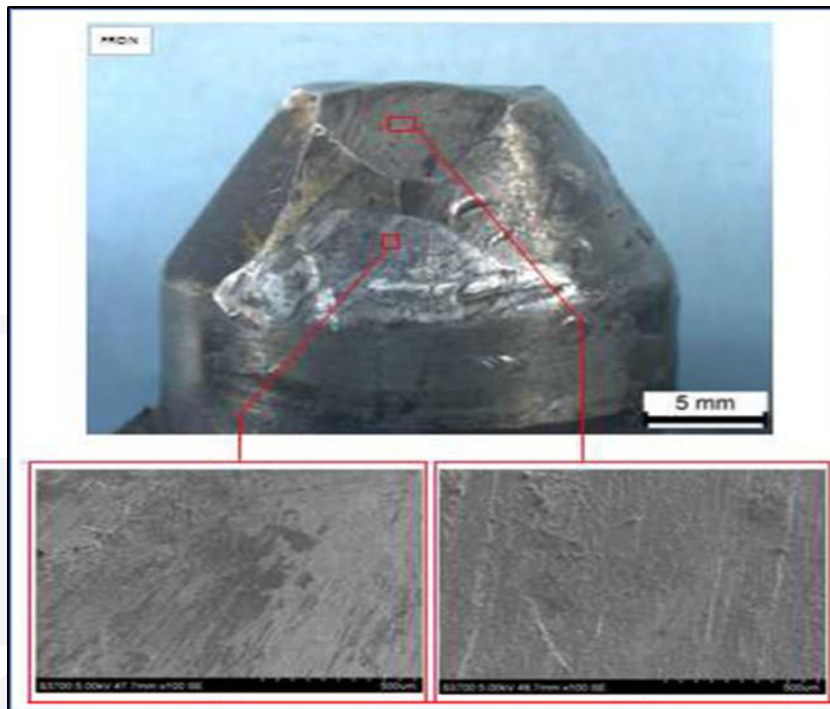
The powder was produced by cyclic wear during the engine operation through the contact points of the annulus filler with the front ring retainer (Figure 28).

Figure 28 - Contact points of the annulus filler with the front ring retainer.
