COMANDO DA AERONÁUTICA
CENTRO DE INVESTIGAÇÃO E PREVENÇÃO DE
ACIDENTES AERONÁUTICOS

FINAL REPORT
A - 142/CENIPA/2018

OCCURRENCE:	ACCIDENT
AIRCRAFT:	PT-OCB
MODEL:	F33A
DATE:	01SEPT2018

This is the Final Report of the 01SEPT2018 accident with the F-33A aircraft model, registration PT-OCB. The accident was classified as “[OTHR] Other | Loss of Consciousness”.

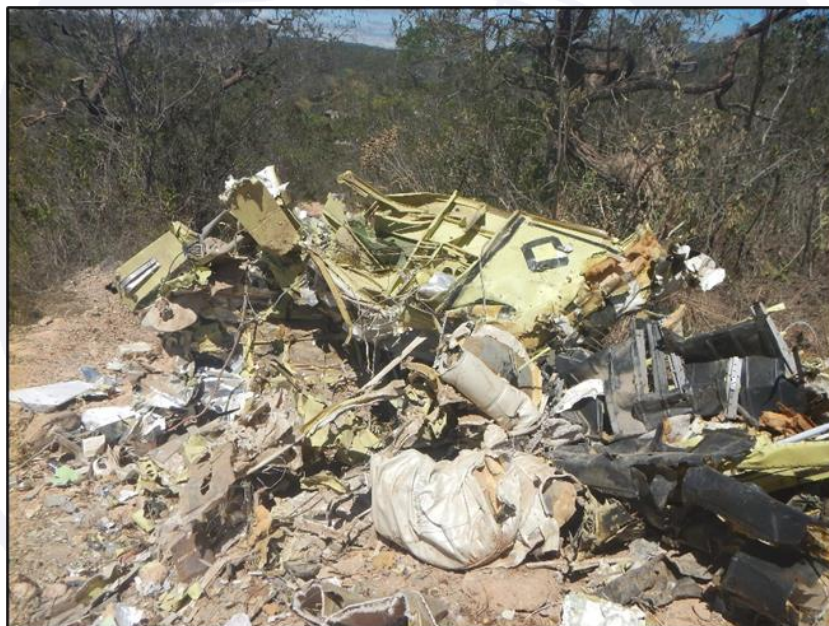
The first and only impact occurred in a pitch up attitude with a high angle (approximately 90° to the ground surface) and great speed, which caused the engine to enter hard ground (about 1.5 meters deep).

Due to the high energy of the impact, the entire structure was twisted. The wings and flight controls detached from the aircraft and were in a position posterior to the final position of the cabin and fuselage. The retractable landing gear has also come off its larger set.

All surfaces of the aircraft's primary and secondary controls were found at the crash site (Figure 1).

Figure 1: Aircraft wreckage concentrated at the accident site.

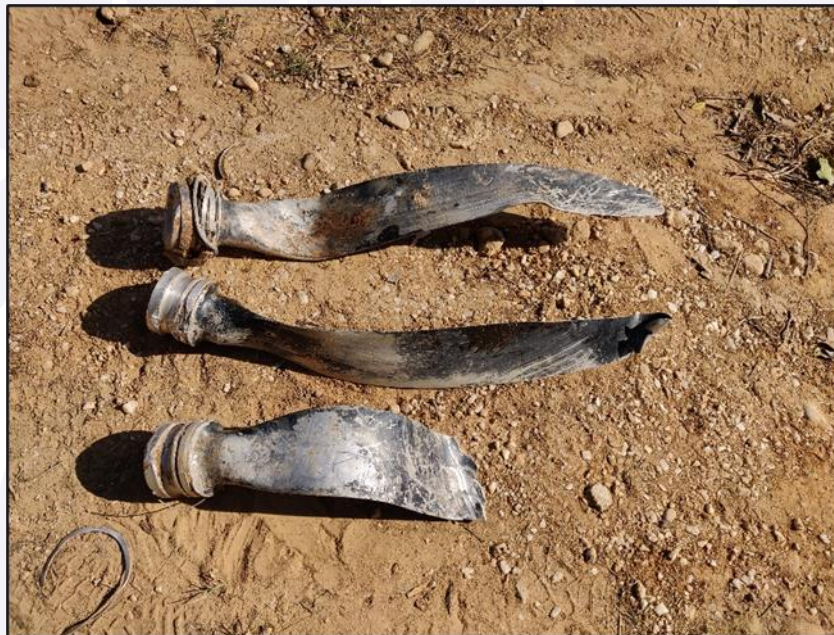
The characteristics of the damage to the engine and the propeller blades were torsions and ruptures by overload. The conclusions of the analysis showed that the engine had evidence that it was operational and that it was developing power at the time of the accident. In addition, the propeller blades showed deformations and breaks characteristic of an engine that developed power at the moment of the impact against the ground, corroborating the conclusions of the analysis of the aircraft engine (Figure 2).

Figure 2 - Propeller blades with torsions and ruptures typical of power impact.

- n) the propeller blades had deformations and ruptures, characteristic of an engine that developed power at the moment of the impact against the ground;
