COMANDO DA AERONÁUTICA
CENTRO DE INVESTIGAÇÃO E PREVENÇÃO DE
ACIDENTES AERONÁUTICOS

FINAL REPORT
A - 018/CENIPA/2013

OCCURRENCE:	ACCIDENT
AIRCRAFT:	PT-OGL
MODEL:	208
DATE:	25JAN2013

This is the Final Report of the 25JAN2013 accident with the 208 aircraft, registration PT-OGL. The accident was classified as “[USOS] Undershoot/Overshoot - Undershoot”.

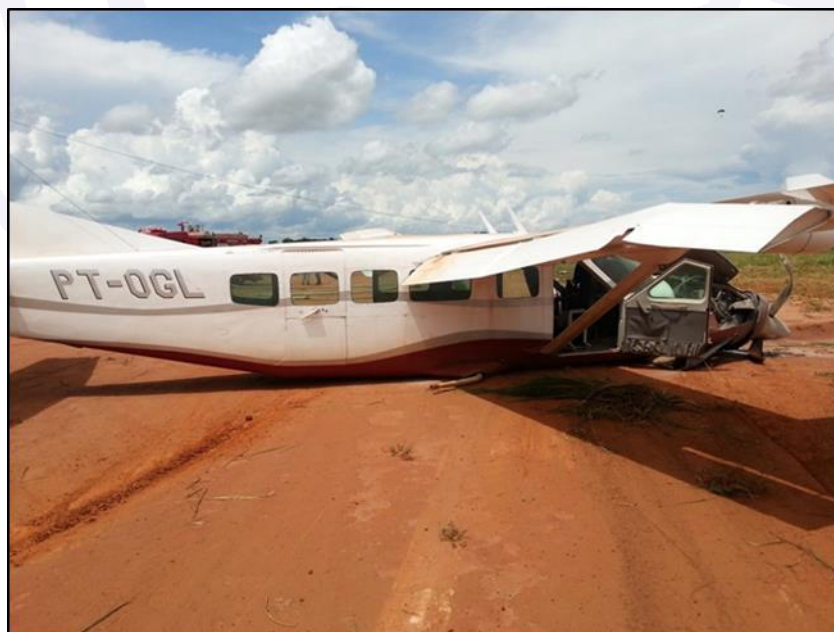
The landing gear, of the fixed type, broke during the impact against the ravine (Figure 1).

Figure 1 - Overview of the aircraft, with damage to the propeller, flaps and landing gear.

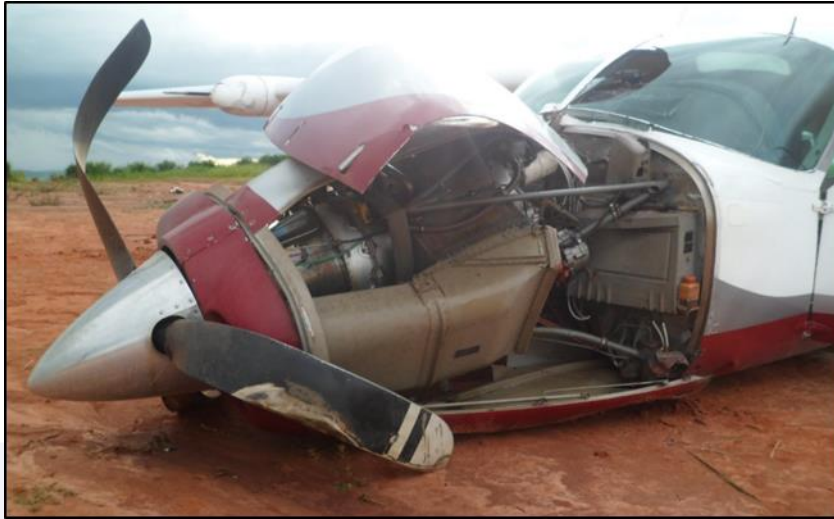
The two engine access doors were pulled out of their original position. The weather radar fairing was broken, as well as part of the left windshield. (Figure 2).

Figure 2 - Damage to the propeller, engine and left windshield.

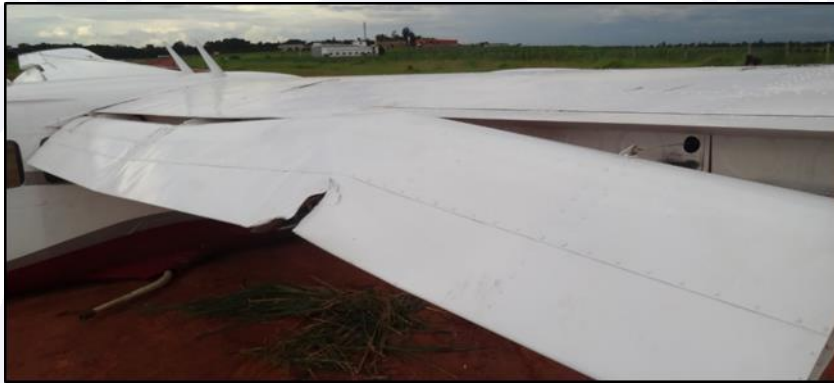
The flaps were lowered and presented kneading (Figure 3).

Figure 3 - Damage to the flaps.

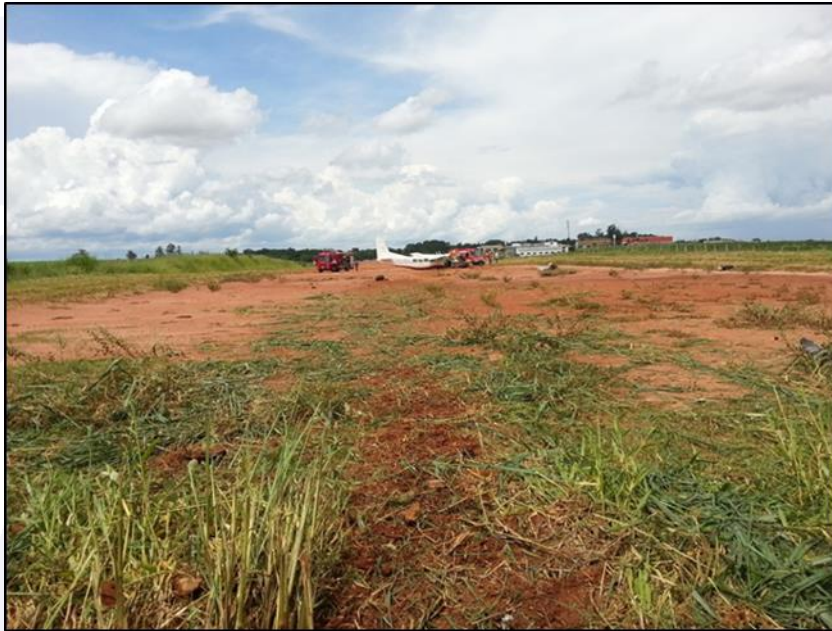
After the impact, the aircraft dragged along the runway, in the same direction as the landing, 78 meters ahead, turning approximately 90° in relation to the axis of the runway to the right, stopping completely (Figure 4).

Figure 4 - Overview from threshold 06.

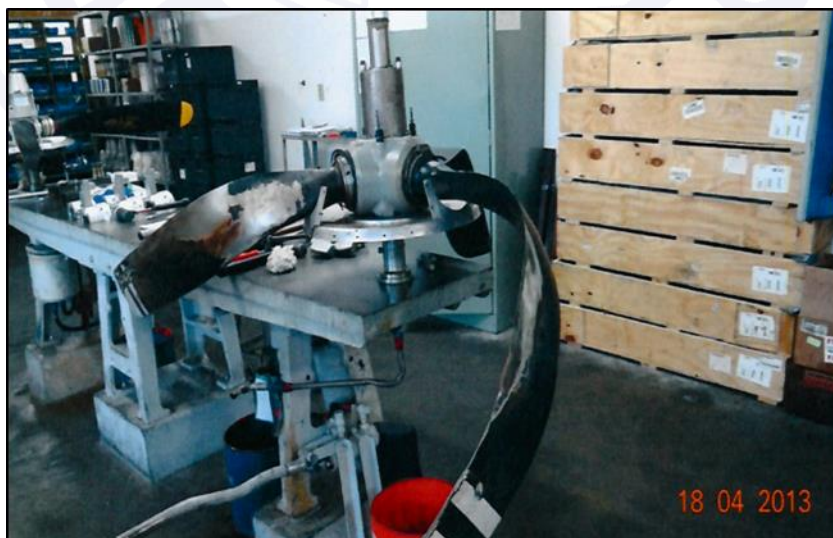
According to the tests, the engine propeller had a characteristic of impact without power as the moment the aircraft crashed into the ground. Two blades were folded close to the root and indicated that there was an immediate stop caused by the weight of the aircraft above them (Figure 5).

Figure 5 - Overview of the propeller.

In addition, the tests revealed that the propeller had characteristics of impact without power at the moment the aircraft collided with the ground. Two blades were folded close to the root and indicated that the immediate stop was caused by the weight of the aircraft above them.

The propeller in reverse pitch has a negative value and produces a negative traction, which uses engine power. If this had actually happened, the evidence would indicate a characteristic of damage to the propeller blades other than those found during the investigation.
