FINAL REPORT
A - 133/CENIPA/2017

OCCURRENCE:	ACCIDENT
AIRCRAFT:	PT-ORU
MODEL:	210N
DATE:	22OCT2017

This is the Final Report of the 22OCT2017 accident with the 210N aircraft, registration PT-ORU. The accident was classified as “[LALT] Low Altitude Operations”.

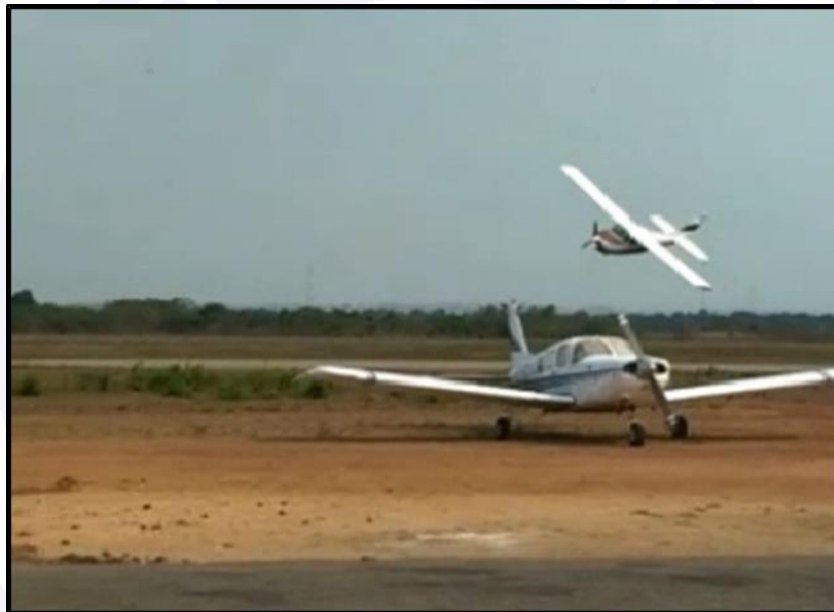
Figure 1 - PT-ORU Low altitude pass on one of the flights preceding the accident.

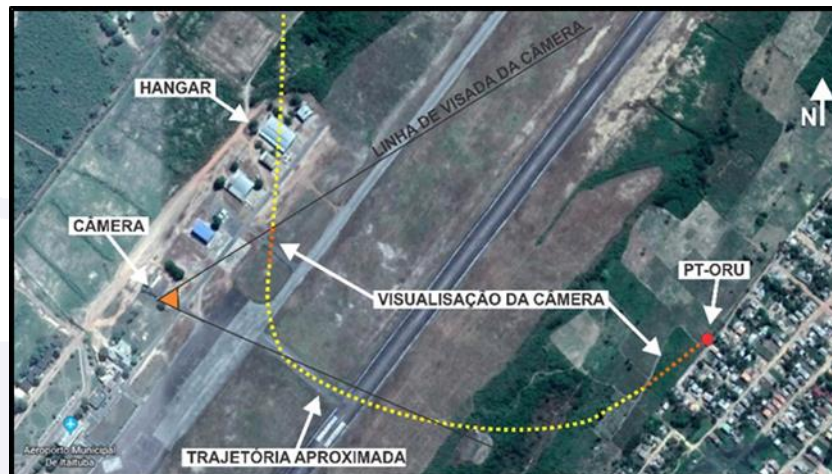
The take-off occurred at 2101 (UTC). However, about 4 minutes after takeoff, another security camera recorded the aircraft making a low altitude pass and performing a

rapid ascent. Soon after the aircraft appeared in recovery and colliding against the ground (Figure 2).

Figure 2 - Sketch of the accident, with the line of sight of the safety camera and approximate trajectory of the aircraft until the impact.

According to information, the aircraft would have performed an acrobatic maneuver (*tonneaux*), but this was not successful.

During the evolution, the aircraft approached the ground in an abnormal attitude and, due to the low altitude, it was not possible the recovery of the flight, denoting an inadequate application of the flight commands.

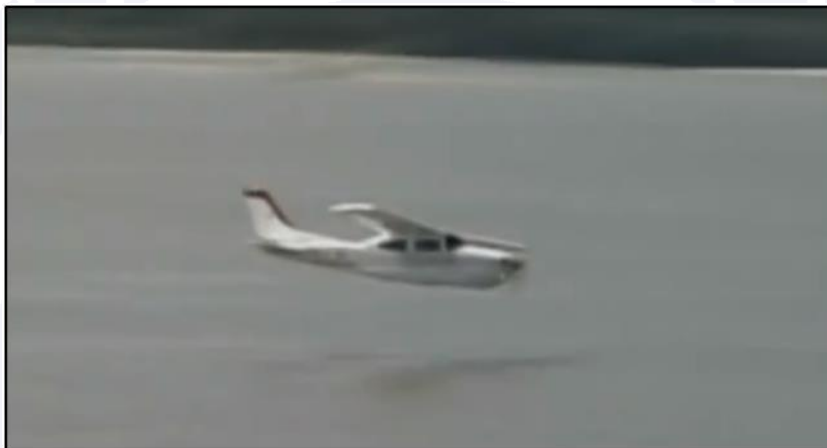
During the investigation, it was verified that it was culture of the regional pilots' group to carry out these types of flight, including several videos and reports in this regard (Figures 3 and 4).

Figure 3 - Image of the Tapajoara TV with an aircraft passing about 10ft over the Tapajós River, in Itaituba - PA, on the Aviator's Day.

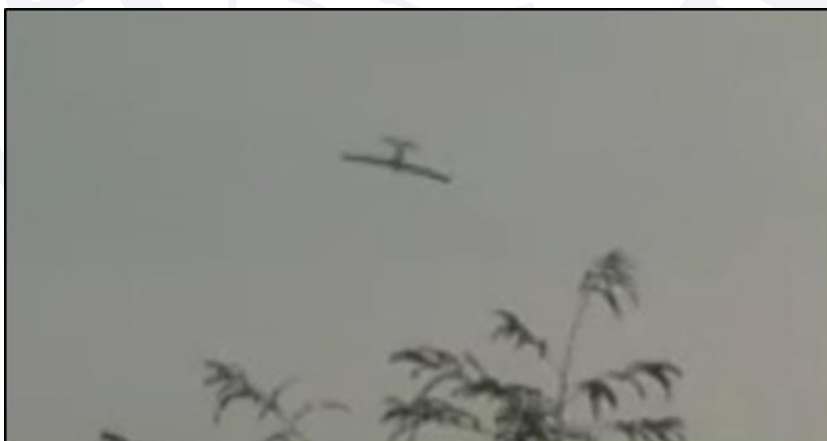
Figure 4 - Image of social medias in which an aircraft performs acrobatic maneuver in Itaituba - PA.
