FINAL REPORT
A - 031/CENIPA/2018

OCCURRENCE:	ACCIDENT
AIRCRAFT:	PT-VKR
MODEL:	EMB-720D
DATE:	22FEB2018

This is the Final Report of the 22FEB2018 accident with the EMB-720D aircraft, registration PT-VKR. The accident was classified as “[LOC-I] Loss of Control in-Flight”.

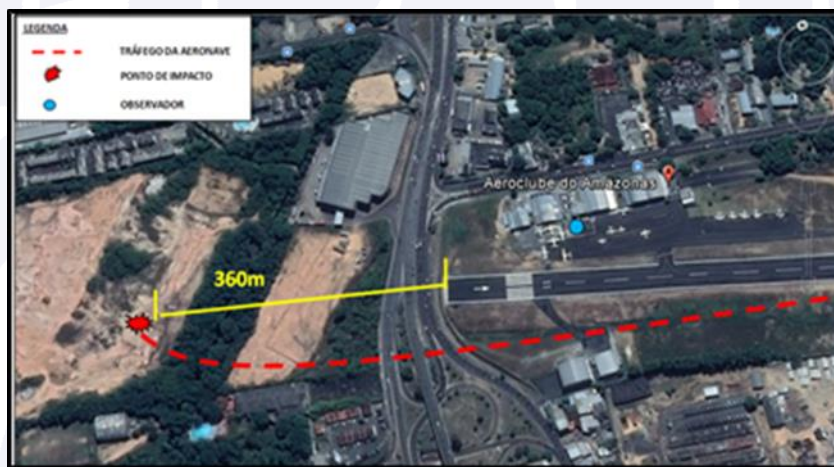
The impact occurred on an open ground near Torquato Tapajós Avenue, in Manaus - AM, approximately 360m away from SWFN threshold 11, and there was no evidence of previous impact. The wreckage distribution was of the concentrated type.

Figure 1 - Sketch of the accident, showing the air view of the impact site and its position in relation to the SWFN threshold 11. The dashed red line shows the route covered by the aircraft until the moment of impact.

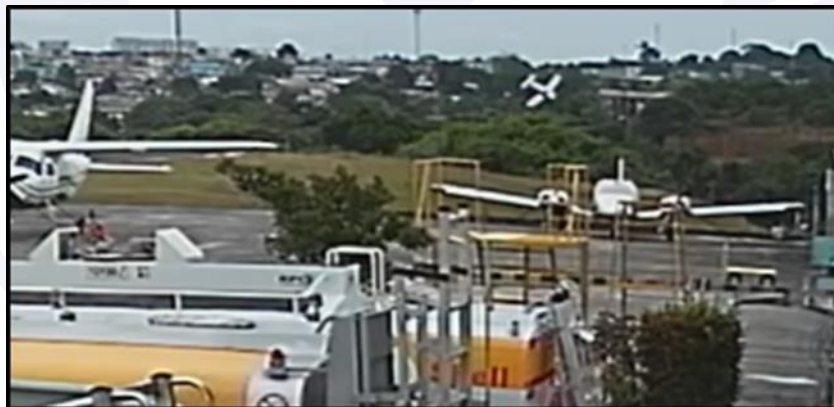
Figure 2 - Aircraft image moments before the impact, taken from the security camera of the Amazonas Aeroclub.

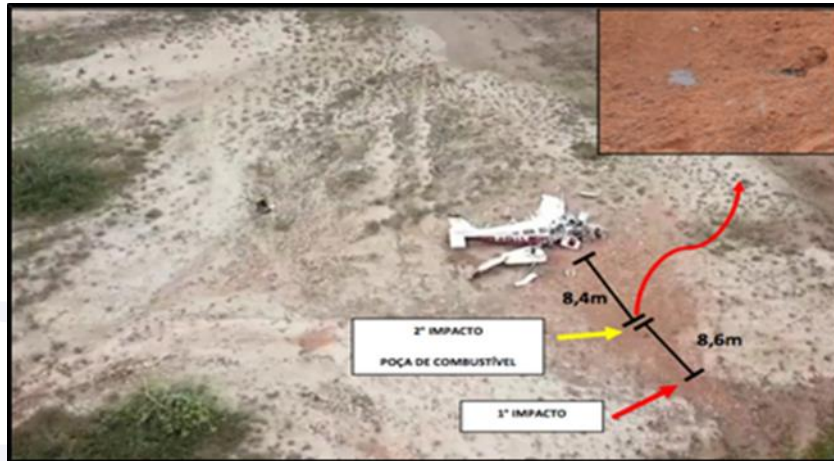
The first impact occurred in a pitch down attitude, approximately 30° , and inclined close to 45° to the right. The impact marks, located 17m from the aircraft's final stop location, were produced by the right wing, causing its twisting in relation to the fuselage, as well as the rupture of the fuel system, which caused the formation of a puddle (Figure 3).

Figure 3 - Overview of the wreckage. The red arrow indicates the 1st point of impact, and the yellow arrow the point of the 2nd impact. In detail, the fuel puddle.

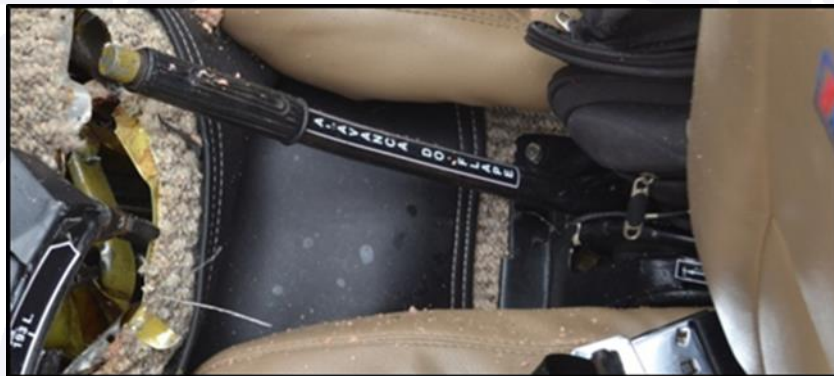
The flaps were retracted, according to the position of the control lever (Figure 4).

Figure 4 - View of the interior of the aircraft. It has been checked the position of the control lever of the flaps in the totally retracted position.

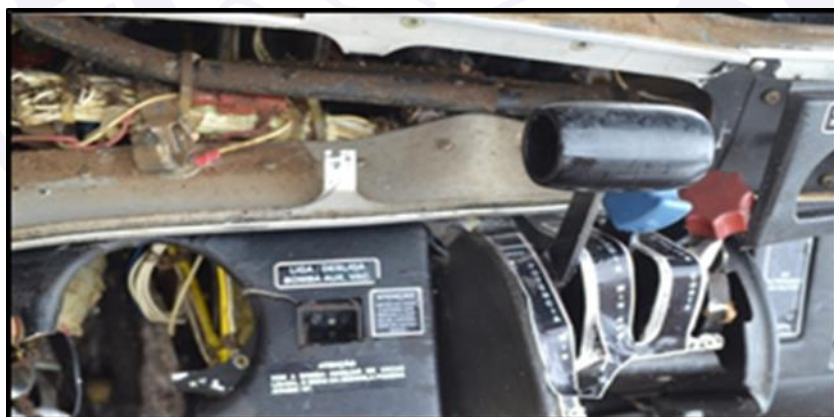
The power, propeller and fuel levers were close to the maximum power, maximum RPM and rich mix markings, respectively. However, as the impact violence caused a warping in the gearbox, it is possible that they have moved (Figure 5).

Figure 5 - Approximate view of the center console, with the levers and its positions.

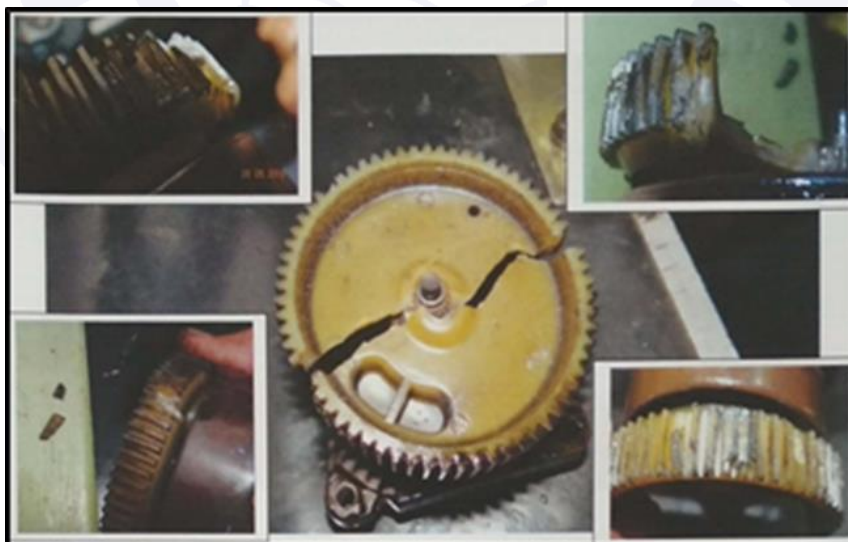
When it was handled, it was noticed that there was something loose inside the left magneto. Such alteration did not prevent the performance of the bench functional test. Initially, it showed spark at all the output terminals for the spark cables, and then it was concentrated in only one terminal.

The highlights of Figure 6 show that several distal gear teeth of the left magneto were damaged by kneading, crushing, or fracture.

Figure 6 - View of the gear and the various distal teeth of the left magneto damaged by dents or fractures.

The damages described may have led to the loss of synchronism of the magnetos, possibly causing the spark to be released out of the correct time, that is, the combustion of

the air / fuel mixture started inside the cylinders outside of the ideal angle. As a result, the engine may have presented failure, loss of power and rotation variation.

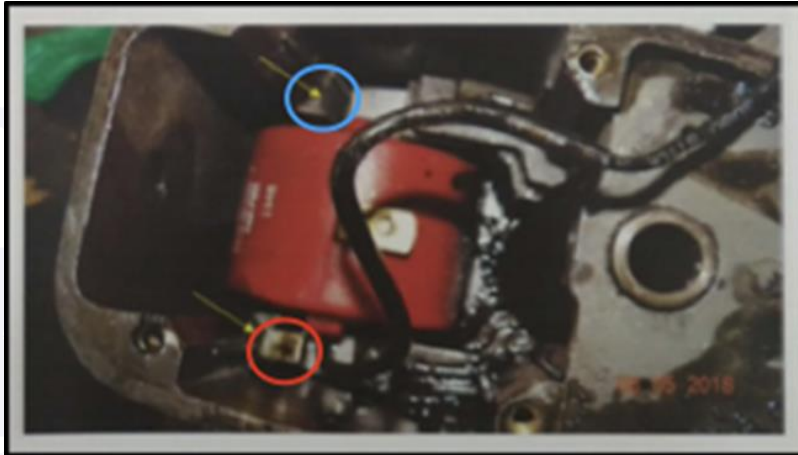
Figure 7 identifies that a lock of the high voltage coil of the left magneto was loose inside its housing.

Figure 7 - Approximate view of the open left magneto. The red circle identifies a latched high voltage coil latch and the blue circle shows the absence of the other latches.

The dismantling of the engine showed that it had little damage, due to the impact on the ground. However, when analyzing its internal components, it was found that the left magneto had the high-voltage coil lock loose, which came into contact with the gear teeth of the magneto distributor, damaging them.

As a result, the magneto lost its synchronism and possibly the spark started to be released outside the correct time, that is, the burning of the air / fuel mixture began to start inside the cylinders, outside the ideal angle that would justify a possible failure, power loss, or rotation variation in the aircraft's engine still in flight.

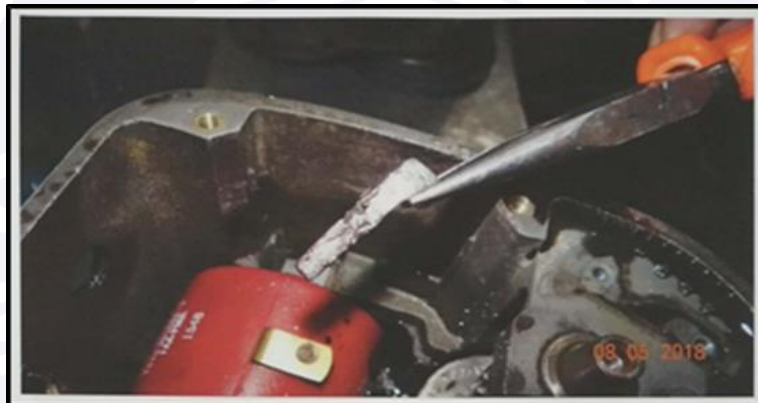
The lock was found, as shown in Figure 8. Several marks were observed due to contact with the gear teeth of both the rotor and the distributor.

Figure 8 - View of one loose coil lock inside the left magneto.

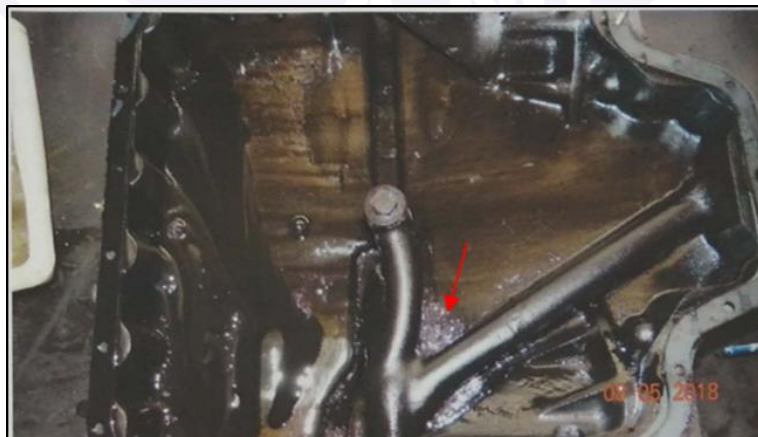
Another important finding was the presence of filings inside the engine crankcase (Figure 9) and the observed scratches on the lubricating oil pump housing.

Figure 9 - View of the engine crankcase interior. The red arrow indicates an accumulation of filings.

Despite the fact that considerable amounts of filings were found inside the crankcase, the report did not show that this fact interfered with the possible malfunction of the engine.

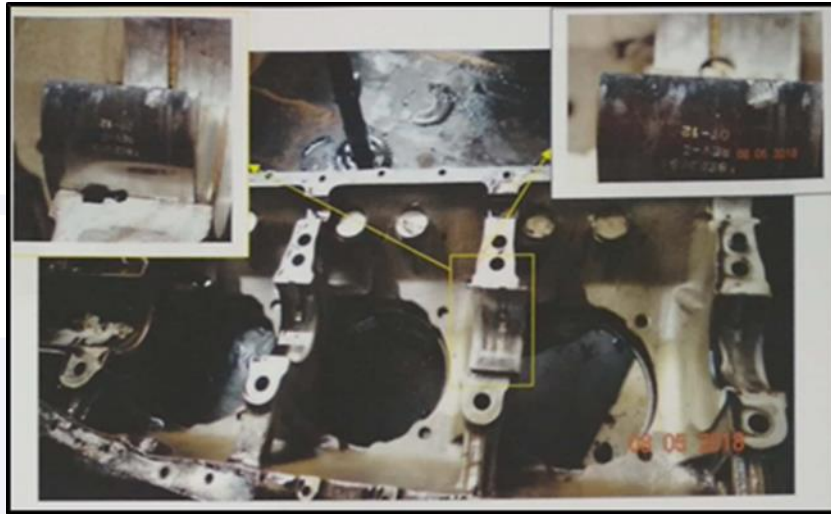
At the time the semi-carcasses were separated, it was observed that the rear intermediate bearings were without their guides (Figure 10).

Figure 10 - General view of the right side of the engine. The highlights show evidence of movement of the rear intermediate bearing bronzine.

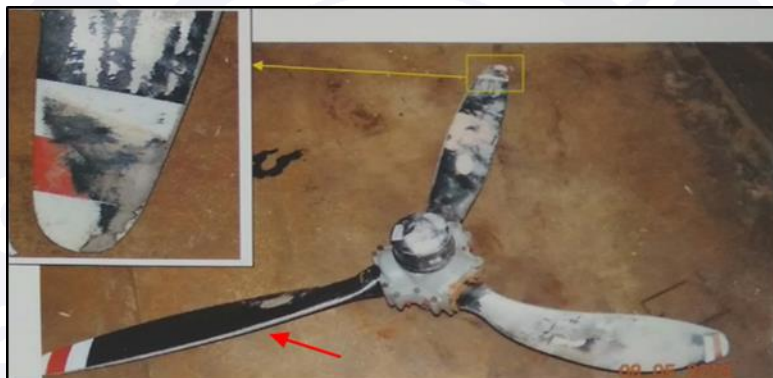
As shown in Figure 11, only one blade of the propeller presented transverse hazards (detail). A second blade presented kneading near its root and was probably the first to touch the ground. The third blade was practically undamaged.

Figure 11 - Overview of the propeller that equipped the PT-VKR. In highlight the blade with the transverse marks. The red arrow indicates the blade that has not been damaged.

The transverse hazards, deformations and folds encountered in the propeller blades showed that, at the moment the aircraft collided with the ground, the engine did not develop high power.

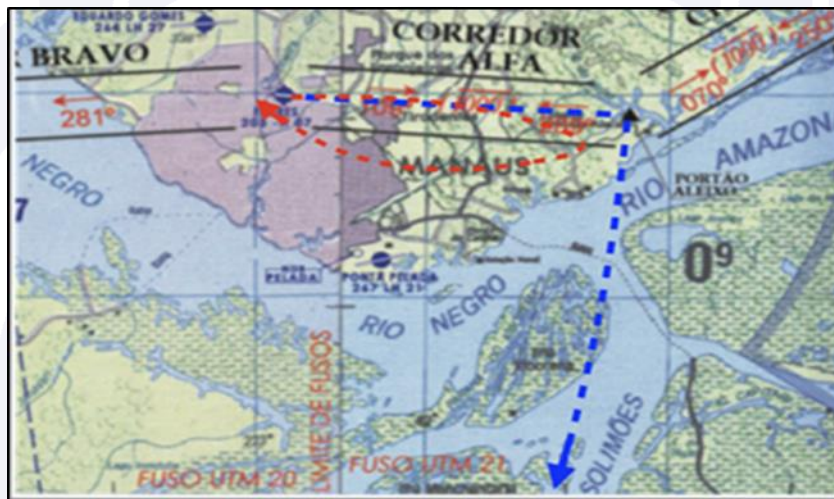
Until moments before the accident, the communications went normal. The APP-MN initially authorized the PT-VKR to maintain "one thousand feet" in the profile of the "Aleixo" exit and, subsequently, authorized 3,500ft climb on the head of "Borba" (Figure 12).

Figure 12 - Special Aircraft Routes in Visual Flight in the Terminal Control Area of Manaus - AM (REA AIC N11 / 10). The blue dash indicates the route authorized by APP-MN, and the red arrow indicates the route traveled by the aircraft until the time of the accident.

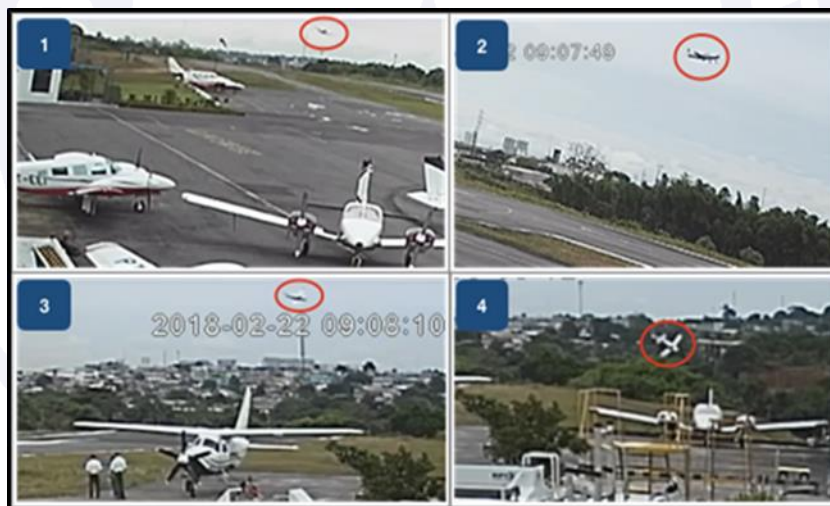
The aircraft continued to fly over the runway and, according to the perception of some people who were in the place, it did not present power in the engine. When turning to return to the runway by threshold 11, the aircraft collided with the ground (Figure 15).

Figure 15 - Photographic sequence of the route of the aircraft, from the go-around procedure until seconds before the impact, taken from the safety camera of the Amazonas Aeroclub.
