COMANDO DA AERONÁUTICA
CENTRO DE INVESTIGAÇÃO E PREVENÇÃO DE
ACIDENTES AERONÁUTICOS

FINAL REPORT
A - 159/CENIPA/2015

PT-VNC

EMB-720D

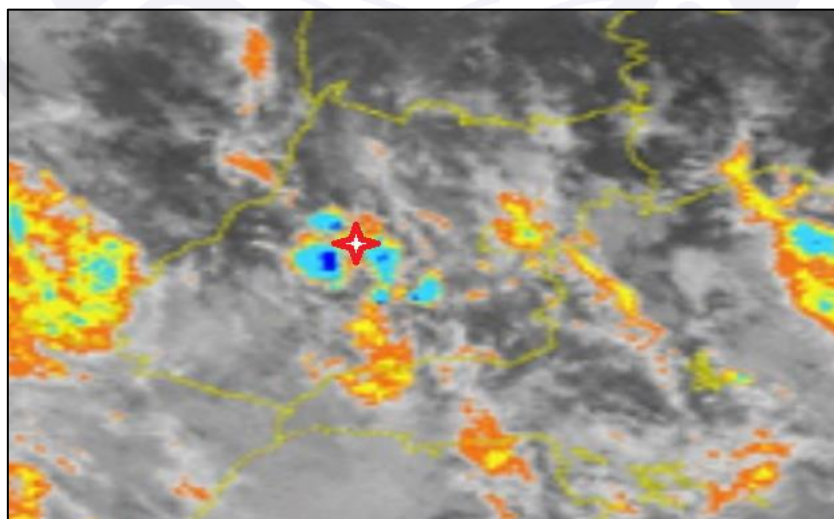
The conditions were not favorable for the visual flight, as reported by observers and the visualization of satellite images (Figures 1 and 2).

Figure 1 - Highlighted satellite image 13h30min (UTC).

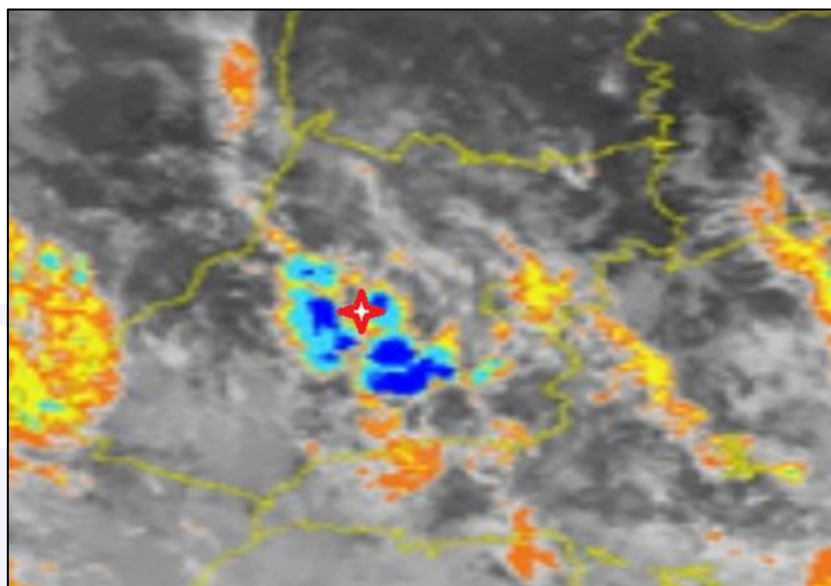
Figure 2 - Highlighted satellite image 14:00h (UTC).

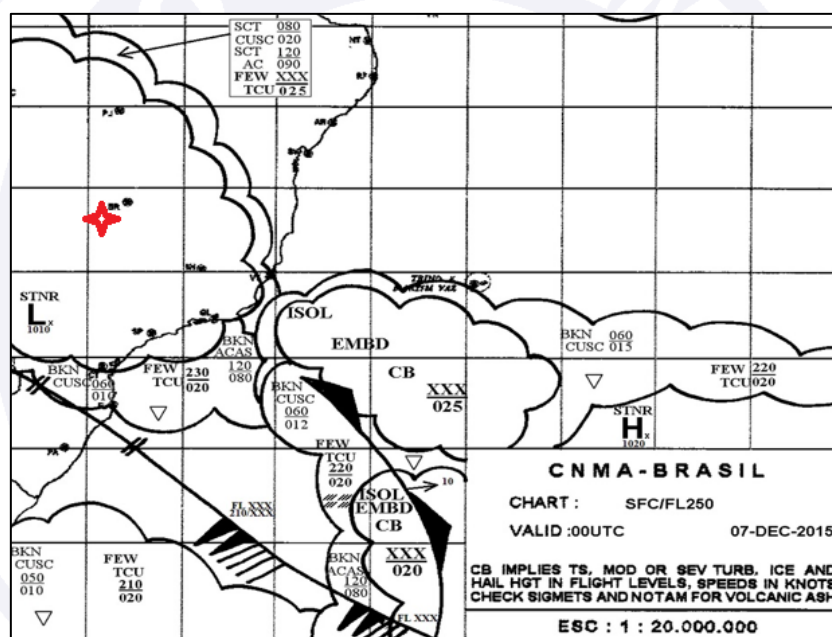
The Significant Weather Chart (SIGWX) generated at 09:57 (UTC), valid until 00:00 (UTC), illustrated the presence of Towering Cumulus clouds (TCU) based on 2,500ft and top in the FL230.

Figure 3 - SIGWX valid till 07DEC2015 00:00 (UTC).

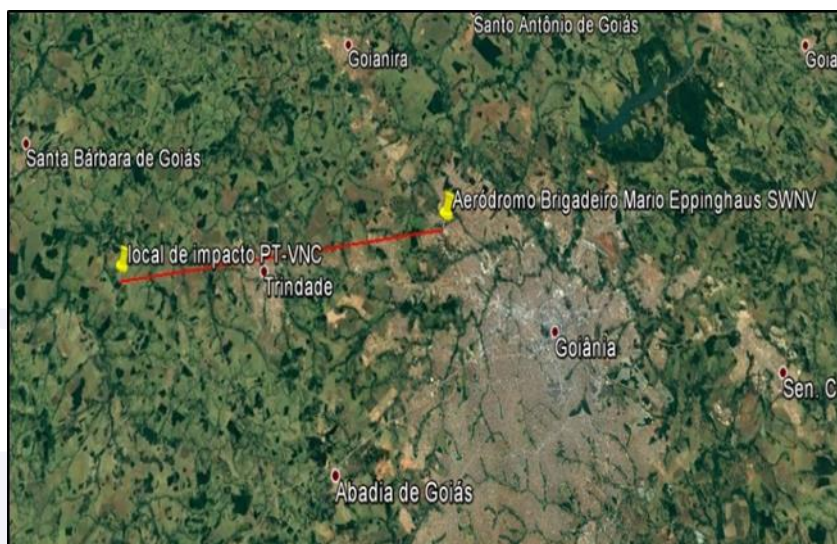
The accident occurred about 20 nautical miles away from SWNV (Figure 4), that is, still within the limits of the Anápolis Terminal Control Area (TMA).

Figure 4 - Distance between the impact site and SWNV.

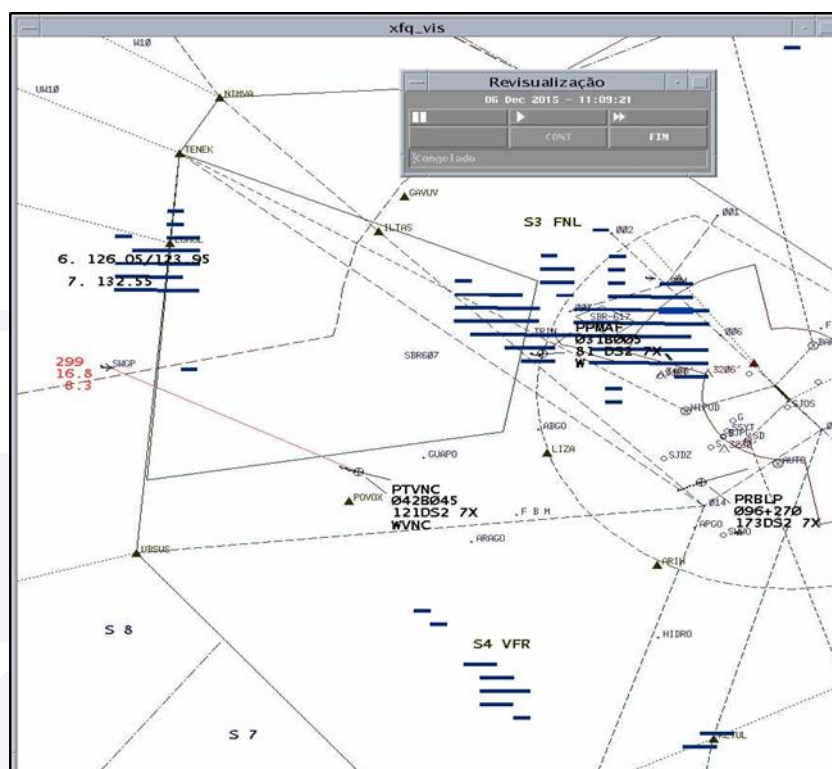
After flying a few minutes in a direction opposite to the ideal one, the aircraft took the SWGP head, where, according to radar images and witnesses statements, made the landing and remained on the ground for a few moments.

Figure 6 - Aircraft flying on the opposite head of the flight plan.

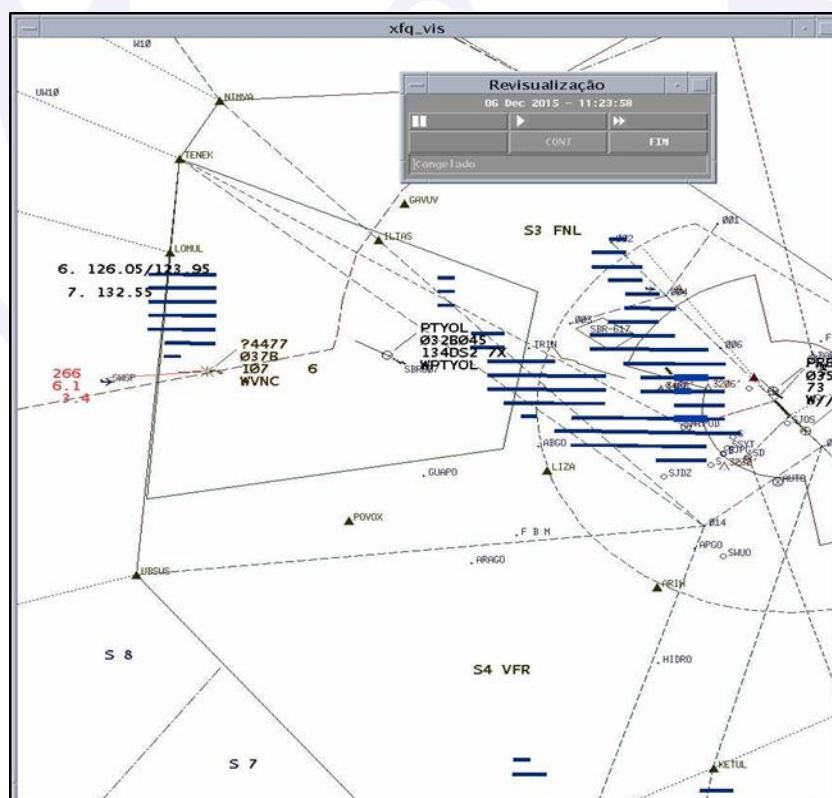
At 1124 UTC, the Approach Control (APP) Anápolis was informed of the aircraft's landing in SWGP, according to information from ground observers and the print of the radar screen.

Figure 7 - Print of the radar screen with the approximate landing time in SWGP.

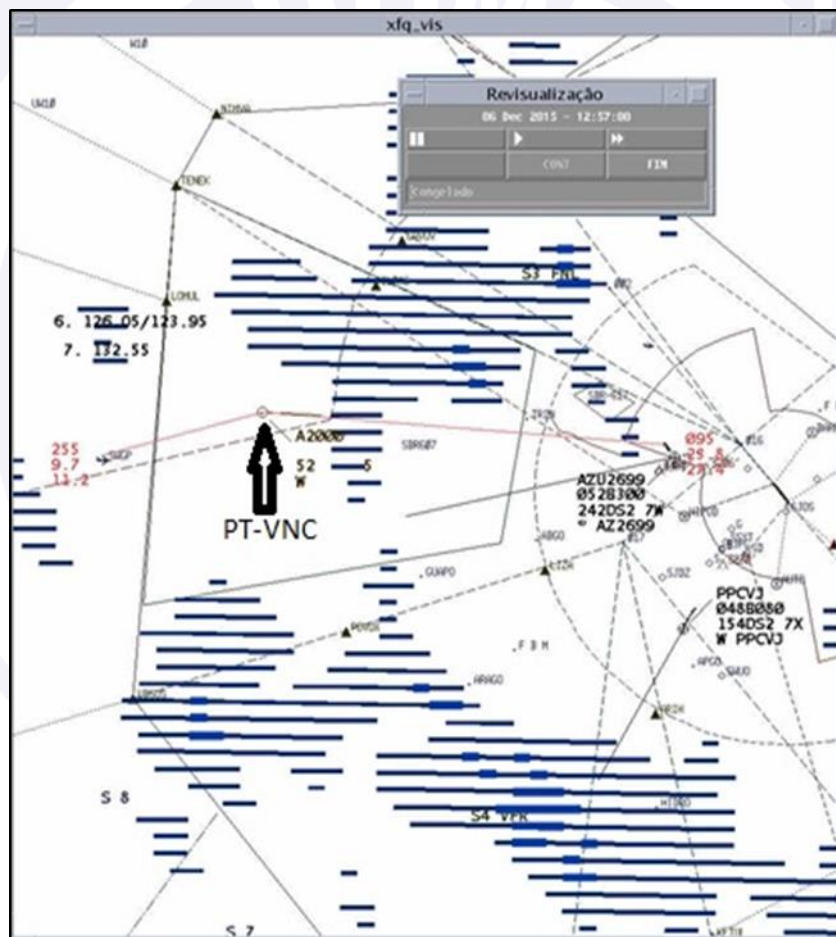
At 1257 (UTC), a copy of the radar screen of Anápolis was made, moments after the aircrafts' takeoff from SWGP to SWNV. The aircraft did not contact the air traffic control agencies, but had made a return flight plan (Figures 8 and 9).

Figure 9 - Moment of the aircraft's radar visualization at the beginning of the return.

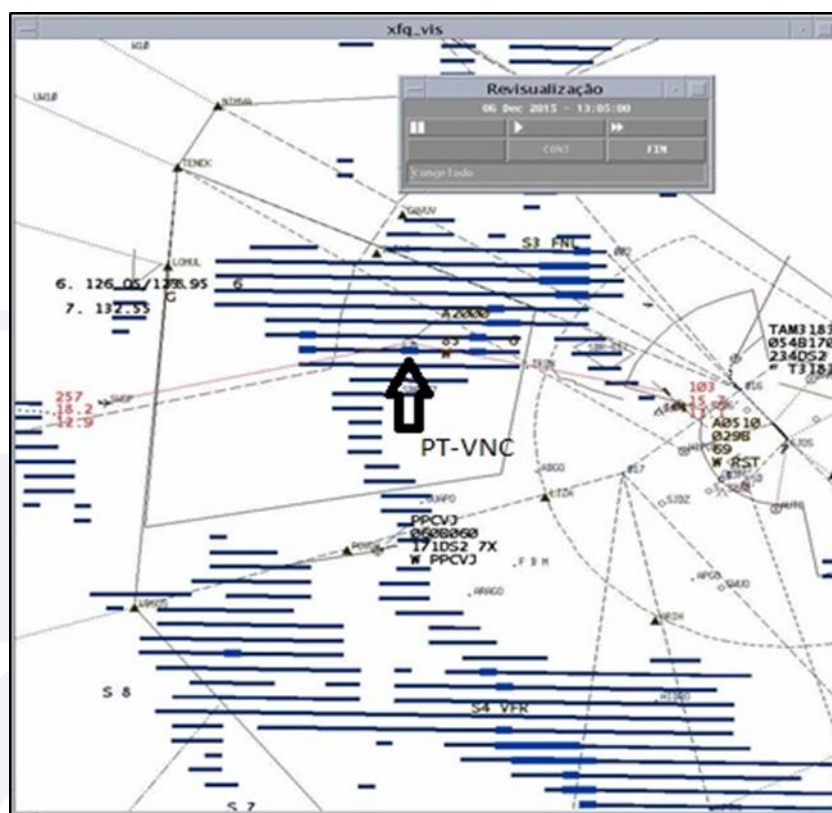
At 1305 (UTC), with the 2000 code on the transponder, PT-VNC was flying within adverse weather formations (convective formations). The aircraft performed flights in circles until it disappeared from the radar screen (Figure 10).

Figure 10 - Last view of the aircraft on the radar screen.

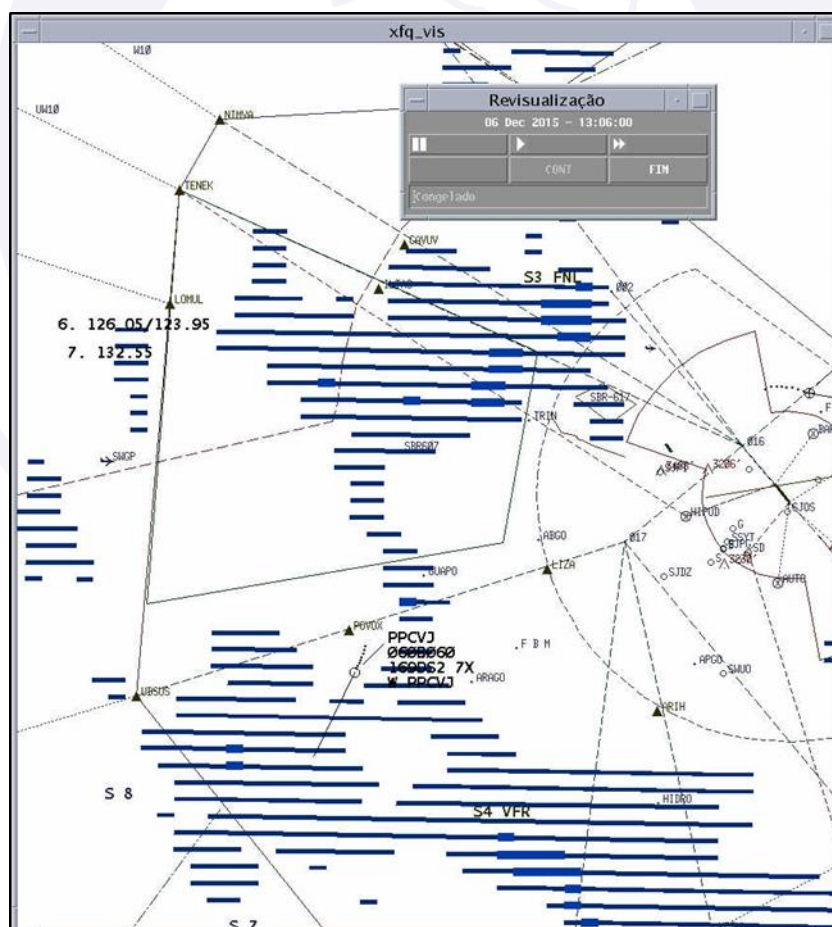
At 1306 (UTC), the air traffic control lost radar contact with the aircraft. (Figure 11).

Figure 11 - Time when the APP loses the radar contact with the aircraft.

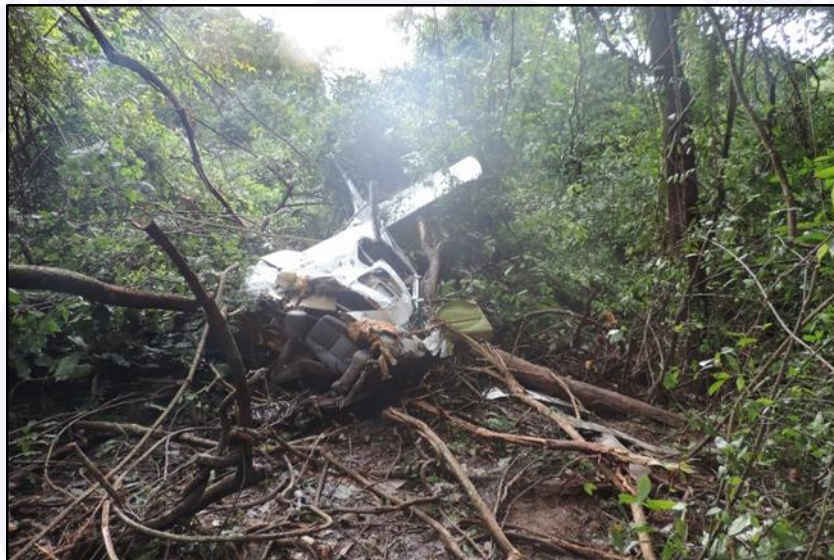
The first impact was between the right wing and a tree in the forest where the aircraft crashed. After the first impact, the right wing detached itself from the fuselage and, after the impact to the ground, the engine detached itself from the fuselage. The degree of destruction prevented the verification of equipment and instruments (Figures 12 and 13).

Figure 12 - View of the aircraft without the wings and without the engine, after the occurrence.

The impact against the terrain and how the wreckage was found indicated that a violent collision occurred on the ground, cutting large trees, which demonstrated that the aircraft hit the ground with a large amount of kinetic energy.

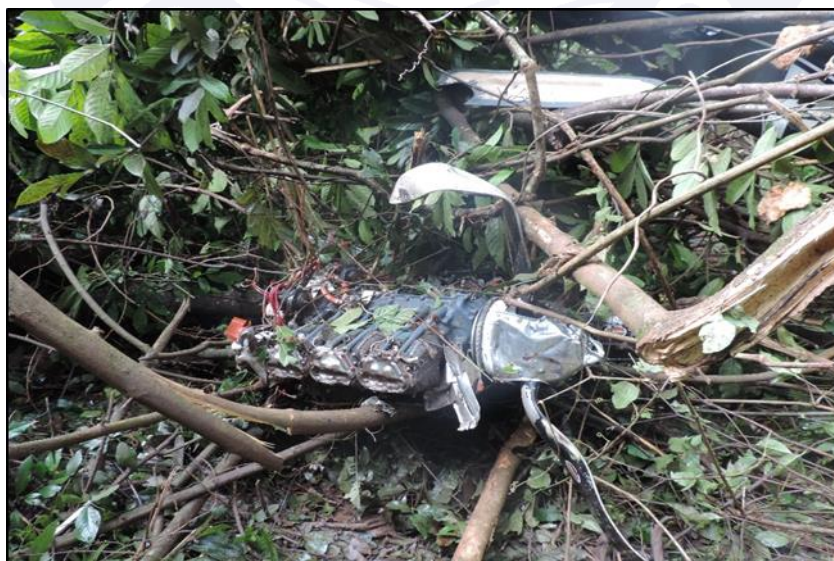
Figure 13 - View of the aircraft engine after the occurrence.

According to the examination performed on the engine during the research, it was evidenced that it was operational and did not present mechanical problems. The development of power could be observed in at least two propellers, which presented a slight folding forward.
